Subject: N222378271 - Customer Satisfaction Program
Vehicle Software Configuration Management Update

Models: 2023 Cadillac LYRIQ

N222378271 Vehicle Software Configuration Management Update

Condition	Certain 2023 model year Cadillac LYRIQ vehicles may have multiple software issues such as no audio, flashing cornering lamps, or lighting concerns.
Correction	Dealers will confirm the over-the-air updates are installed. Various modules will be manually updated by the dealer with the latest software.

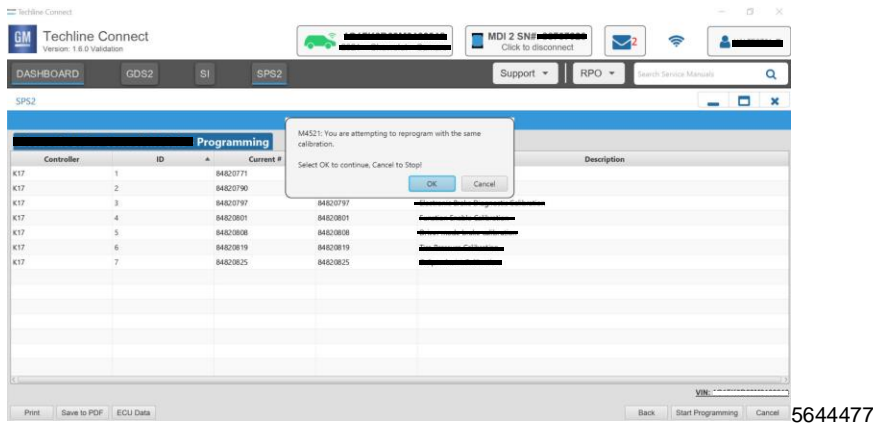
Important: Techline Connect screens shown above.

Important: If the same calibration/software warning is noted on the TLC Summary screen, select OK and follow screen instructions. After a successful programming event, the WCC is located in the Service Programming System dialogue box of the SPS Summary screen. No further action is required. Refer to the Warranty section of the bulletin.

1. Reprogram the Forward Range Radar Sensor – Long Range, Power Steering Control and Front View Camera modules. Refer to *B233B Forward Range Radar Sensor - Long Range: Programming and Setup*, *K43 Power Steering Control Module: Programming and Setup* and *B174W Front View Camera - Windshield: Programming and Setup* in SI.
