Jib Support Replacement (Effer — Campaign ID: CL202217)

CIRCULAR LETTER

Campaign id: CL202217

JIB support replacement

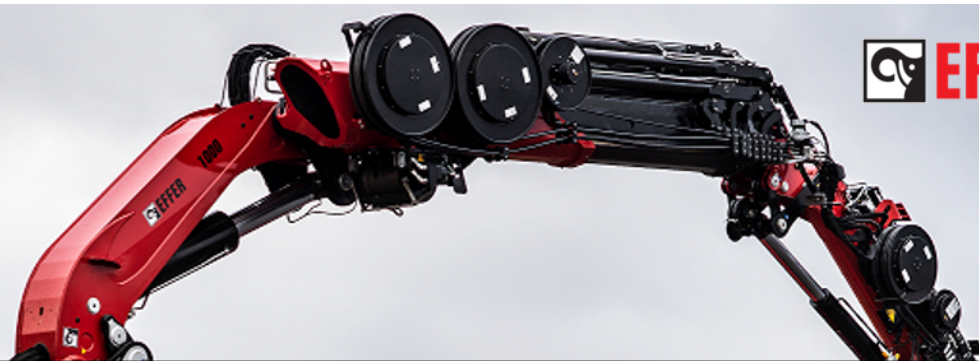
Based on information from the market, we found a problem with the JIB support in crane model EFFER 505. During the transport of the crane, we could see some bouncing movements of the JIB against its support. Thus, Effer R&D decided that in these cases it is necessary to replace the JIB support.

First, replace the JIB support.

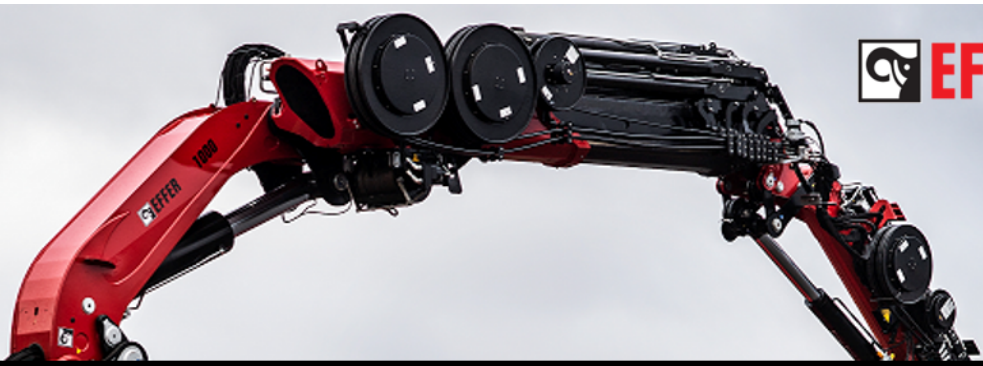
Where the rib is welded to the tubular of the boom, the crack is probably on all the thickness of the tubular plate. If the crack is not visible to the unaided eye, perform an LPI (Liquid Penetrant Inspection) or similar test on the internal surface (Step 1 in the drawing below). If the crack is passing through the plate (so it is also in the internal surface), start to repair it by grinding from inside the boom (Steps 2, 3, 4, and 5 in the drawings below). If the crack is not inside, you can repair it only from the external side (Steps 4 and 5 in the drawings below).

1. Remove the boom from the crane.
2. Remove the extensions and all the parts that can hinder the repair of the boom.
3. Clean, remove the paint from the affected area(s) and degrease the boom before proceeding with the next steps. Clean accurately the surface inside the tubular of the 2nd boom.
