Technical product information

Topic	Clicking noises from the left and/or right front corner(s)
Market area	Bentley: worldwide (2WBE)
Brand	Bentley
Transaction No.	2052853/11
Level	EH
Status	Approval
Release date

Bentayga series

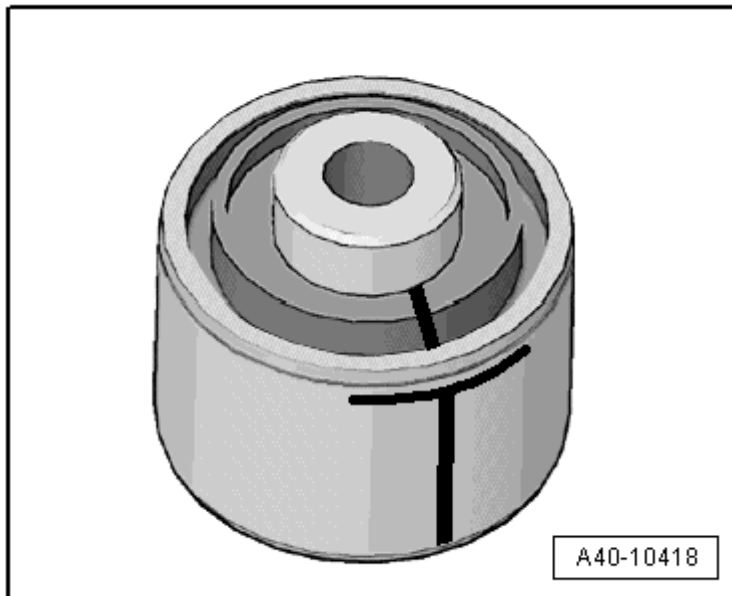
- Transfer marking for installation depth from old bonded rubber bush to new bush.

- Apply a thin coat of assembly paste - G 052 566 A2 - to bonded rubber bush.
- Insert bonded rubber bush -1- into track control link -2-. Align mark -3- with -4-.
- Set up special tools as shown in illustration.
- Press bonded rubber bush into track control link, taking care to keep it straight.
- Use marking -arrow- made before removal as a guide.
