| HYUNDAI Technical Service Bulletin | GROUP BODY ELECTRICAL | NUMBER 23-BE-001H |
| | DATE JANUARY, 2023 | MODEL(S) SANTA FE (TMA) SANTA FE HYBRID (TM HEV) SANTA FE PLUG-IN HYBRID (TM PHEV) PALISADE (LX2) |
| SUBJECT: TPMS DTC(S) WITH SURROUND VIEW MONITOR | | |

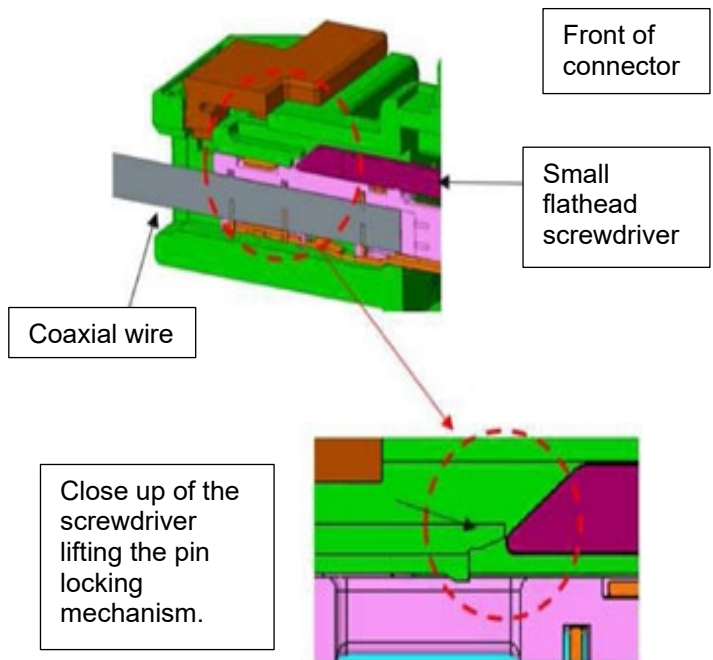
Inspect the female pins for deformation. Measure the distance between vertical sides to ensure they are within specification.

Spec: 3.55~3.67mm
