GENESIS

## Technical Service Bulletin

23-01-001G

SIDE SILL BODY PANELS INSPECTION AND REPAIR  
(SERVICE CAMPAIGN T23G)

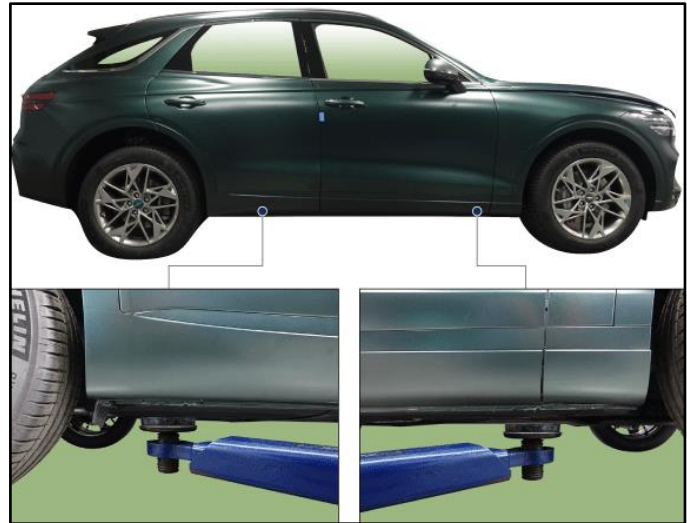
2. Inspect the underside and backside of side sill body panel in the indicated area (A).

Inspect the indicated area (A) on both sides of the vehicle.
