Body/Chassis – Water Leak From Roof Area

22-23MY Range Rover, 23MY Range Rover Sport SVR

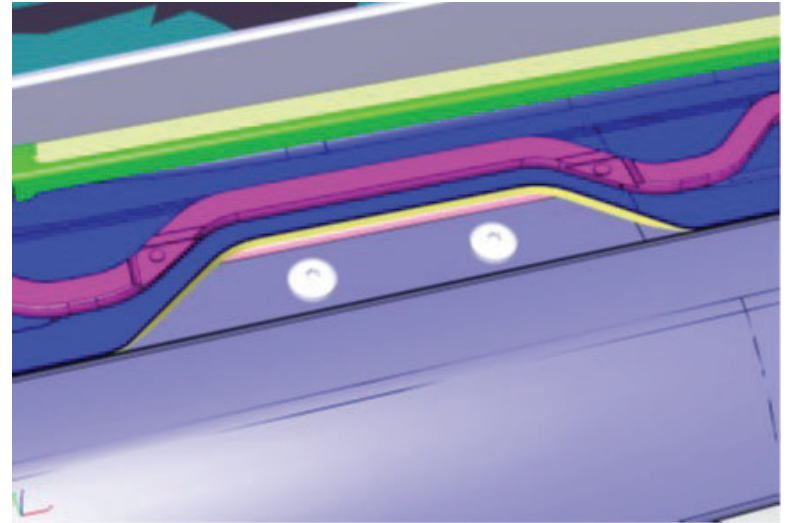
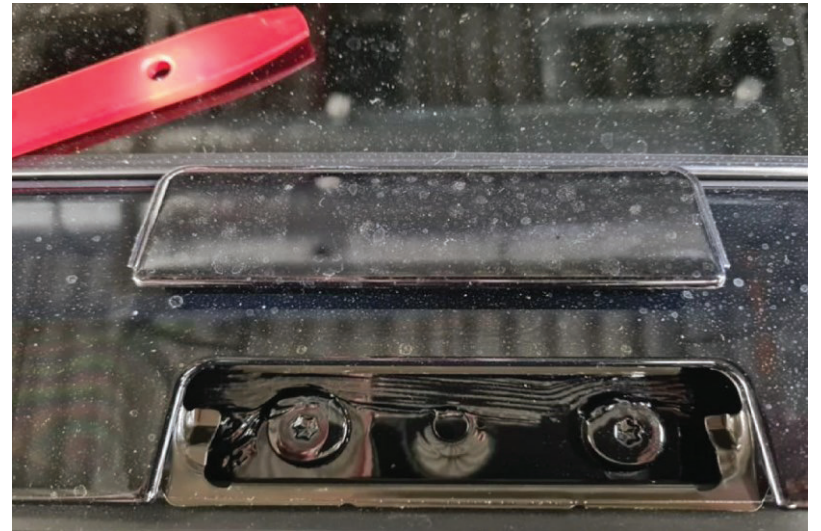
- Water may enter the vehicle cabin through a roof body seam or gap in the panoramic roof opening panel cassette sealant.

Seal this area
