Technical Service Bulletin

CVT BELT CHECK - SERVICE MANUAL REVISION

TSB-23-23-001

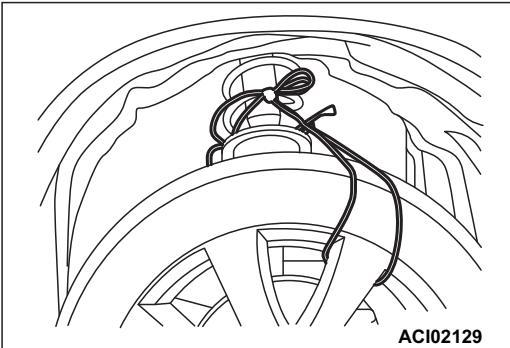
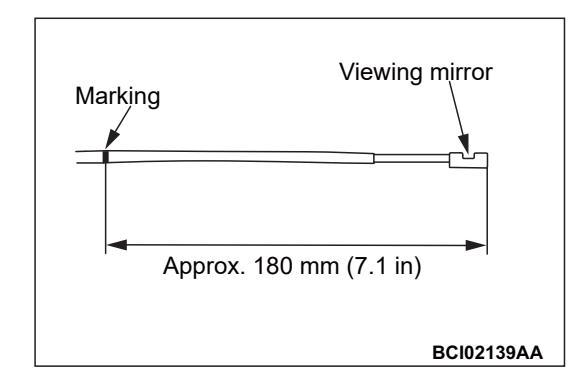
Check the CVT fluid and the inside of the oil pan. If a large metal chip is found, abort the operation and replace the CVT assembly (Refer to GROUP 23A - Transaxle assembly).

8. Refer to the OK samples and the damage samples below to determine the condition of the flanks (grooved surfaces) of belt elements. When a damage is found on the flanks of the belt elements, replace the CVT assembly (Refer to GROUP 23A - Transaxle assembly).
