# QUALITY ACTION

# CAMPAIGN BULLETIN

## Front Bumper/Headlamp Dealer Inventory

Reference: P2A21  
Date: January 18, 2023

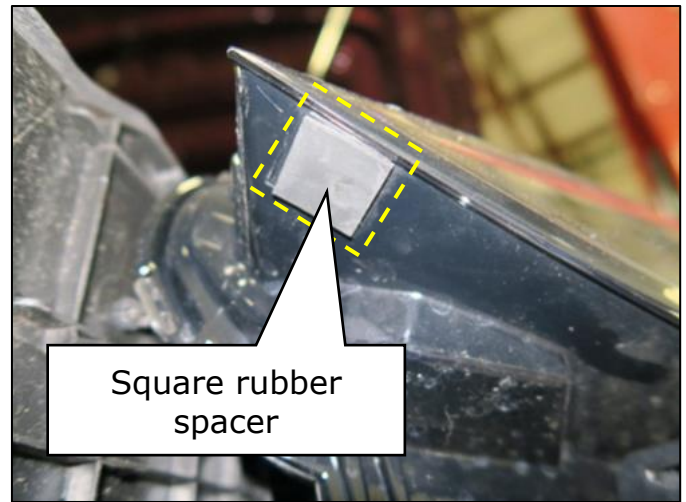
Figure 28

25. Locate and remove the square or triangle foam spacer from both headlamps. (Figure 28)

- Remove the residual adhesive using either a 70% isopropyl alcohol Prep pad or 3M adhesive remover

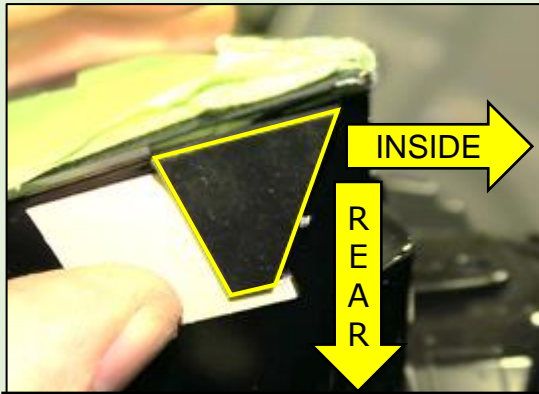
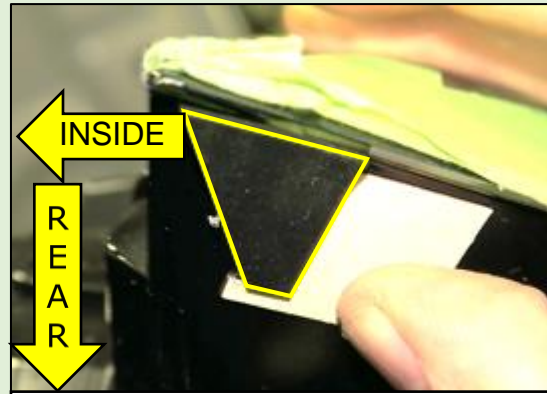
The rubber triangle spacers are different for LH and RH headlamps. Refer to the below descriptions and Figure 30 for identifying and the correct spacers.

- The long angled edge of the spacer will face the inside of the vehicle.
- The short flat edge will face toward the rear of the vehicle
- Print and cut out the spacer alignment template on the last page
