Technical Service Bulletin

60 Panoramic sunroof noises

60 23 62 2054203/5 February 6, 2023. Supersedes Technical Service Bulletin Group 60 number 20-40 dated March 12, 2020, for reasons listed below.

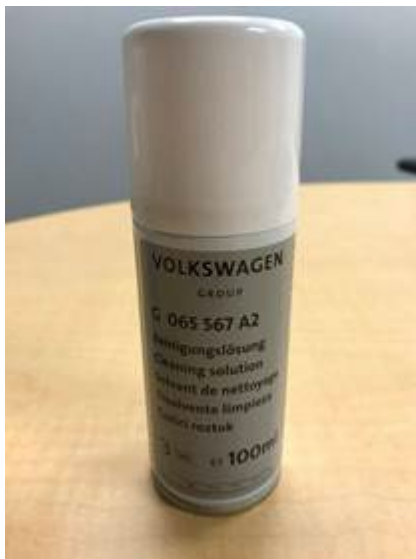
Figure 1. All purpose cleaner: **G 065 567 A2.**

The only maintenance materials approved for use on the sunroof frame are the cleaner and lubricant specified above. Alternative cleaners and lubricants used on this sunroof mechanism may cause permanent mechanical damage and worsen the level of noise from the sunroof mechanism.

If the sunroof mechanism has been lubricated with an unapproved lubricant it must be thoroughly cleaned off of the mechanism components using the cleaner G 065 567 A2 and lubricated with the approved lubricant G 060 567 A2.

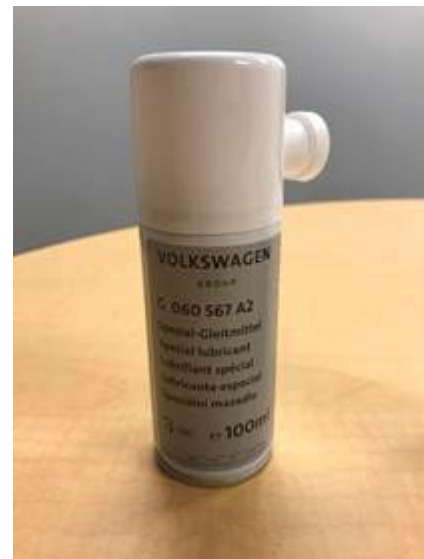
Figure 2. Special lubricant: **G 060 567 A2.**
