<b>REFERENCE:</b>	<b>TSB:</b> 08-008-23 <b>GROUP</b> 08 - Electrical	<b>Date:</b>	January 12, 2023	<b>REVISION:</b>	08-117-21, 08-102-21 and 08-016-19 REV. F
<b>VEHICLES AFFECTED:</b>	<p>2018 - 2022 (LA) Dodge Challenger                  2018 - 2022 (LD) Dodge Charger                  2018 - 2022 (LX) Chrysler 300                  2018 - 2021 (DS) RAM 1500 Pickup                  2018 (DJ) RAM 2500 Pickup                  2018 (D2) RAM 3500 Pickup                  2018 (DD) RAM 3500 Cab Chassis                  2018 (DF) RAM 3500 &lt;10K Cab Chassis                  2018 (DP) RAM 4500/5500 Cab Chassis</p> <p><b>NOTE:</b>This bulletin applies to vehicles equipped with a Uconnect 4C With 8.4" Display radio (Sales Codes UAS or UCS).</p>			<b>MARKET APPLICABILITY:</b>	
<b>CUSTOMER SYMPTOM:</b>	<p><b>Customers may experience one or more of the following:</b></p> <ul style="list-style-type: none"> <li>• **Wi-Fi hotspot connection failure.</li> <li>• Speaker popping, crackle noise during Voice Recognition (VR) response and navigation guidance.</li> <li>• Mobile Station Integrated Services Digital Network (MSISDN) missing from radio, no connected services working.**</li> <li>• Wireless con

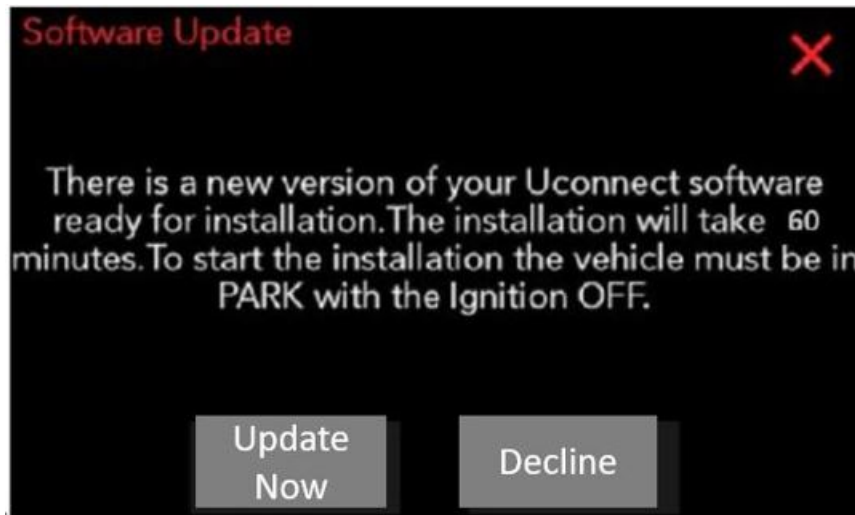
Fig. 6

Software Update Is Available

12. Once the system has verified there is an available update, press the “Update Now” button. Make sure the vehicle is in park, **DO NOT** turn off the ignition (Fig. 6) .
