GLOBAL SAFETY FIELD INVESTIGATIONS  
DCS6453  
URGENT - DISTRIBUTE IMMEDIATELY

Subject: REVISION: N212355140-01 – Service Update  
Diesel Engine Control Module Diagnostics  
Updated Warranty Period, Title, and Condition Statement

Models: 2021-2022 Cadillac Escalade, Escalade ESV  
2021-2022 Chevrolet Suburban  
2021-2022 Chevrolet Tahoe  
2021-2022 GMC Yukon, Yukon XL  
Equipped with 6-cylinder, 3.0L Diesel engine (RPO LM2)

## N212355140 Diesel Engine Control Module Diagnostics

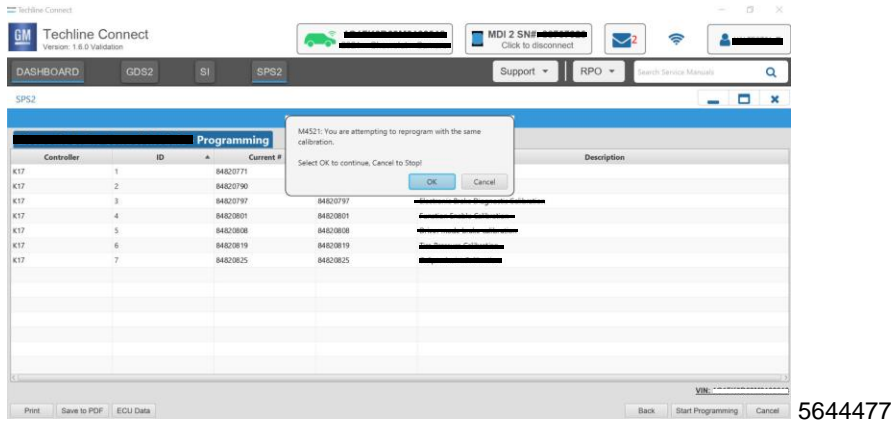
5644477

**Important:** Techline Connect screens shown above.

**Important:** If the same calibration/software warning is noted on the TLC Summary screen, select OK and follow screen instructions. After a successful programming event, the WCC is located in the Service Programming System dialogue box of the SPS Summary screen. No further action is required. Refer to the Warranty section of the bulletin.
