Service Bulletin

Bulletin No.: 22-NA-229

Subject: Possible Audible Knock Due to Reduced Knock Sensor Detection Capability DTC P0325, P0330, P0326, P0331, P06B6 or P06B7 May be Set in History

Brand:	Model:	Model Year:		Break Point:		Engine:	Transmission:
		from	to	from	to		
Cadillac	Escalade	2023	2023		December 5, 2022	6.2L RPO (LT4)

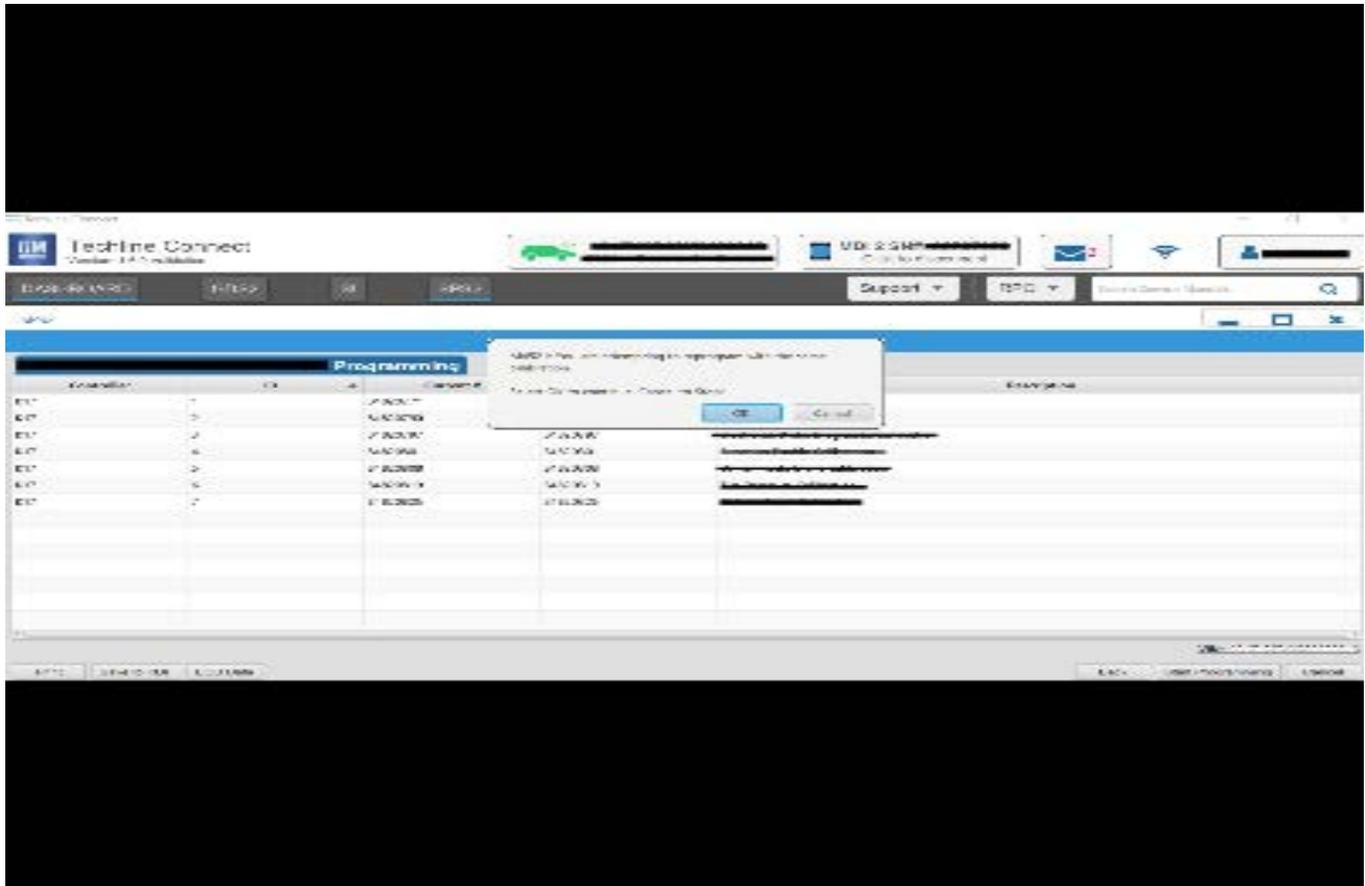
5644477

Caution: Be sure the VIN selected in the drop down menu (1) is the same as the vehicle connected (2) before beginning programming.
