**From:** [REDACTED]  
**Sent:** Wednesday, January 18, 2023 5:14 PM  
**To:** [REDACTED]  
[REDACTED]  
[REDACTED]  
**Subject:** Remote fuel hose/ PN 6316754

# Screening Instructions- Remote Fuel Line

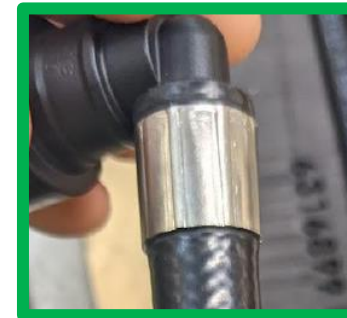
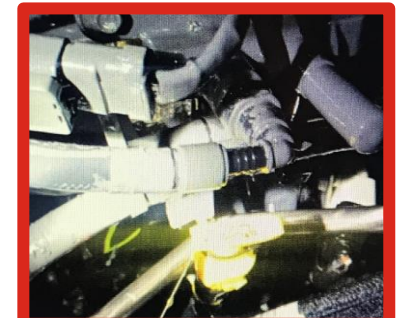
- Fuel leak on remote fuel line (low pressure side).

- TBD – Awaiting failed parts return.
- Suspect assignable cause is insufficient crimping. – Returned parts will be analyzed to validate suspect assignable cause.

- Containment hold initiated on in house engines to replace 6316754 remote fuel lines with 5717302 in house at RMEP
- Initiated lineset hold on production of engines at RMEP with 6316754 remote fuel lines.
- Inspection hold and quarantine of 6316754 inventory implemented.
- Inspection hold and quarantine of similar parts manufactured by same supplier.

- Investigate similar parts manufactured by same supplier that have a tentative start date of 1/23/2023.
- Supplier evaluating improvements to pressure testing capabilities.
- CMI engineering to review testing requirements on print/design standards.
- Checks to be performed at Paccar & Kenworth Mexicana for engines built with 6316754 to screen product based on initial supplier investigation.
- Instructions to be provided to Cummins BIS team to perform the checks.
