Service Bulletin

Bulletin No.: 19-NA-076

Subject: Blue or Black Screen and Service Rear Vision System Message on Radio Display Shifting into Reverse

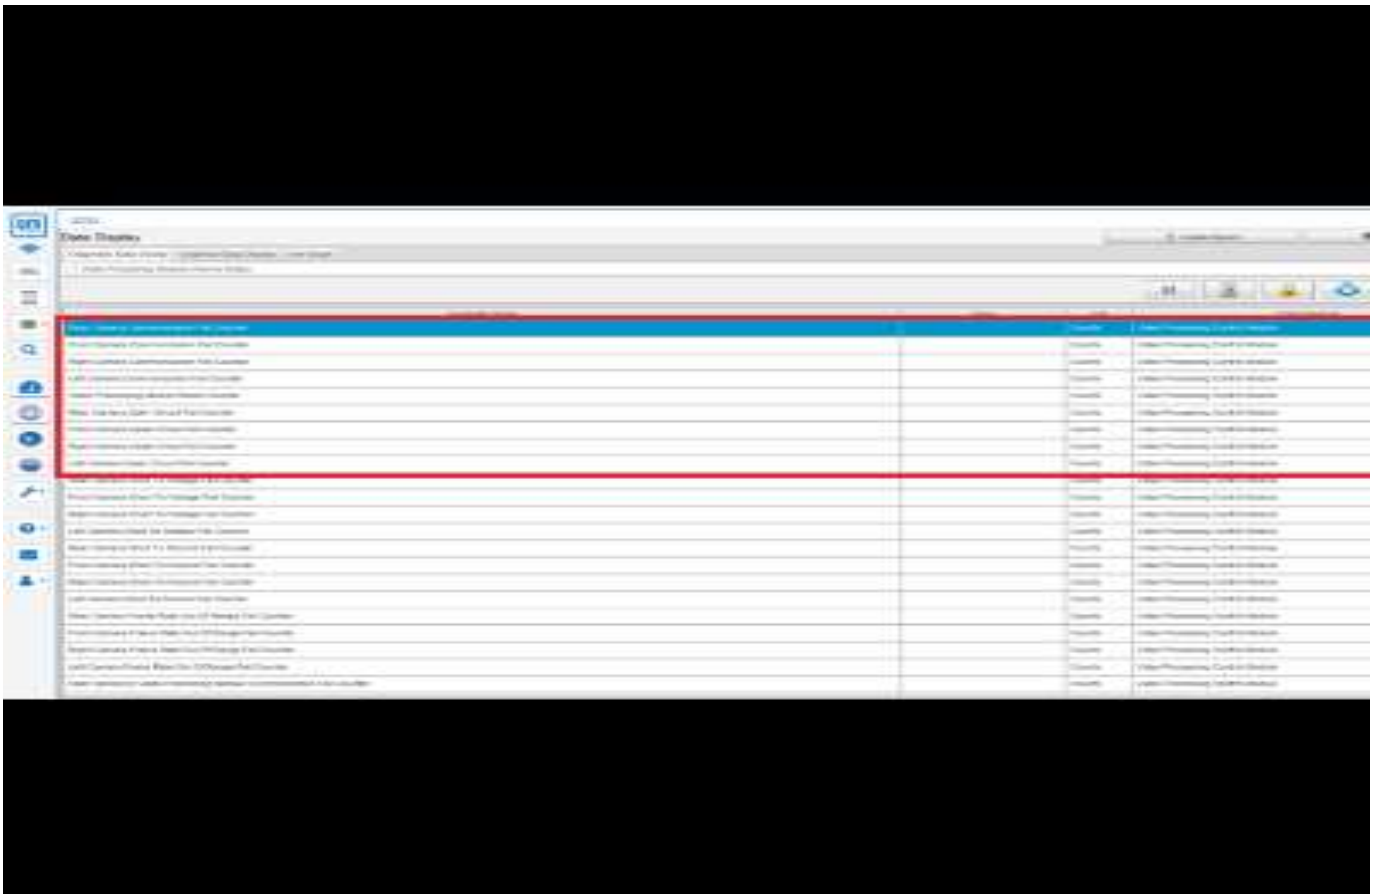
6100776

Module Diagnostics / K157 Video Processing Module / Video Processing Module Internal Status.

3. The three most critical parameters to look at are:
 - Camera Communication Fail Counter
 - Video Processing Module Reset Counter
 - Camera Open Circuit Counter
4. Write down the counters found in the VPM using the scan tool.
5. Cross-reference the DTCs and counters with the troubleshooting table below to determine most probable cause.

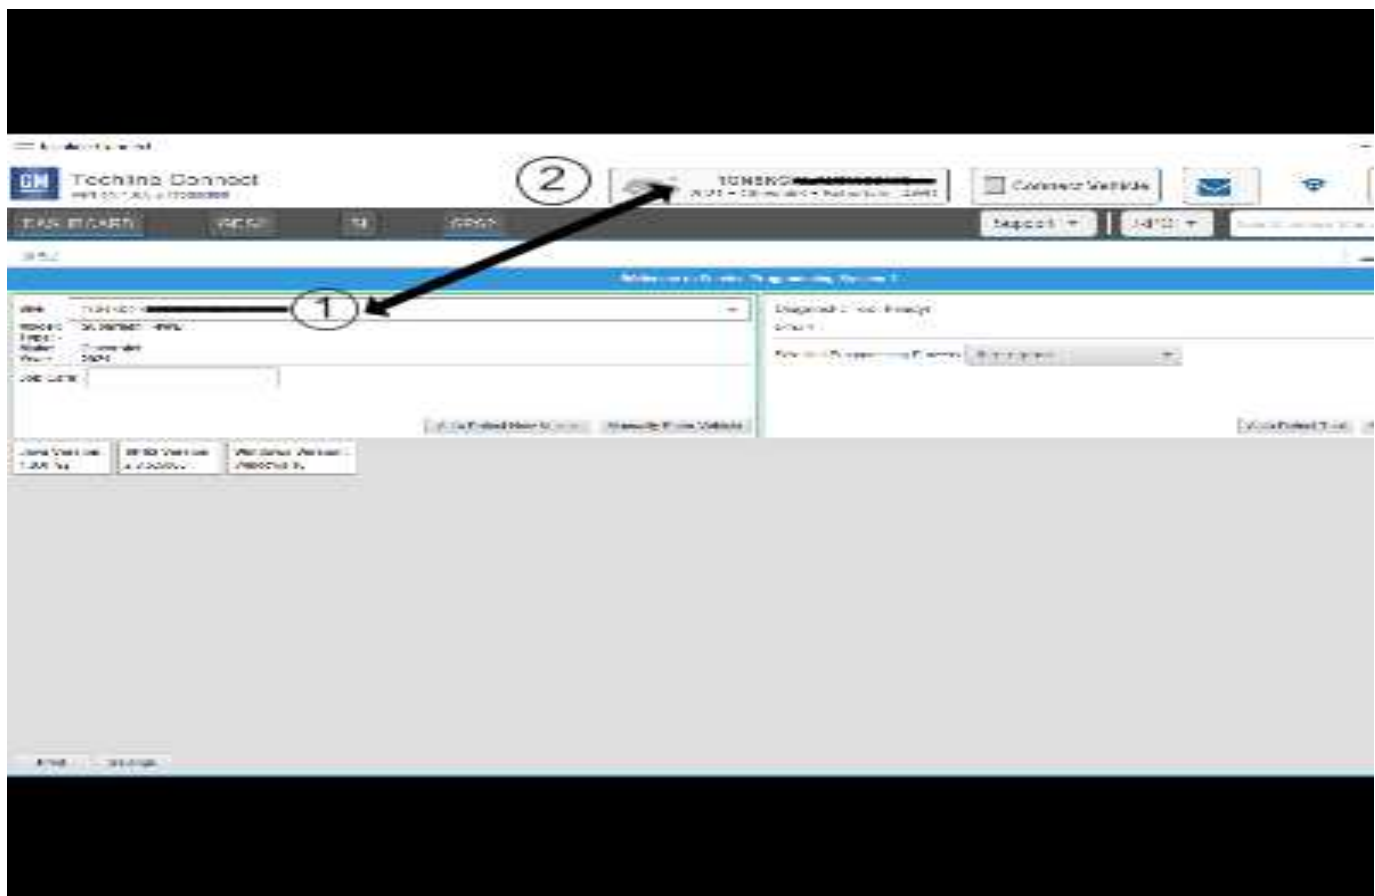
5743643

Caution: Be sure the VIN selected in the drop down menu (1) is the same as the vehicle connected (2) before beginning programming.

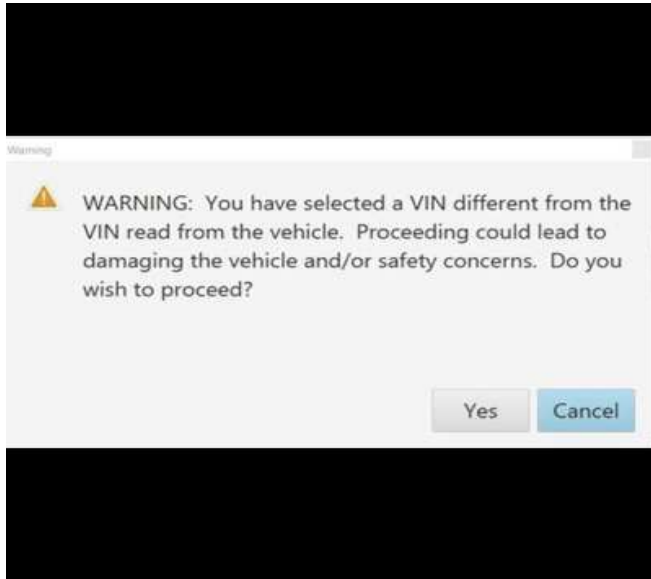
5877000

Important: If the vehicle VIN DOES NOT match, the message below will be shown.

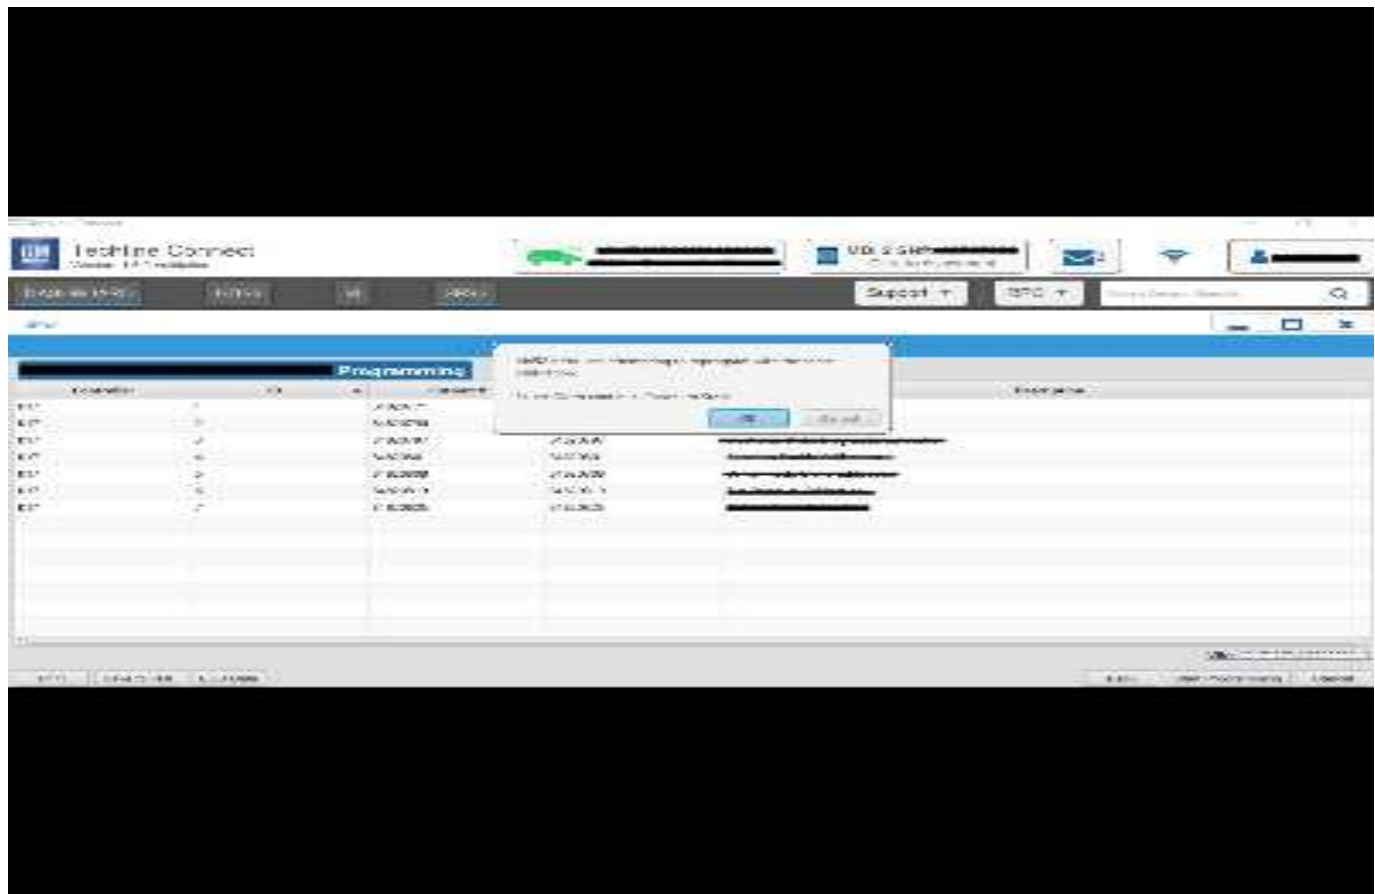
5644477

Important: Techline Connect screen shown above.

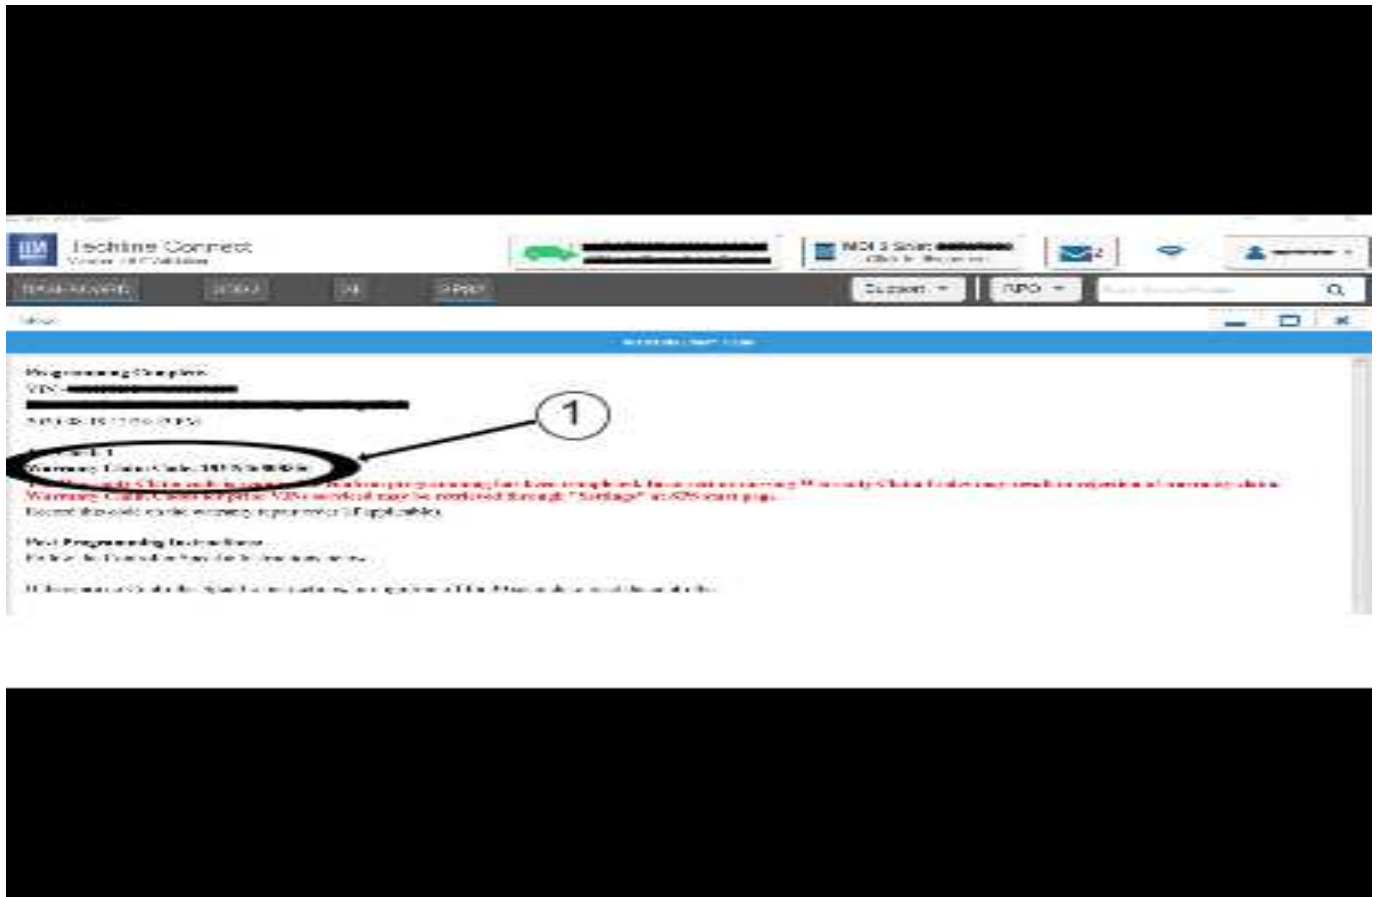
5644478

Note: The screenshot above is an example of module programming and may not be indicative of the specific module that is being programmed. Module selection and VIN information have been blacked out.

1. Reprogram the Video Processing Control Module. Refer to *K157 Video Processing Control Module: Programming and Setup* in SI.
