Technical Service Bulletin

| GROUP CAMPAIGN | NUMBER 23-01-017H |
| DATE MARCH 2023 | MODEL(S) Ioniq 5 Electric (NE1) |

SUBJECT: IONIQ 5 EV BATTERY CONDITIONING TO OPTIMIZE COLD DC CHARGING (SERVICE CAMPAIGN T9Q)

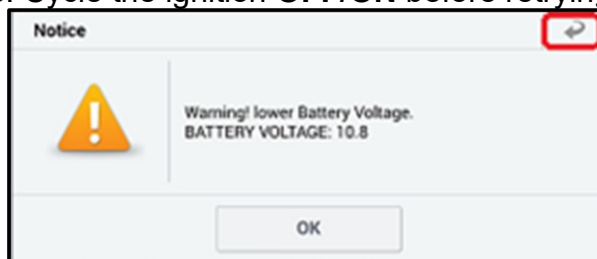
GDS Vehicle Battery Voltage:

- If the voltage is below 12 volts as per the GDS warning, then select **Back** and run the vehicle at least 15 minutes to reach an adequate battery state of charge to prevent an ECU Update failure. Cycle the ignition **OFF/ON** before retrying ECU update again.
