SERVICE BULLETIN

NUMBER: 15-236-18R

SUBJECT: Reprogramming File Availability for Optimization of Harman Gen 3.1 and Gen 3.1α Audio and Navigation Head Units

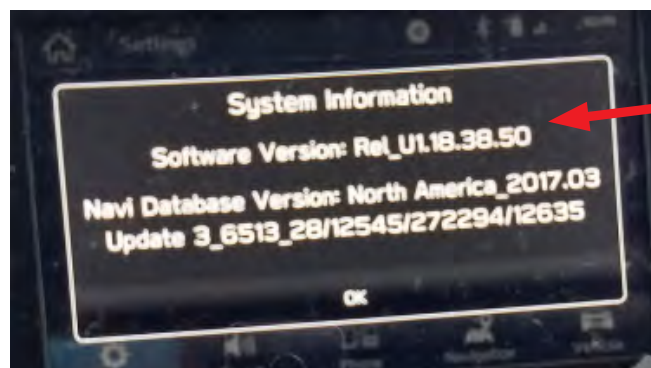
- The currently installed software version will be displayed. If the Software Version is **Rel_UA.20.38.70** or **Rel_UA.22.05.45 NAVI only**, (or before), proceed to **Step 2**.

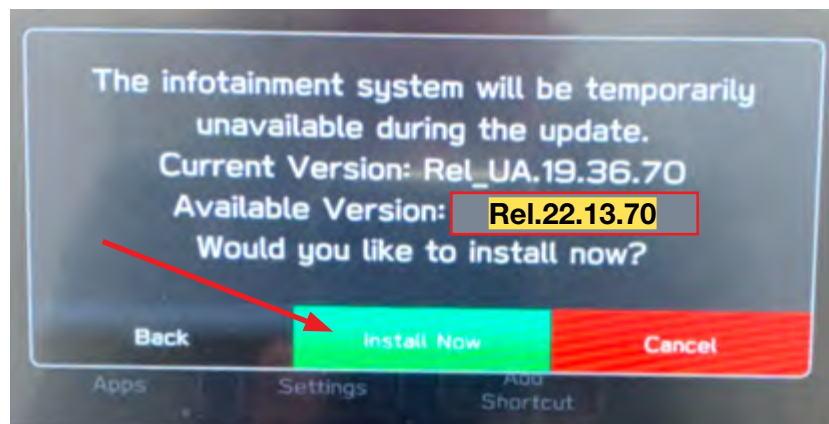
- The current and available software version information will be displayed. The Available Version I.D should be **Rel_UG.22.13.70**.

- After confirming the Available Version, press “Install Now” to start the reprogramming process. The screen will go blank (black) for a brief period after installation begins.
- Each of the updates (Base, Mid and High) should take less than 10 minutes to install.

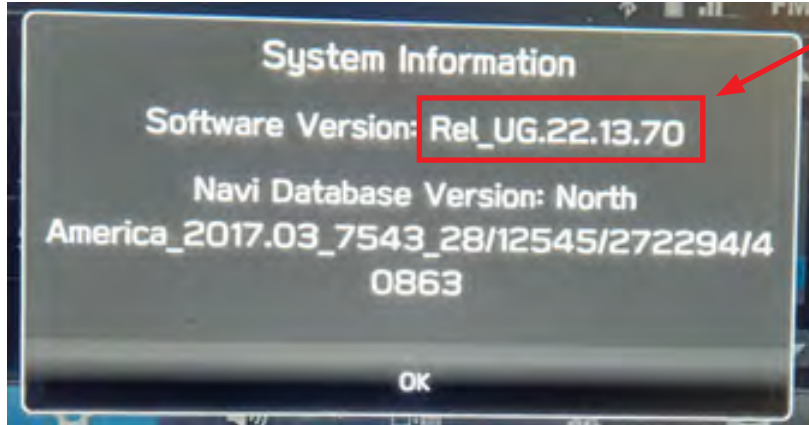
- Confirm Software Version is now “Rel_UG.22.13.70,”.

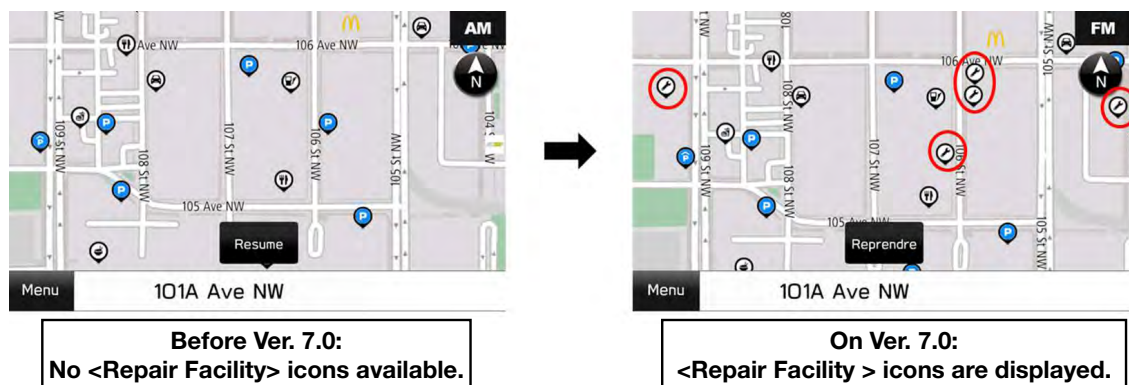
NOTE 4: Displaying Repair Facility POI icons:

<Repair Facility> Icons can be displayed in the NAVI Map.

<Repair Facility> Icons can be turned On or OFF by going to: Settings > Navigation > POI Icons.
