PRODUCT CAMPAIGN BULLETIN

APPLICABILITY: 2019-2022MY Ascent

NUMBER: WRL-22R

SUBJECT: PTC Heater Ground Bolt

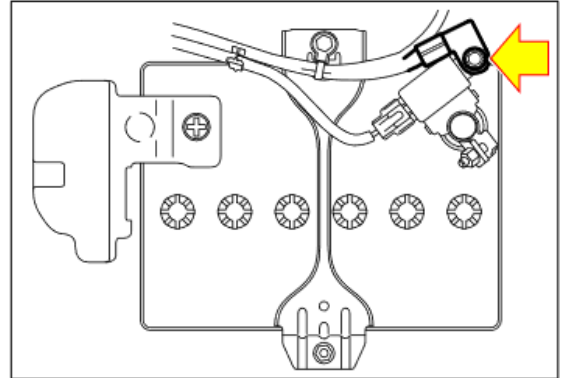
STEP 2: CAREFULLY disconnect the ground terminal from the battery sensor.

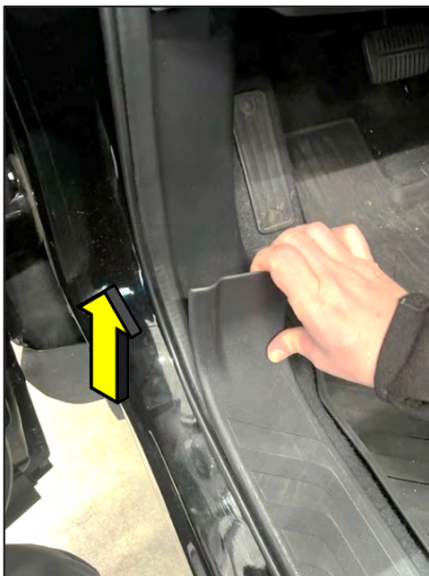
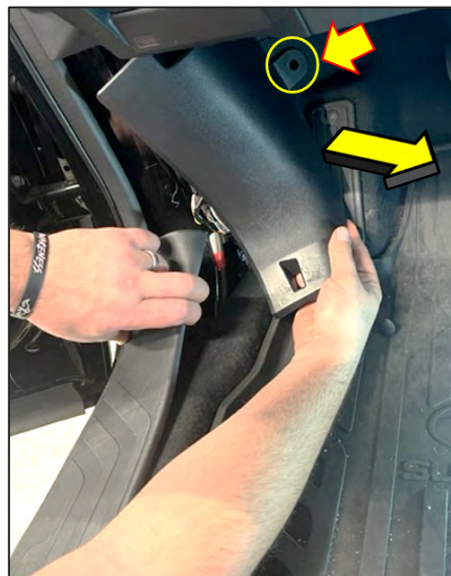
STEP 3: Remove the mounting nut securing the left front side sill cover. CAREFULLY detach the front section of the left rear side sill cover. While holding the front section, use your other hand to detach and remove the left front side sill cover.

CAUTION: ALWAYS remove the cover when it is or has reached room temperature. Any attempts of removal in cold ambient temperatures may result in unwanted breakage DO NOT use excessive force when pulling the cover upward. This may cause damage to the cover.

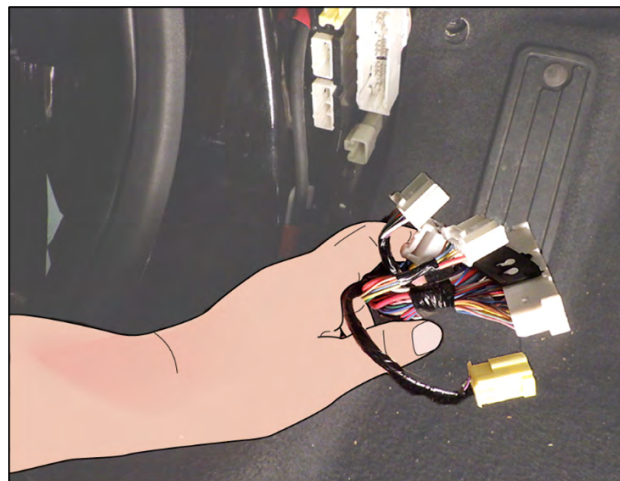
STEP 4: Disconnect all electrical connections from the connector holder.

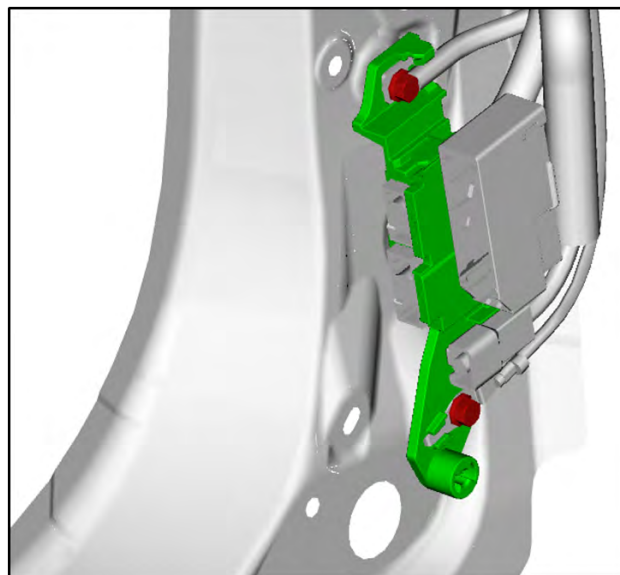
STEP 5: Remove the two heater ground bolts.

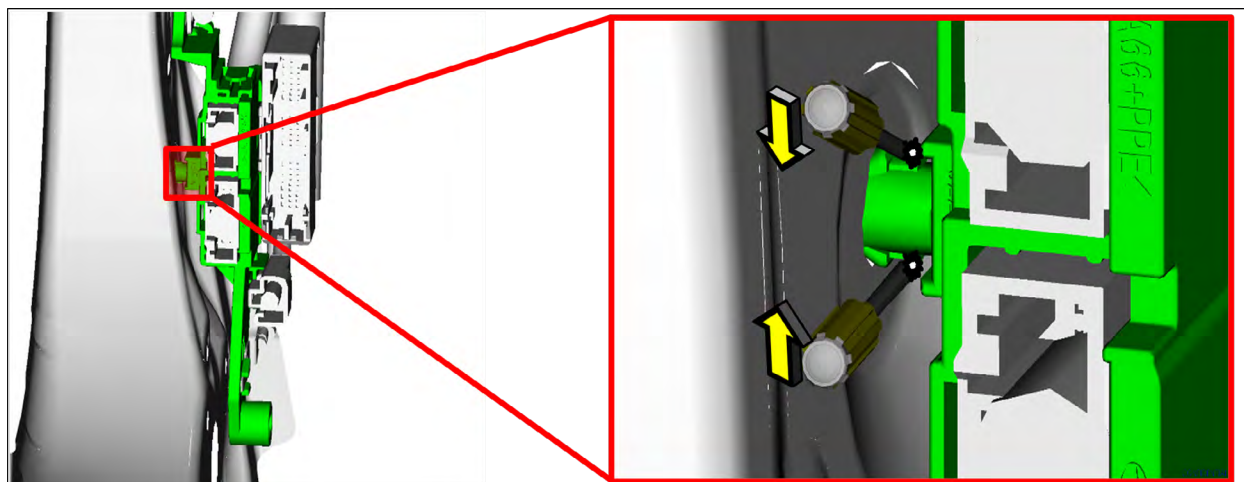
STEP 6: Release the connector holder cover mounting clip security tabs.

CAUTION: To prevent any damage, **DO NOT** attempt to remove the connector holder **WITHOUT** releasing the security tabs first.

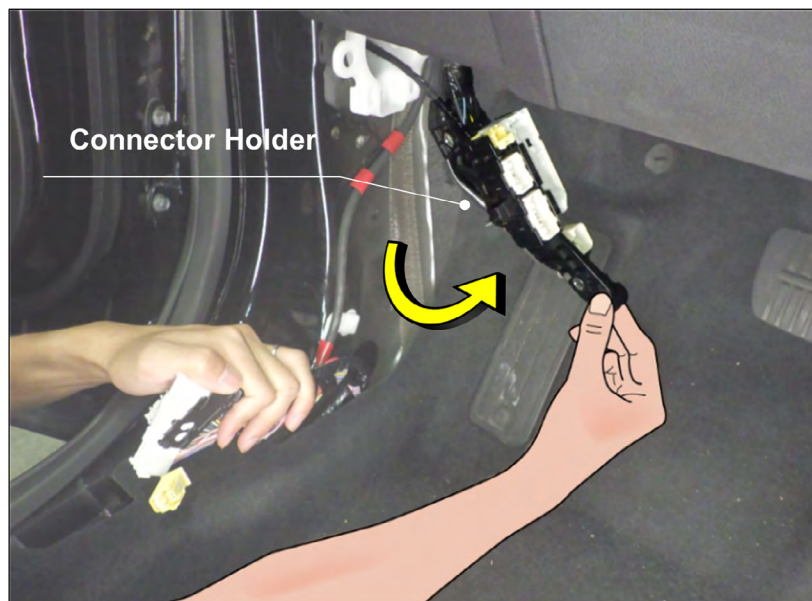
STEP 7: Move the connector holder aside to allow room for workspace.

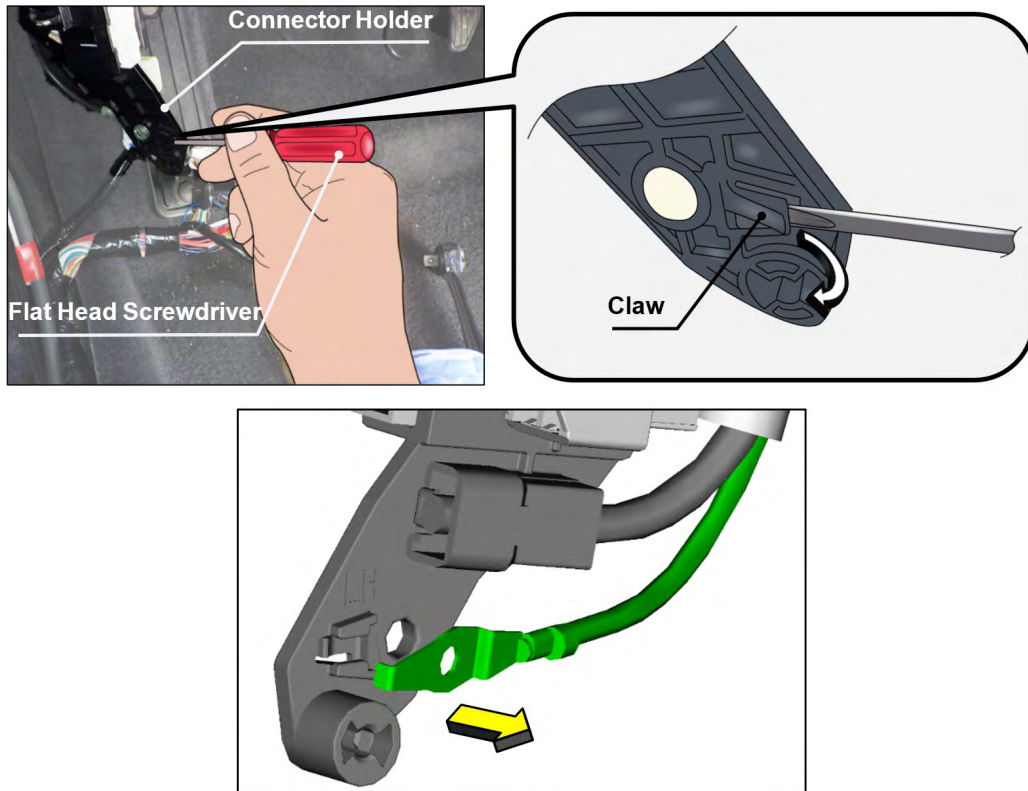
STEP 9: Using a small flat head screwdriver, release the holding claw on the back of the connector holder. With the claw released, remove the PTC heater ground terminal from the connector holder.

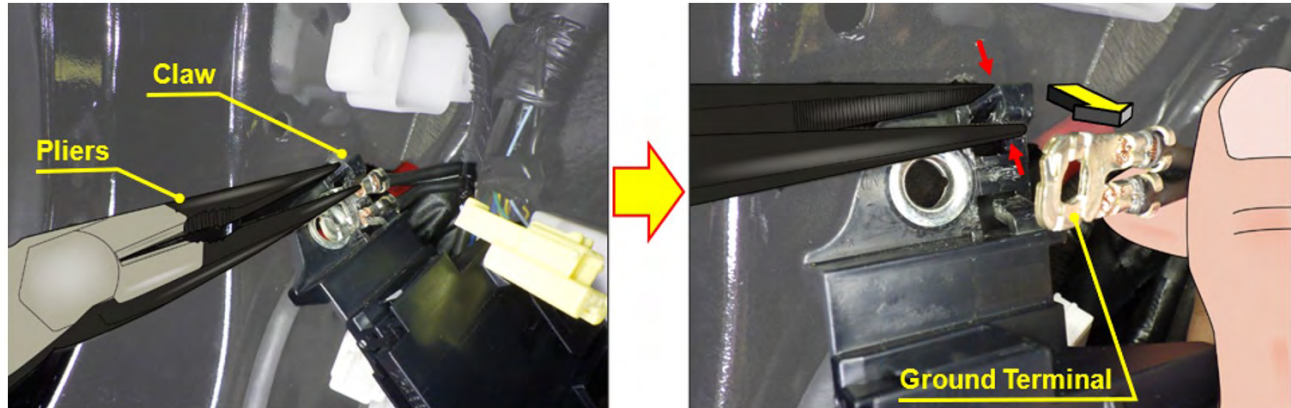
STEP 18: Using needle nose pliers, pinch the claw of the connector holder and remove the ground terminal.

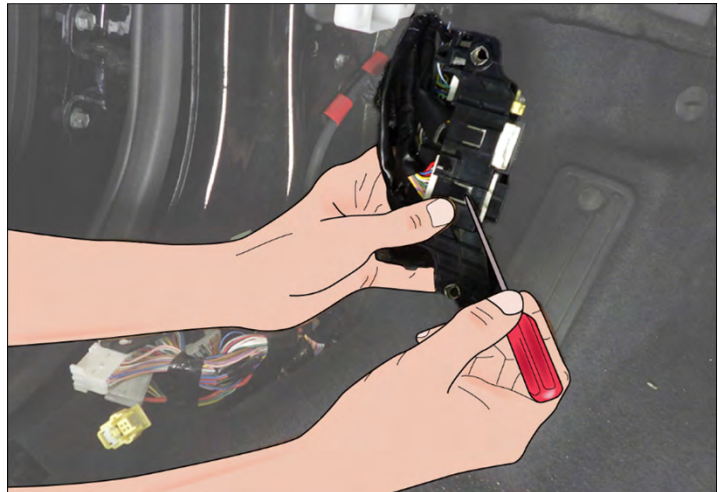
STEP 19: Release the locking tab using a flathead screwdriver. Disconnect all electrical connections and remove the connector holder.

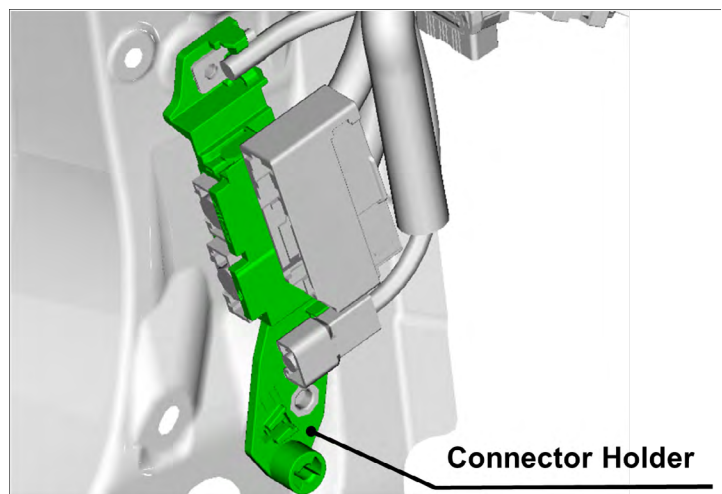
STEP 20: Install the new connector holder supplied in harness kit (SOA635175). Connect all the electrical connections in the reverse order of disassembly. Secure the connector holder to the vehicle body with the mounting clip.

CAUTION: DO NOT install the mounting bolts at this time.

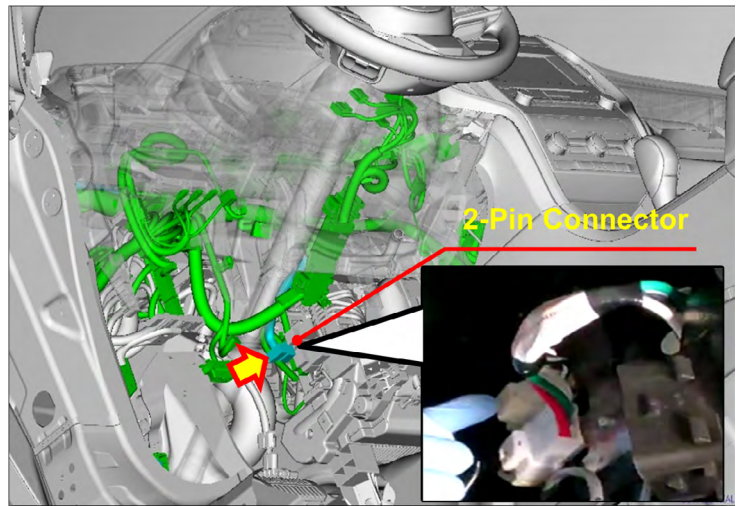
STEP 21: Disconnect the original ground wire connection. Connect the new ground harness supplied in the harness kit (SOA635175).

NOTE: The original ground wire will remain in place. The ends will be trimmed in later STEPS.

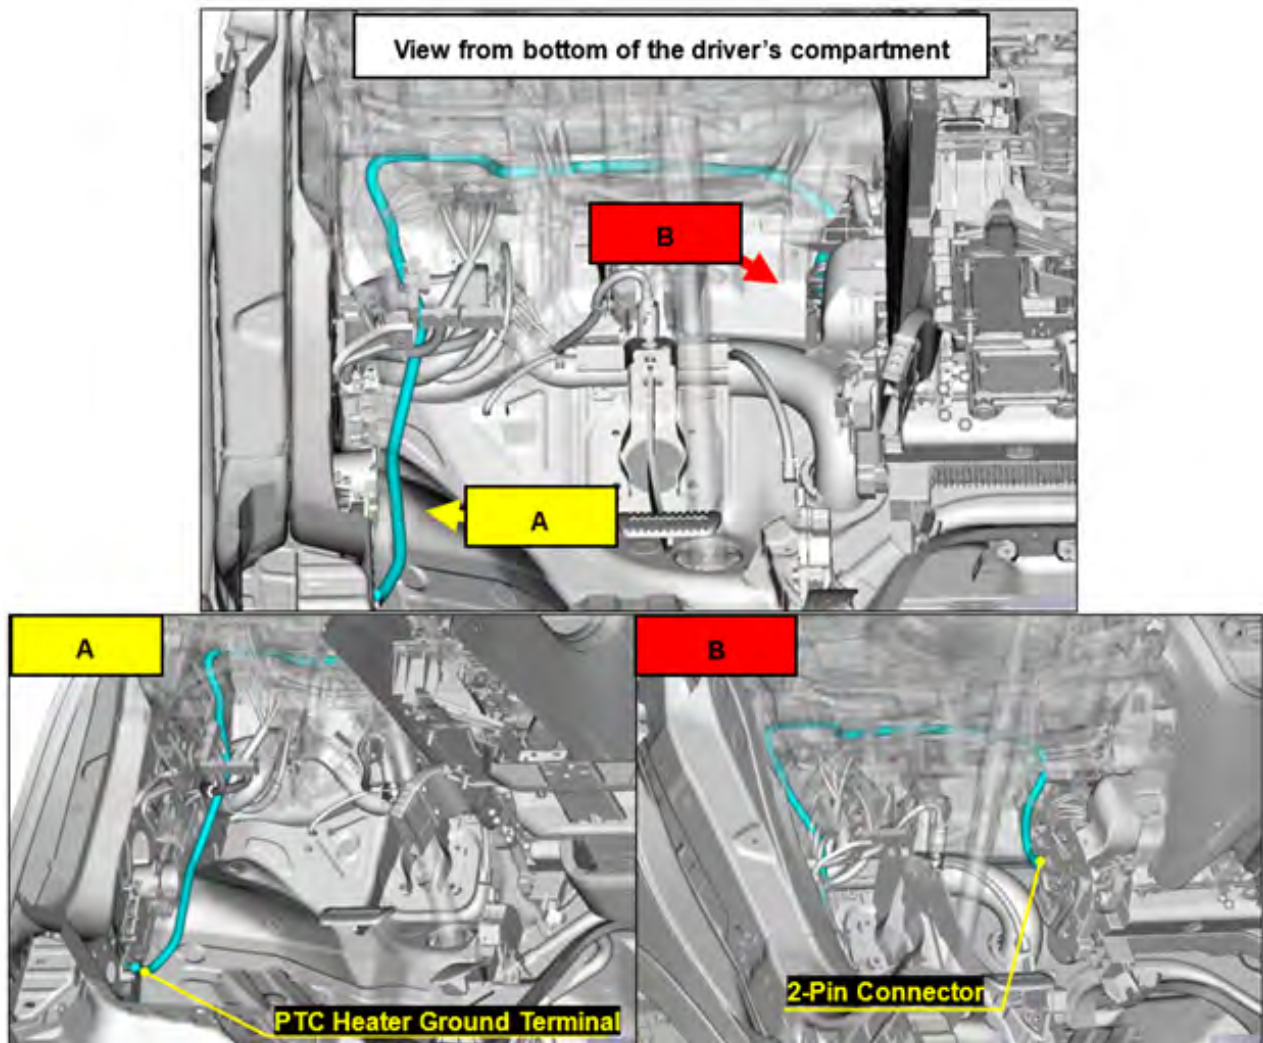
STEP 22: Route the new ground wire along the instrument panel harness as shown below.

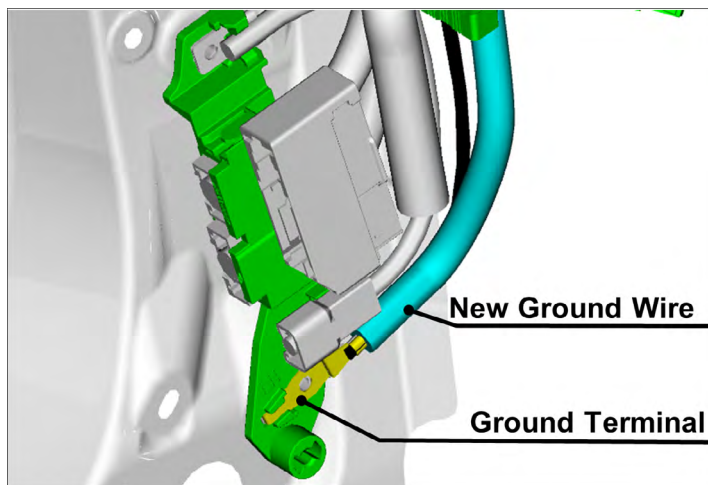
STEP 23: Align and attach the ground terminal of the new ground wire to the connector holder.

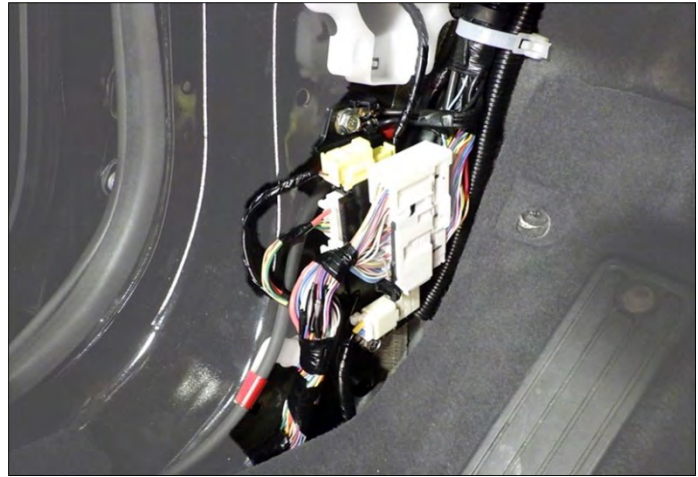
STEP 26: Connect all the previously removed connectors to the connector holder.

NOTE: If performing bolt replacement **ONLY**, proceed to **STEP 32**.

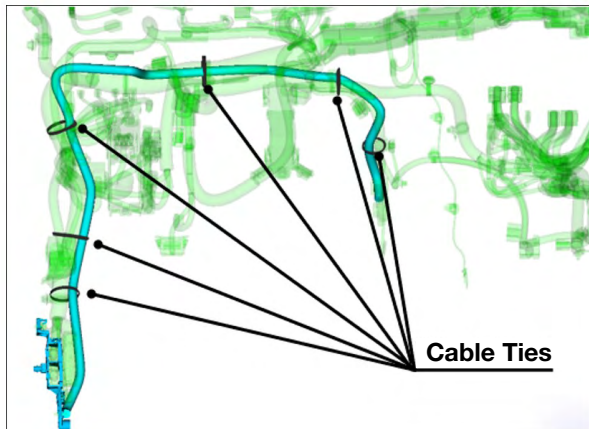
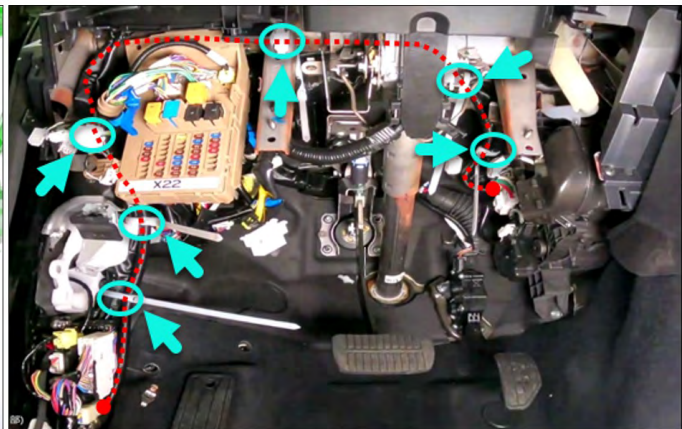
STEP 27: Using cable ties, secure the new ground wire at the six locations indicated in the images below. The original harness wire strap locations can be used as reference. Confirm the tension of the ground wire is evenly distributed.

NOTE: 12-inch wire straps are recommended for the best results.

CAUTION: Always trim the edges of the cable ties to prevent any interference with other parts.

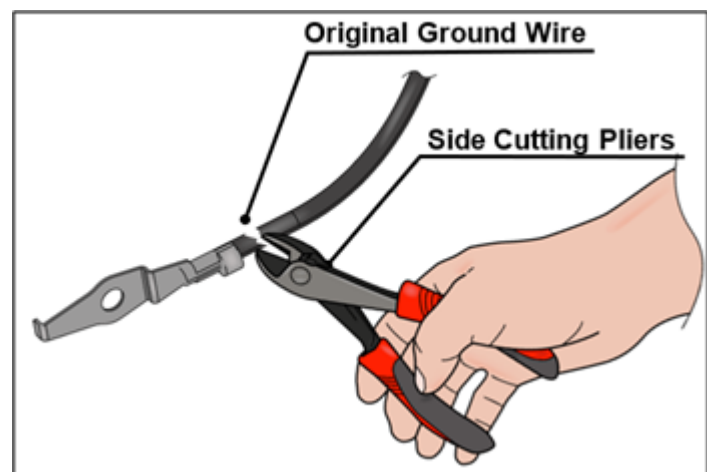
STEP 28: Using side cutting pliers, **CAREFULLY** cut the **ORIGINAL** ground wire and remove the terminal.

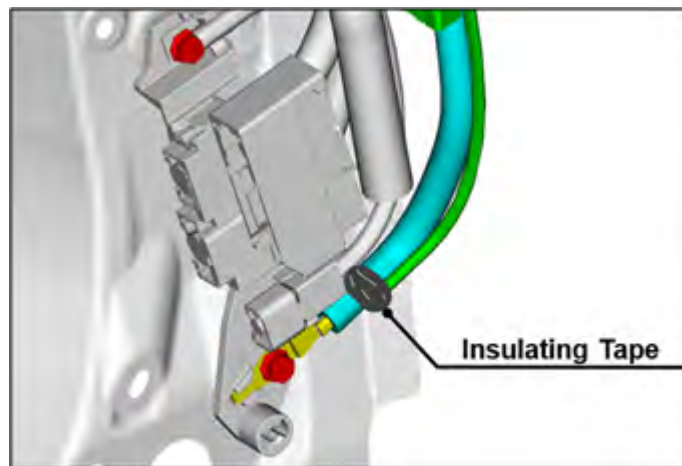
STEP 29: Seal the cut end of the original ground wire with electrical insulation tape. The wire can then be taped to the new ground wire.

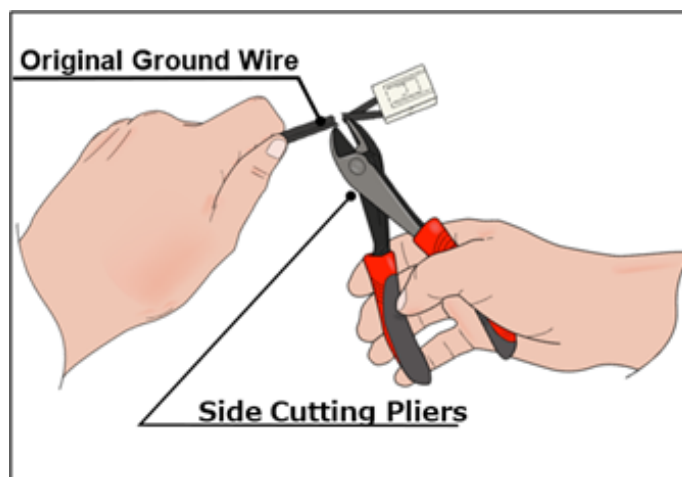
STEP 30: Cut the opposite end of the ORIGINAL ground wire and remove the connector.

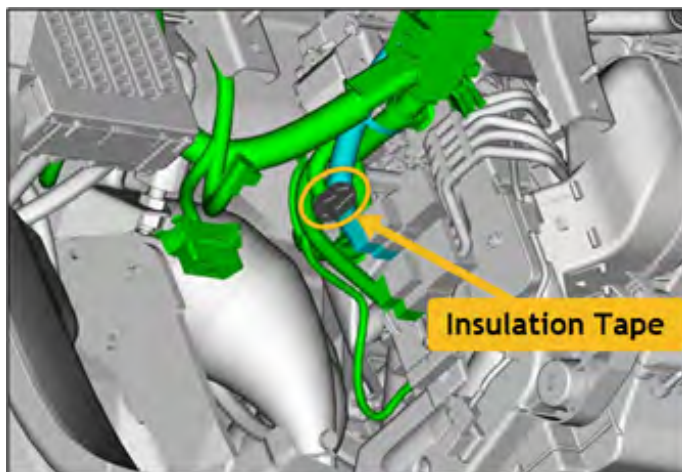
STEP 31: Seal the cut end of the original ground wire with electrical insulation tape. The wire can then be taped to the new ground wire.
