Articles Contained in this Issue

15 CP 1.0/1.5 Software Version Verification

07 CAN Communication Diagnosis – Where To Start?

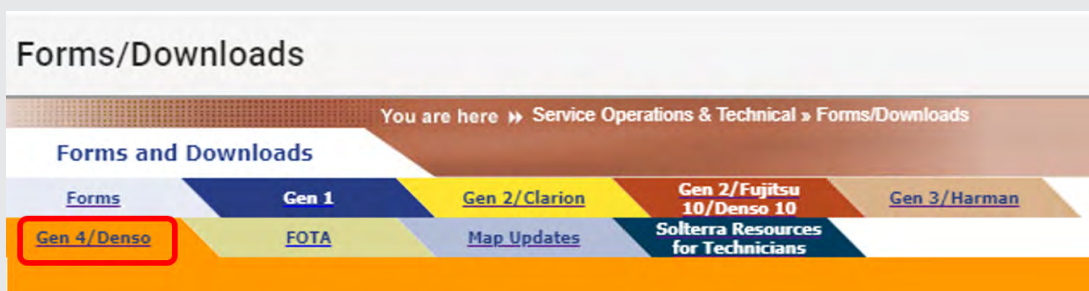
Reminder: For infotainment related concerns please always remember to review the “Forms and Downloads” Gen 4/Denso tab on Subarunet. All TSB's related to each head unit are listed on their respective tabs.

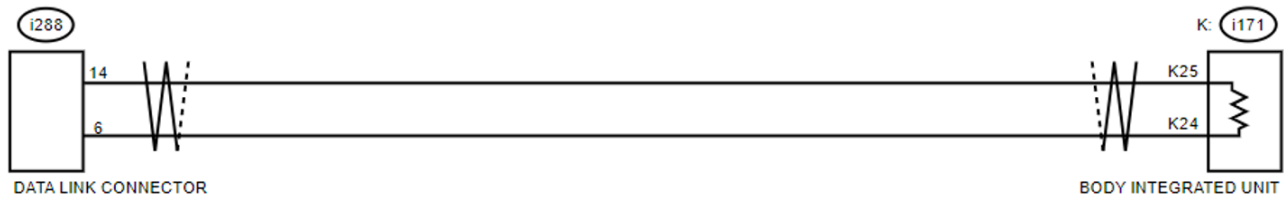
“The Subaru warranty manual dictates that the harnesses must be replaced if any physical damage occurs to CAN B or C wiring (Twisted pair) under warranty. Outside of the warranty period, customer pay repairs to the wiring may be performed. Industry standard repair procedures must be used. Following the procedure listed in STIS. The proper twist must be maintained and the length between CAN high and low must be maintained to ensure message synchronization.”
