SERVICE INFORMATION

APPLICABILITY: All Models with STARLINK Telematics System **NUMBER:** 15-195-16R
SUBJECT: Servicing and Claim Submission Requirements for STARLINK Diagnosis and Repair Involving the Data Communication Module (DCM) **DATE:** 04/28/20
REVISED: 02/27/23

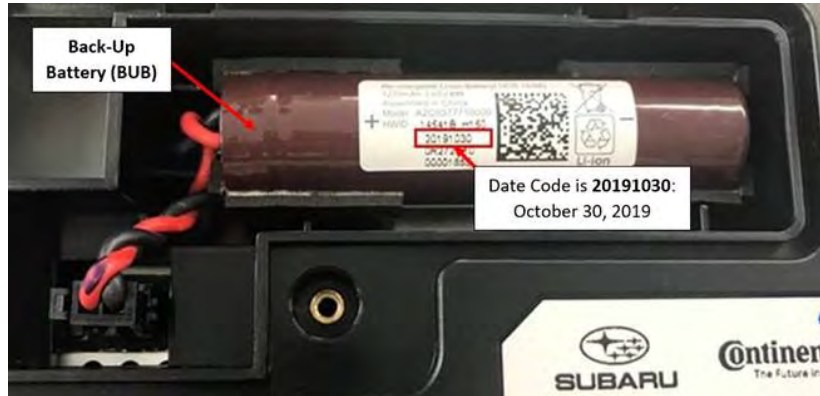
5) Effective Immediately, all claims for DCM replacement **MUST** include the 10-digit DCM Serial Number of the installed (new) DCM. This number is found on the DCM label shown here and **MUST** be entered in the Miscellaneous Detail field of the claim entry.

5. All claims for DCM replacement **MUST** include the Serial Number of the NEW DCM in the Miscellaneous Detail Field of the claim entry.
