Technical Service Bulletin

WRINKLES ON LEATHER SEAT SURFACE OF NEW (UNSOLD)
VEHICLE

Bulletin No.: 09-007/23 Last Issued : 02/01/2023

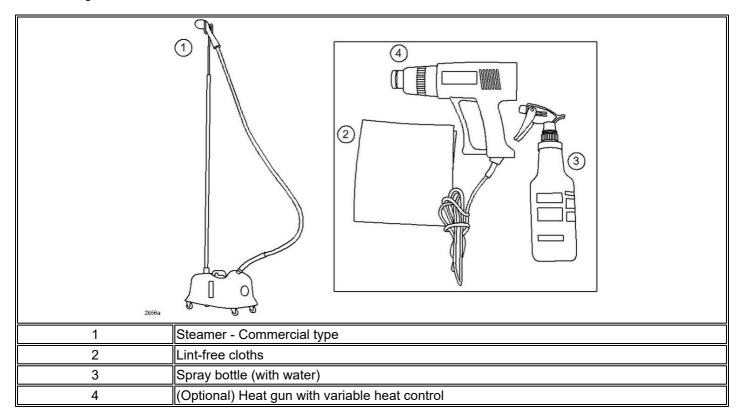
At PDI or when new vehicle is delivered, some customers may complain about wrinkles on the leather seat cushion and/or seat back surface.

- · A qualified upholstery repair specialist is required for this repair procedure.
- Explain to the customer before performing the repair that the wrinkles may not be completely removed.
- Explain to the customer that the leather is a natural material and may develop some wrinkles due to aging or wear during normal use. This is normal behavior of the leather material.

Customers having this concern should have their vehicle repaired by a qualified upholstery repair specialist using the following repair procedure.
