# TECHNICAL SERVICE BULLETIN

## Second Row Seat Back Does Not Fold Down Or Recline

**23-2036**

<b>Ford</b> 2018-2023 Expedition
<b>Lincoln</b> 2018-2023 Navigator

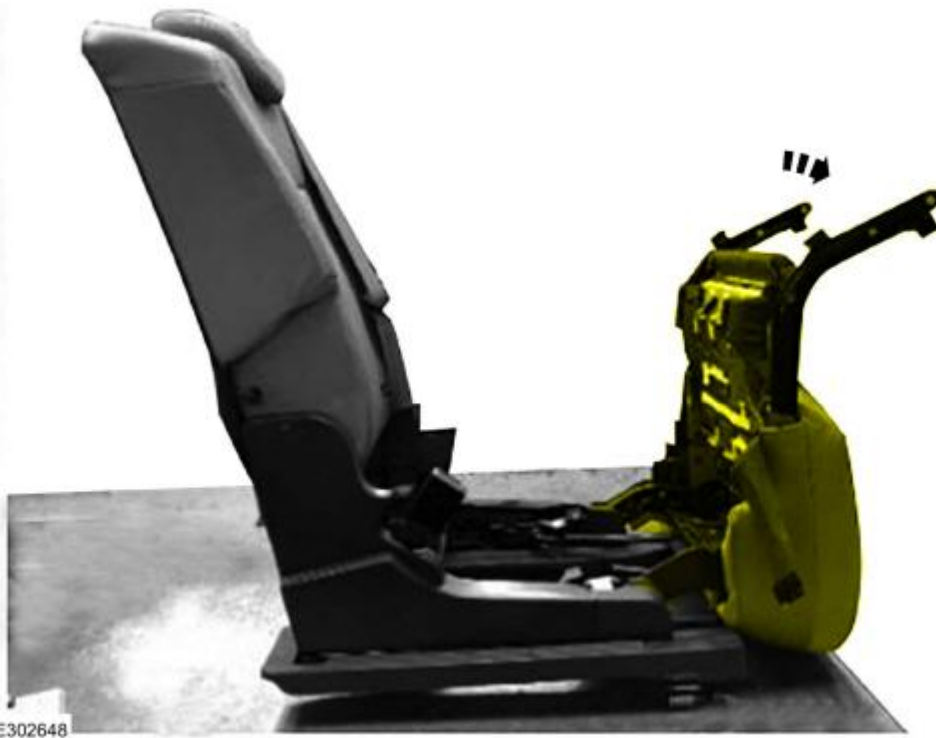
Figure 8

**NOTE: Avoid sliding the seat on the seat track front to back while the seat cushion is flipped forward or damage may result to the neighboring seat trim and material. (Figure 8)**

**NOTE: Avoid sliding the seat front to back while the seat cushion is flipped forward or damage can occur to the neighboring seat. (Figure 8)**
