Allison Reduced Engine Load At A Stop (RELS) Diagnostic Trouble Code P071a Or P07ce - GR/TE Models Built, With The Split Shaft Package, June 2022 to October 2022

It is possible for GR/TE models built June 2022 to October 2022 to have Diagnostic Trouble Code P071a or P07ce along with complaints of the transmission not going in to neutral when coming to a stop and/or the transmission will go in to 4th gear lock up when applying the service brake.

This solution has been created for Concrete Pump and Vacuum Truck Applications with Split Box PTO

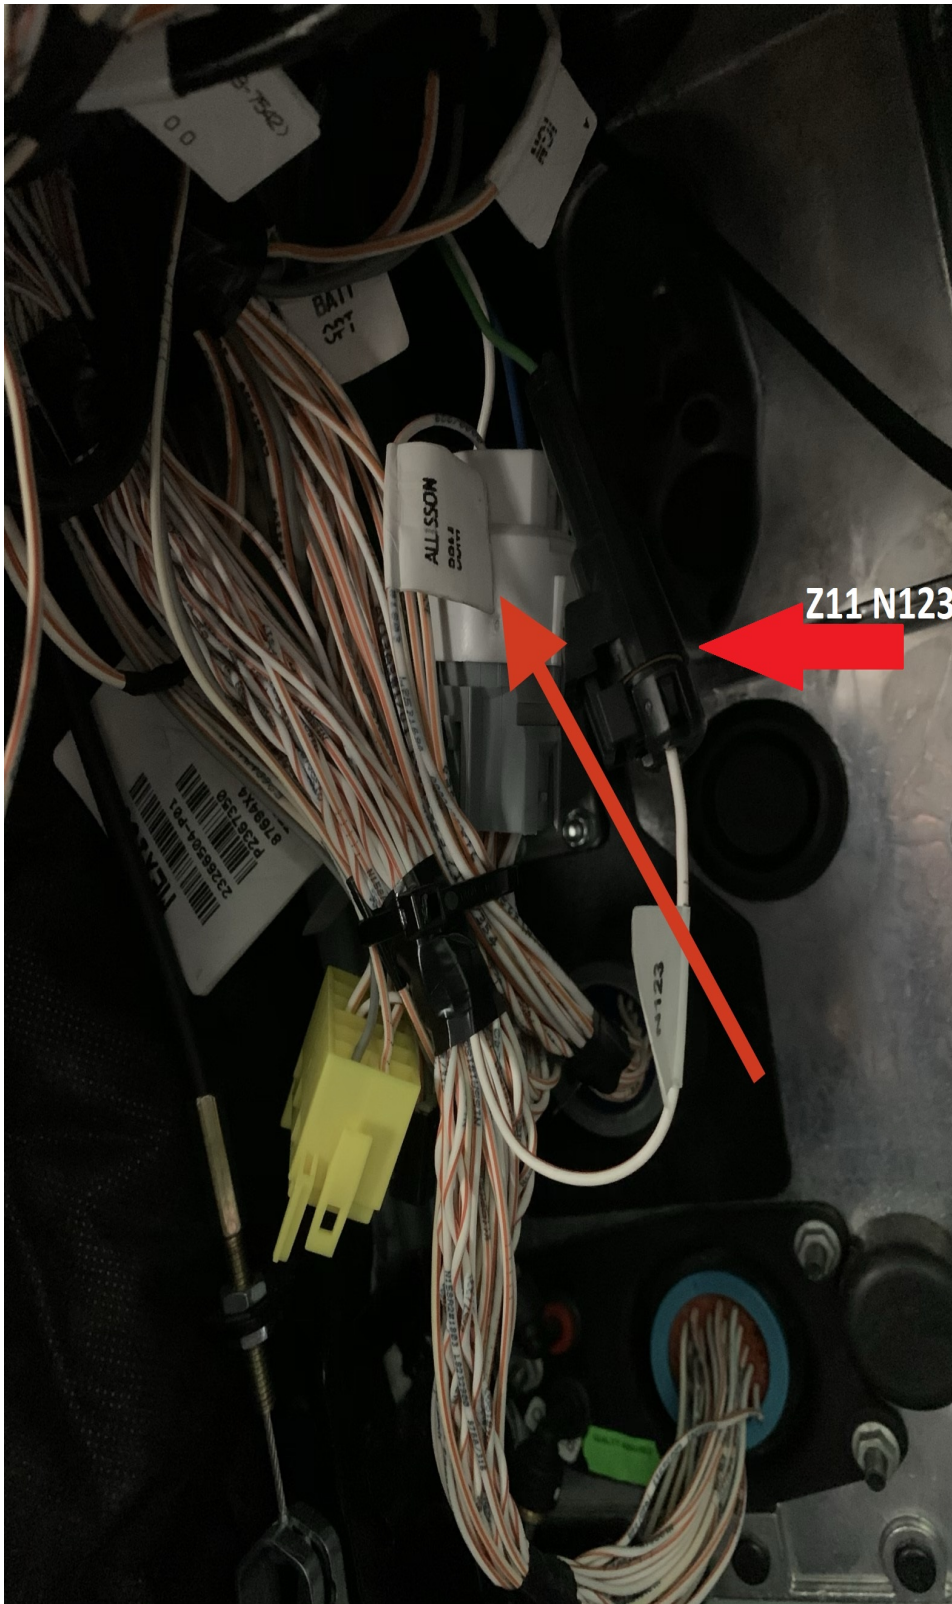
Rectangular Brown Connector: Look near this connector for a single wire connector marked Z11 RELS (Reduce Engine Load Stop) (See image below) If body builder has wire connected to that connector remove and install that wire in cavity 18 Body Builder side of the Brown Connector. If a new terminal is needed please use p/n 978295.

**If either Connector Gray or Brown is fully Populated on the Body Builder Side look for the Round RP170A 31 Pin Connector located at the back of cab and remove the Body Builder Wire from Cavity 18
Move it to Cavity 19.
