Service Bulletin

Bulletin No.: 21-NA-149

Date: March, 2023

Subject: Engine Wire Harness Chafing / IPC Gauges Sweep / IPC Warning Message / SES/Check Engine/MIL / No Start / No Crank / Runs Rough / Stalls / Reduced Engine Power / Various DTCs

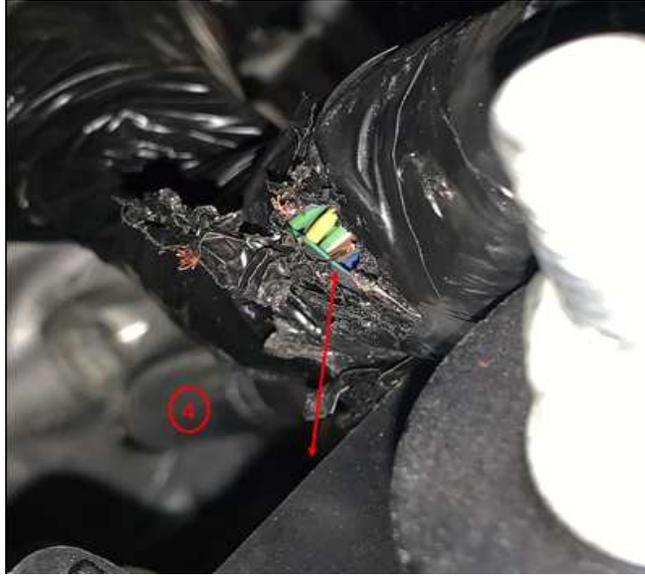
5583331

This Cause pertains to vehicles equipped with engines 5.3L L82, 5.3L L84, 6.2L L87, 4.3L LV3, 2.7L L3B, or 3.0L LM2.

The cause of the condition may be an engine wire harness clip was removed during production due to ergonomic issues (hand clearance and branch stiffness). This led to an uncontrolled branch that came into contact with a sharp edge (1) & (2) on the ECM/TCM bracket, driver side upper control arm, and/or shock tower and caused chaffing during engine vibration and roll.

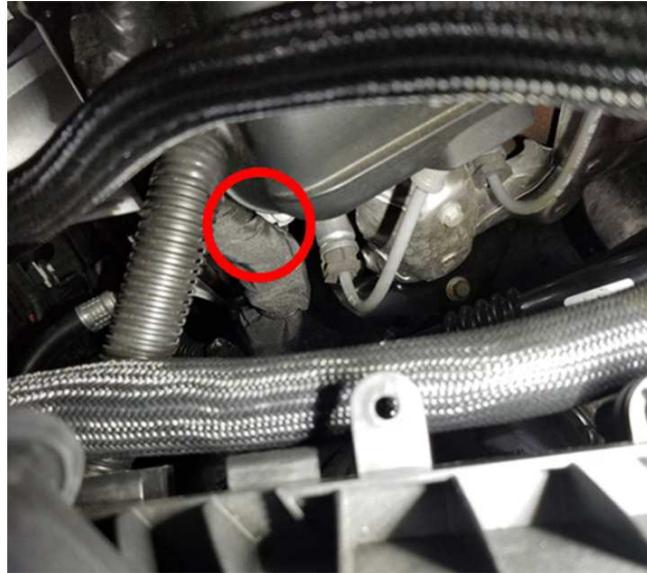
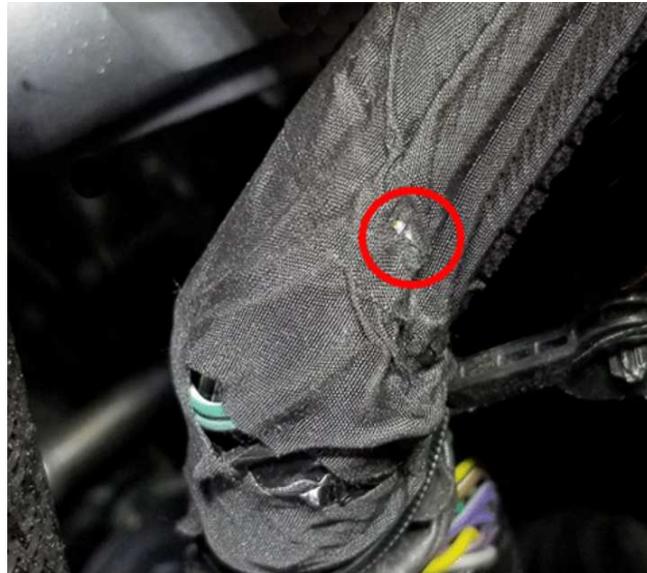
This Correction pertains to vehicles equipped with engine 4.3L, LV3 only.
Note: The first graphic below is a before, and after (2), repair example of harness chaffing at the Oil Dipstick bracket.

To correct this concern, repair the damaged wiring following the SI wire-to-wire repair procedures. Once repaired, protect and reposition the engine wiring harness to prevent future harness damage.

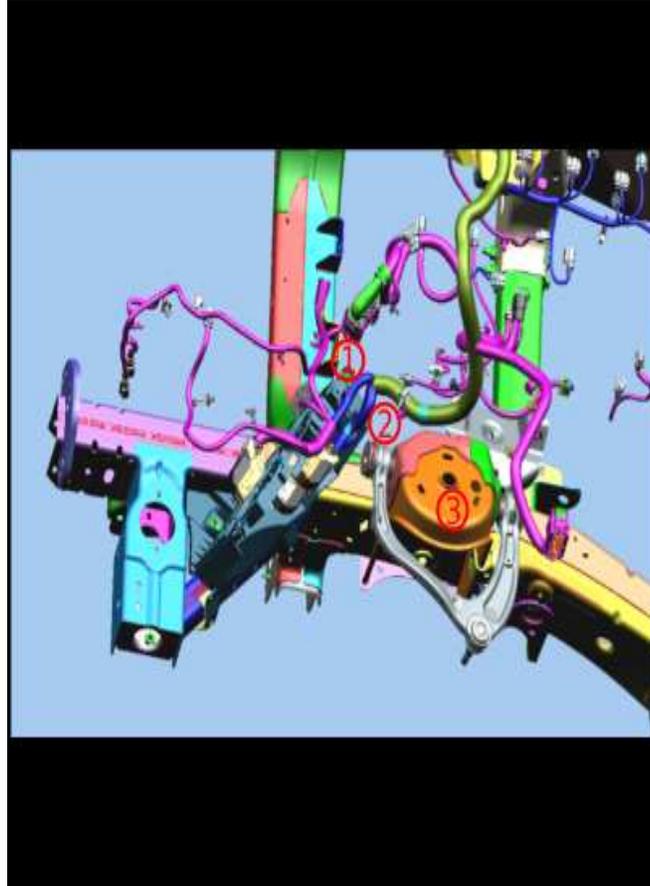
5868341

3. Locate the three contact points where the wire harness is chaffing, the ECM/TCM black bracket (1), the upper control arm (2), and the shock tower bolt (3).

Utilizing Engine Harness sleeves, anti-abrasion tape, and zip-ties to secure the harness away from one or more of the chaffing points. Follow the Service Procedure steps below.

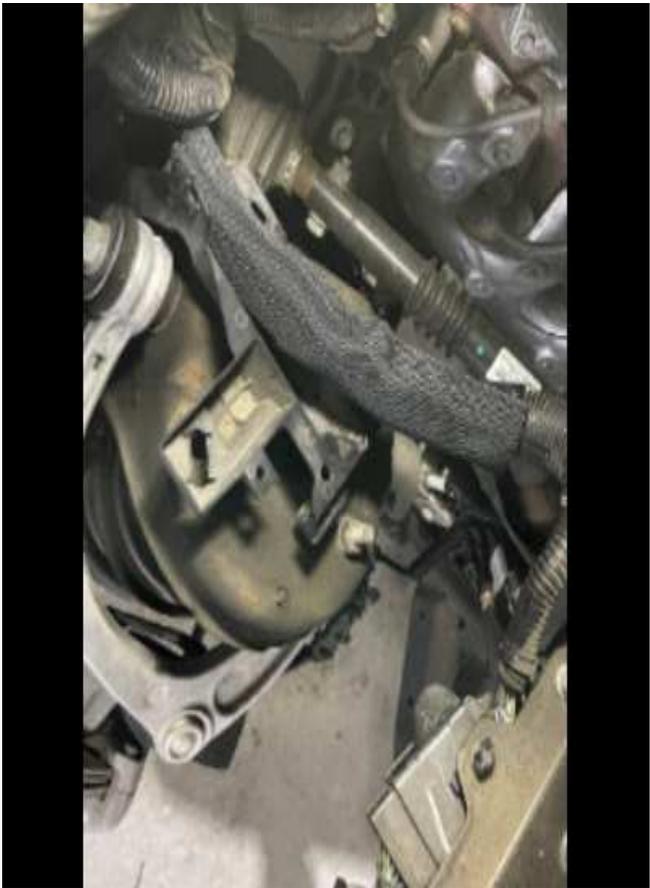
5868358

9. At the shock tower point there is a wire harness canal (1).

11. Verify the wire harness is wrapped and secured at all three points, the ECM/TCM Bracket (1), Upper Control Arm (2), and the Shock Tower (3). Then reassemble the vehicle.
12. Reinstall the front wheelhouse liner and tire and wheel. Refer to *Front Wheelhouse Liner Replacement* and *Tire and Wheel Removal and Installation* in SI.
13. Remove the support and lower the vehicle.
