GLOBAL SAFETY FIELD INVESTIGATIONS
DCS6489
URGENT - DISTRIBUTE IMMEDIATELY

Subject: N222375791 - Customer Satisfaction Program
Park Assist Retrofit

Models: 2022 – 2023 Cadillac XT4
2022 – 2023 Cadillac XT5
2022 – 2023 Cadillac XT6
2022 – 2023 Chevrolet Camaro

N222375791 Park Assist Retrofit

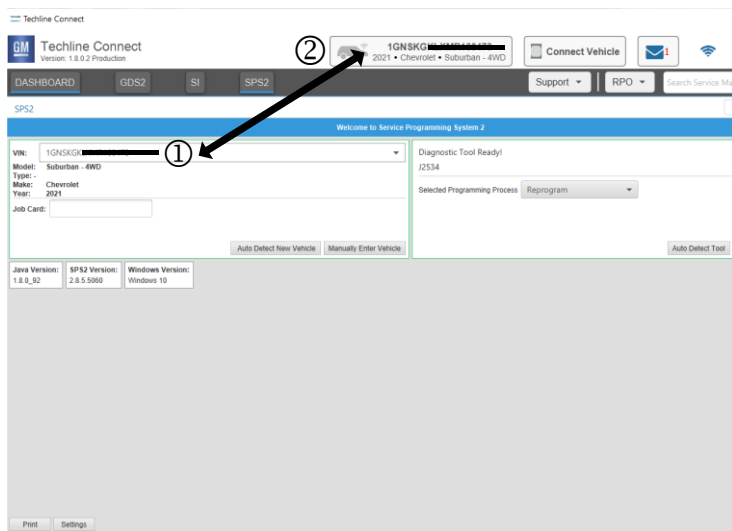
5743643

Caution: Be sure the VIN selected in the drop down menu (1) is the same as the vehicle connected (2) before beginning programming.

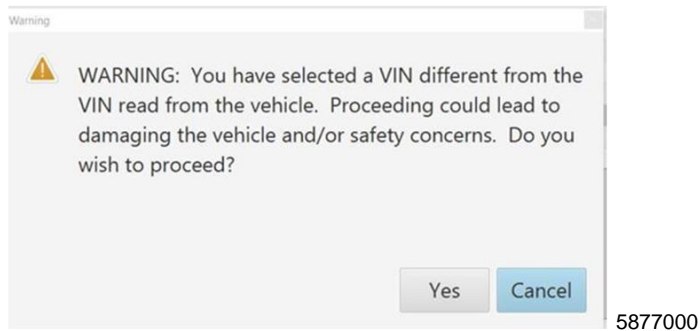
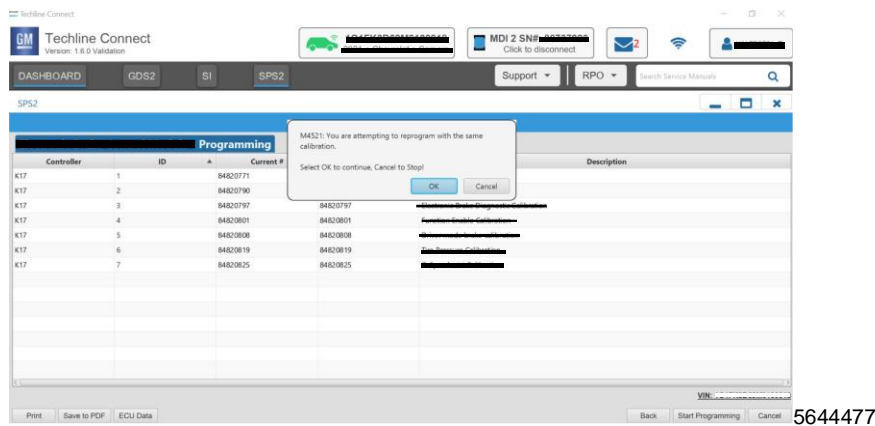
Important: If the vehicle VIN DOES NOT match, the message below will be shown.

Important: Techline Connect screens shown above.

Important: If the same calibration/software warning is noted on the TLC Summary screen, select OK and follow screen instructions. After a successful programming event, the WCC is located in the Service Programming System dialogue box of the SPS Summary screen. No further action is required. Refer to the Warranty section of the bulletin.

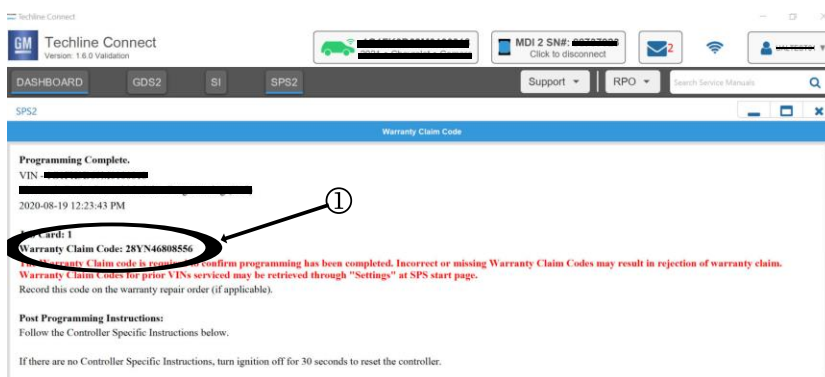
5644478

Note: The screenshot above is an example of module programming and may not be indicative of the specific module that is being programmed. Module selection and VIN information have been blacked out.

2. Reprogram the Parking Assist Control Module. Refer to *K182 Parking Assist Control Module: Programming and Setup* in SI.
3. Perform setup and configuration on the Parking Assist Control Module. Refer to *K182 Parking Assist Control Module: Programming and Setup* in SI.
4. Perform setup and configuration on the Instrument Cluster. Refer to *P16 Instrument Cluster: Programming and Setup* in SI.

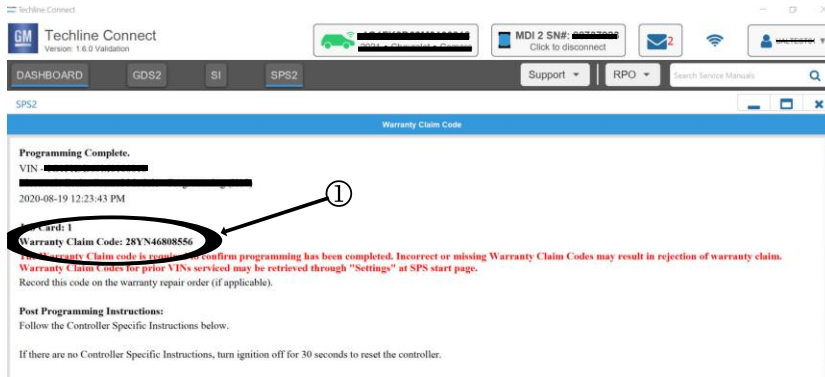
5644478

Note: The screenshot above is an example of module programming and may not be indicative of the specific module that is being programmed. Module selection and VIN information have been blacked out.

3. Perform setup and configuration on the Parking Assist Control Module. Refer to *K182 Parking Assist Control Module: Programming and Setup* in SI.
4. Perform setup and configuration on the Instrument Cluster. Refer to *P16 Instrument Cluster: Programming and Setup* in SI.

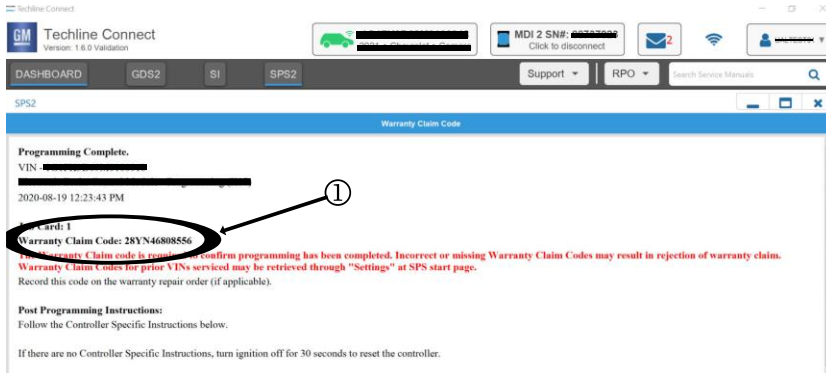
5644478

Note: The screenshot above is an example of module programming and may not be indicative of the specific module that is being programmed. Module selection and VIN information have been blacked out.

2. Reprogram the Parking Assist Control Module. Refer to *K182 Parking Assist Control Module: Programming and Setup* in SI.
3. Perform setup and configuration on the Parking Assist Control Module. Refer to *K182 Parking Assist Control Module: Programming and Setup* in SI.
4. Perform setup and configuration on the Instrument Cluster. Refer to *P16 Instrument Cluster: Programming and Setup* in SI.

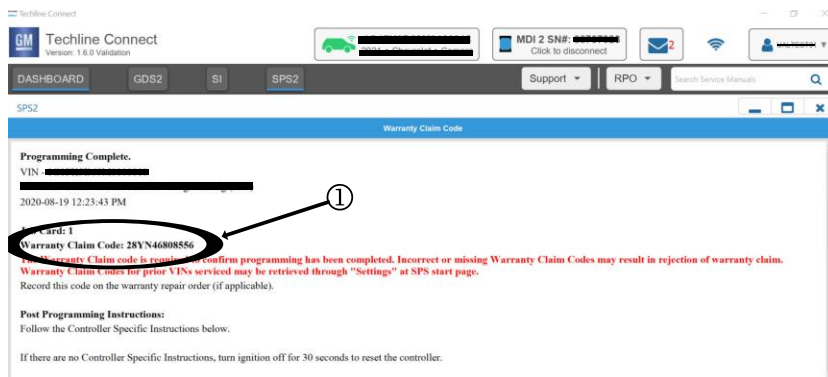
5644478

Note: The screenshot above is an example of module programming and may not be indicative of the specific module that is being programmed. Module selection and VIN information have been blacked out.

2. Reprogram the Parking Assist Control Module. Refer to *K182 Parking Assist Control Module: Programming and Setup* in SI.
3. Perform setup and configuration on the Parking Assist Control Module. Refer to *K182 Parking Assist Control Module: Programming and Setup* in SI.
4. Perform setup and configuration on the Instrument Cluster. Refer to *P16 Instrument Cluster: Programming and Setup* in SI.
5. Reprogram the Active Safety Control Module. Refer to *K124 Active Safety Control Module: Programming and Setup*.
