GROUP	MODEL
ELE	2023MY Carnival (KA4)
NUMBER	DATE
289	March 2023

## TECHNICAL SERVICE BULLETIN

### SERVICE ACTION: TIGHTENING OF IGNITION GROUND BOLTS (SA531)

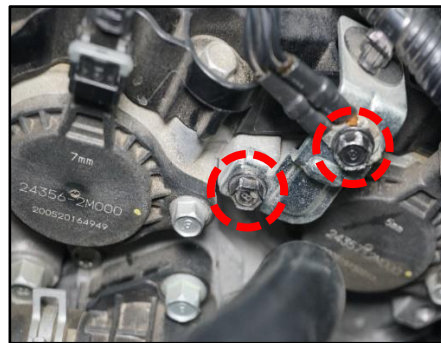
This bulletin provides information to tighten the two (2) ignition ground bracket bolts on certain 2023MY Carnival (KA4) vehicles produced from November 8, 2022 through November 11, 2022, which may not have been properly torqued during assembly and cause the vehicle to exhibit an intermittent engine hesitation and/or poor starting condition. Follow the procedure outlined in this publication to torque the two (2) ignition ground bracket bolts to the specified torque specification listed in this publication. Before conducting the procedure, verify that the vehicle is included in the list of affected VINs.
