# Rapid Update 591

## Grecale – Air suspension system leak check

DATE: FEBRUARY 21 2023

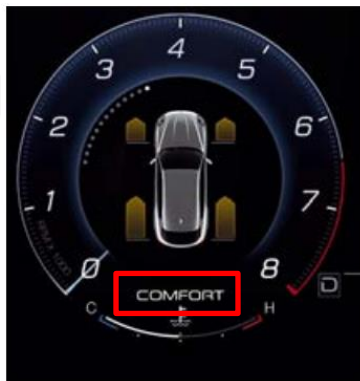
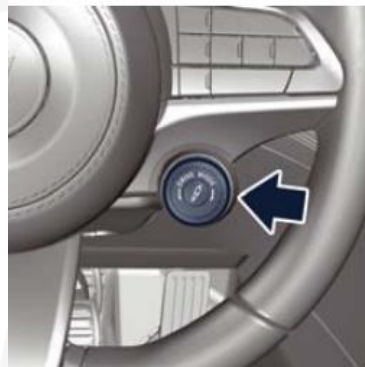
1. Always check ModisCS+ to see if the vehicle is involved in this action and if it has not been previously performed.
2. Start the Engine and make sure "Comfort" mode is activated via the instrument cluster (IPC) display using the selector located on the steering wheel.

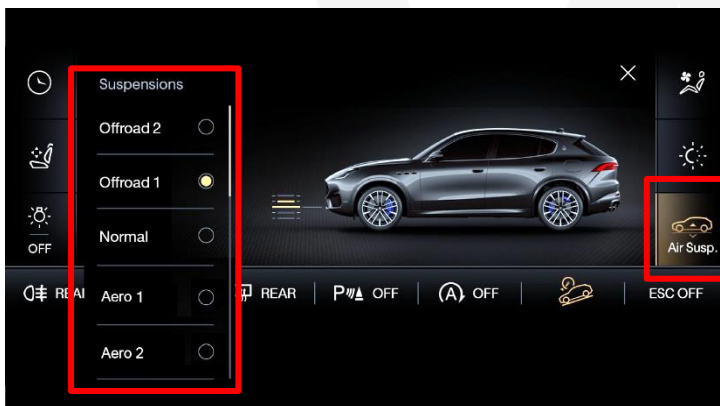
3. Cycle from "Off Road 2" to "Aero 1" position (highest to lowest) 5 (five) times, via the "Suspension" menu" in the MIA. **Wait 10 seconds between cycles to avoid overheating the system.**

Perform 5 cycles.  
Wait 10 secs between cycles

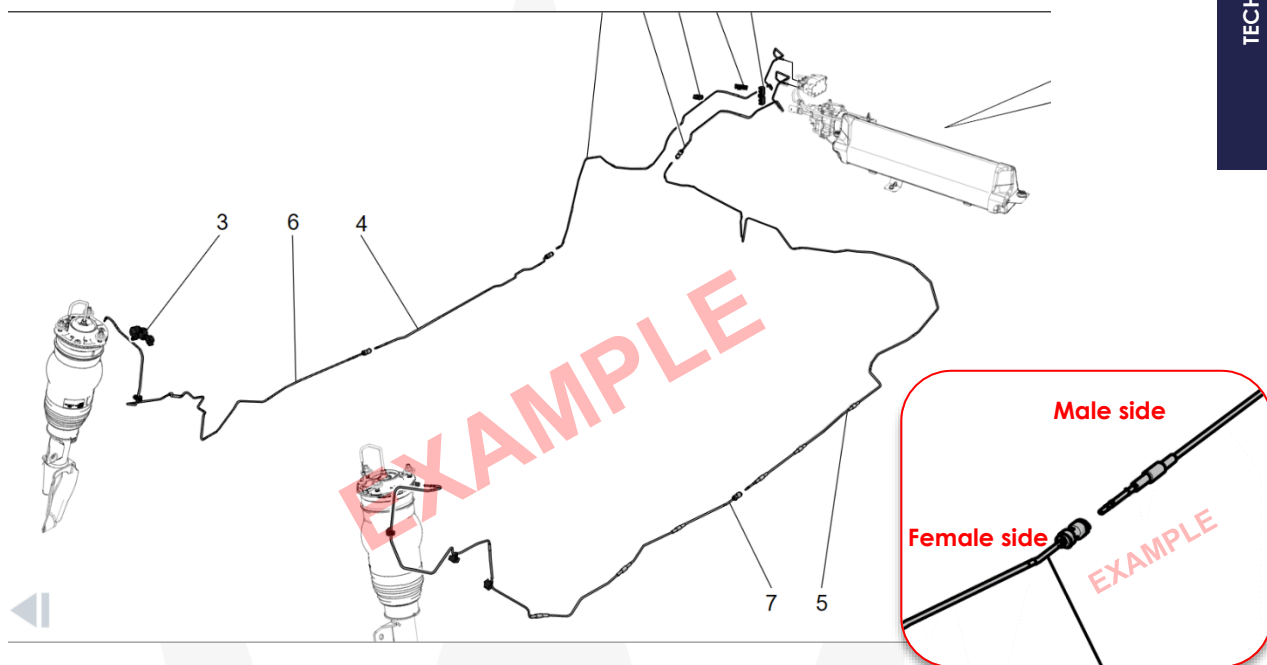
- OK = No leaks found. ► Open a BOL as "SUPPORT REQUEST" and report findings even if there are no obvious leaks. Attach pictures and a vehicle scan. (Vehicle scan must be in PDF format)
- NOT OK ► Air leak is present. Open a BOL as "SUPPORT REQUEST" and attach pictures of the leak, including a vehicle scan and report all the information collected throughout all the above checks. . (Vehicle scan must be in PDF format)

**NOTE:** If an air leak is evident from any of the areas of the air pipe couplings, it is necessary to replace the two components of the sections (male end and female ends) following the workshop procedure.
