## Service Bulletin

## Subject: Radio Software Version Y167 – Multiple Updates for IOK

This Service Bulletin is replacing PIT5976. Please discard all previous copies of PIT5976.

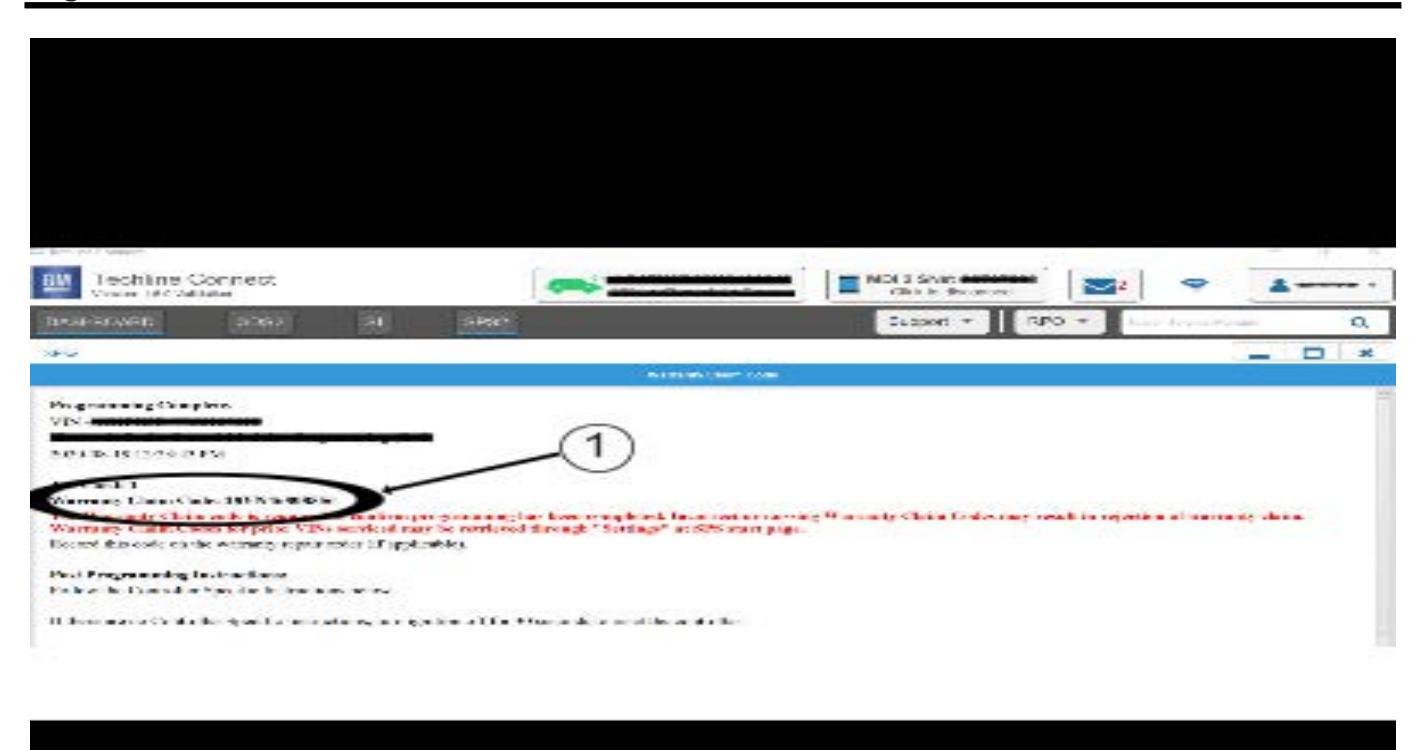
**Note:** The screenshot above is an example of module programming and may not be indicative of the specific module that is being programmed. Module selection and VIN information have been blacked out.

**Important:** To avoid warranty transaction rejections, you MUST record the warranty claim code provided on the Warranty Claim Code (WCC) screen shown above on the job card. Refer to callout 1 above for the location of the WCC on the screen.
