TECHNICAL SERVICE BULLETIN

Bulletin No.: TSB-046

Subject: VP ¾" and 1" Fuel Line Leaks

Models: 2022 MY Quantum 40 Series VP Trailers

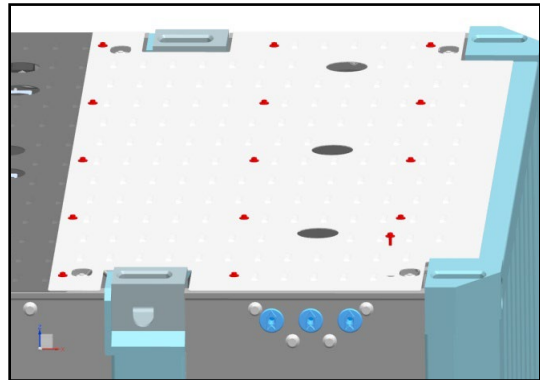
1. Remove and retain the fasteners securing the three rear roof panels.

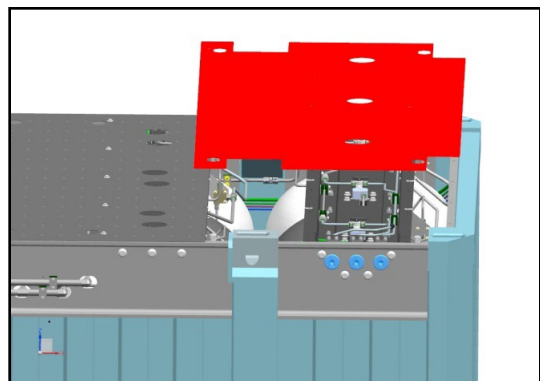
2. Mark the roof panels to indicate its position on the trailer. Remove and retain the roof panel.

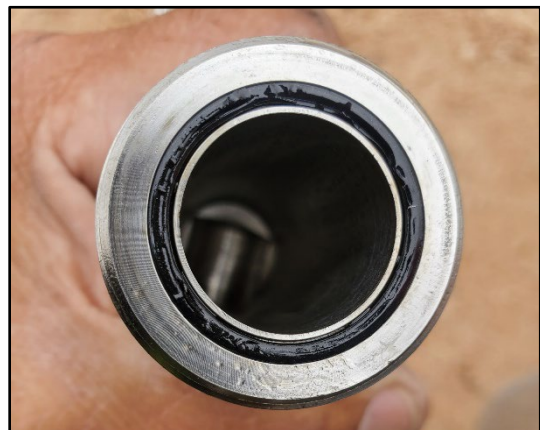
3. Disassemble the leaking fitting making sure to capture the O-ring for later inspection if needed.
4. Inspect the Parflange® surface of the joint being serviced. Refer to Parflange® Inspection in this document.
5. Inspect the ORFS Fitting of the joint being serviced. Refer to ORFS Fitting Inspection in this document.
6. Clean the Parflange® and ORFS fitting face, lubricate and install a new O-ring.

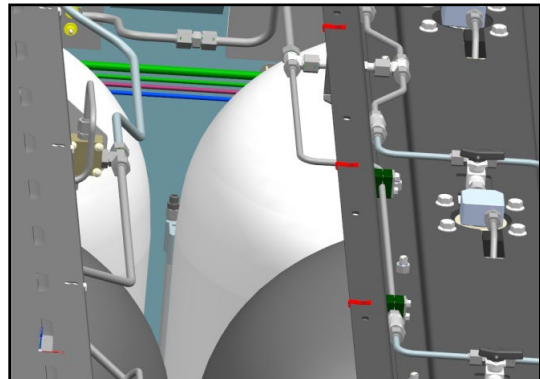
10. Pressurize pipes that were serviced and check for leaks at all disturbed fittings.
11. Verify all U-Nuts are in place for the roof panels, install new U-Nuts as needed.

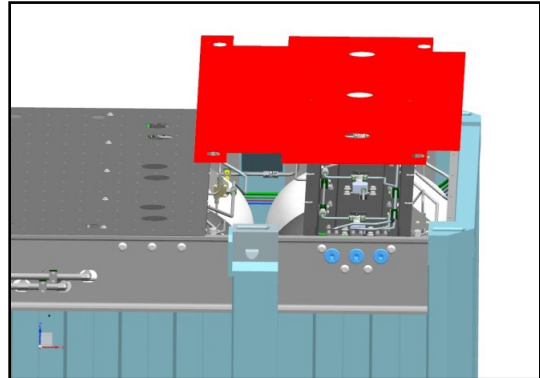
12. Locate the roof panel that was marked during removal for the position being installed. Place the roof panel in the position and align as needed.

IMPORTANT: Use care when positioning the panels, when sliding the panels across the cross members the edge of the roof panel can catch and knock off the U-Nuts.

Where panels overlap, the forward panel should always be on top of the panel to the rear.

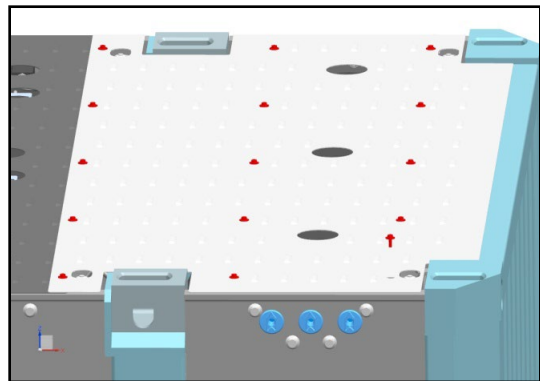
13. Loose fit all the roof panel fasteners; be sure to replace any fasteners that may have been missing prior to disassembly.

14. For Steel Roof Panels, starting in the center and working towards outside.
Tighten fasteners to 22 lb.ft (30 Nm.)

For Aluminum Roof Panels, starting in the center and working towards the outside
Tighten fasteners to 24 lb.ft (33 Nm.)
