# Service Action

## Code: 93P7

<b>Subject</b>	HV Battery Cell Module(s)															
<b>Release Date</b>	March 29, 2023															
<b>IMPORTANT!</b> <b>Battery Cell Evaluation/Replacement</b>	<ul style="list-style-type: none"><li><b>Vehicles with CRITERIA 02 in ELSA</b> have already been identified by the factory as requiring battery cell module replacement(s). Owners of these vehicles <b>MUST</b> schedule this service action directly with a certified Volkswagen battery repair dealer.</li><li><b>Vehicles with CRITERIA 04 in ELSA</b> can be scheduled for battery cell evaluation with any authorized Volkswagen dealer; however if the evaluation indicates battery cell replacement(s) is needed, the dealer performing the replacement(s) <b>MUST</b> be a certified Volkswagen battery repair dealer.</li></ul>															
<b>Affected Vehicles</b>

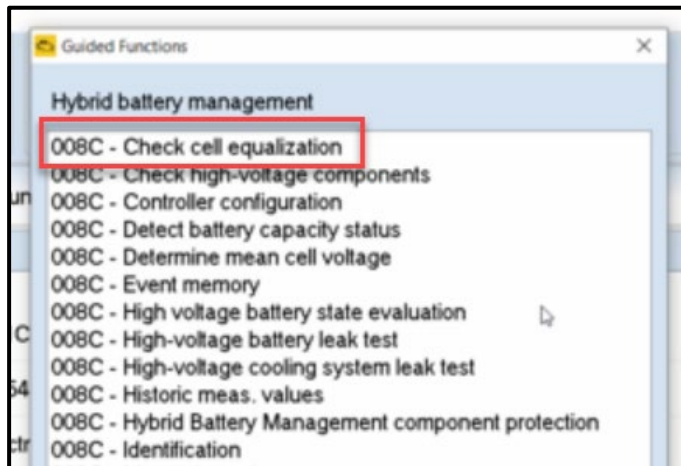
#### Check cell balancing and determine if any modules require replacement:

- Perform a diagnostic scan of the vehicle.
- Select the 008C Guided Functions test plan:
  - 008C – Check cell equalization
- Follow the test plan steps. The test plan will identify which (if any) additional cell module(s) will require replacement due to increased self-discharge.
- If the HV battery is OK and NO cell modules require replacement:
  - Proceed to Section D
- If the test plan indicates that a cell module requires replacement:
  - Send the diagnostic protocol to GFF Paperless.
  - Document which cell module requires replacement on the repair order.
  - **Non-battery repair dealers cannot perform the cell module replacement.**
  - **DO NOT apply the campaign completion label.**
  - The customer must be informed that a cell module requires replacement and an appointment will be required at a battery repair dealer.
  - **Work is complete for a non-battery repair dealer.**

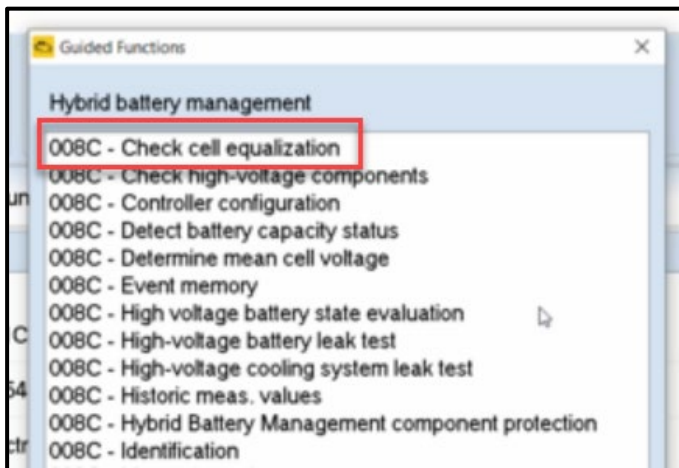
**Check cell balancing and determine if additional modules require replacement:**

If a non-battery repair dealer already performed this inspection, the inspection must be performed again by the battery repair dealer to ensure all affected cell modules are replaced.

- Perform a diagnostic scan of the vehicle.
- Select the 008C Guided Functions test plan:
  - 008C – Check cell equalization
- Follow the test plan steps. The test plan will identify which (if any) additional cell module(s) will require replacement due to increased self-discharge.
- If additional cell modules require replacement, place the order for the additional parts and continue with this procedure once all parts have arrived.
- If no additional cell modules require replacement and all parts are available to complete this repair, continue with the next steps.
