Service Alert

Mazda North American Operations
Irvine, CA 92618-2922

Subject: CONNECTED VEHICLE SYMPTOM TROUBLESHOOTING	Service Alert No.: SA-009/23
	Last Issued : 03/28/2023

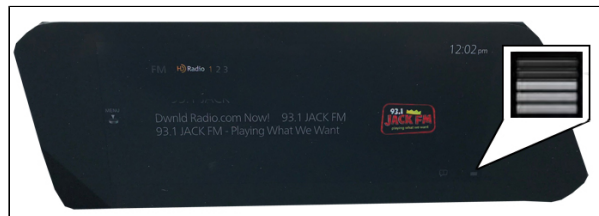
4. Confirm the customer's phone and vehicle have good to strong reception during the concern as shown in the table below.

- If the reception is weak, move the vehicle to a location where the reception is good to strong as shown in the table, then try to get the Authorization Code and/or operate the remote functions before proceeding to the Repair Procedure if there is still an issue.
- If the reception is good to strong, proceed to Connected Vehicle Troubleshooting below.

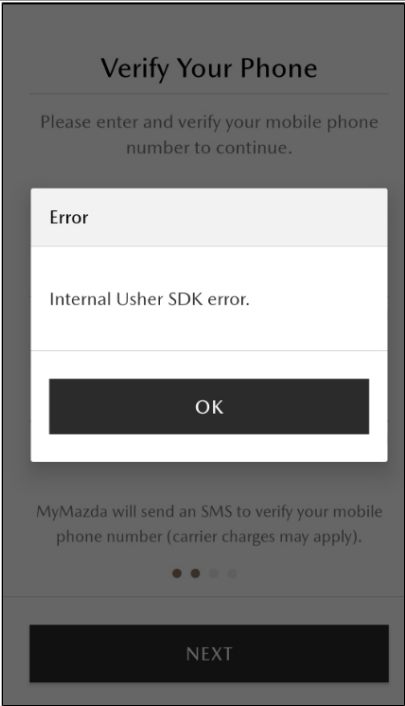
Connected Vehicle Troubleshooting			
	Symptom	Cause	Action
1	The customer is not able to create a MyMazda account. The customer receives the following error: MyMazda App - Internal Usher SDK error.	Customer inadvertently texted "Stop" to 1-949 518-0058 (Twilio SMS for Mazda)	1. Text "Start" to 1-949 518-0058 (Twilio SMS for Mazda) 2. Retry to create a MyMazda account. NOTE: USA and Canada only

<p>Verify Your Phone</p> <p>Please enter and verify your mobile phone number to continue.</p> <p>Error</p> <p>Internal Usher SDK error.</p> <p>OK</p> <p>MyMazda will send an SMS to verify your mobile phone number (carrier charges may apply).</p> <p>NEXT</p> <p>MyMazda Website - ERROR! Unable to send one-time password.</p>

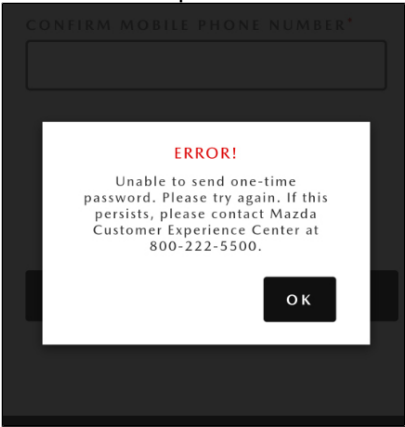
<p>CONFIRM MOBILE PHONE NUMBER</p> <p>ERROR!</p> <p>Unable to send one-time password. Please try again. If this persists, please contact Mazda Customer Experience Center at 800-222-5500.</p> <p>OK</p>		
<p>2</p> <p>Remote function(s) inoperative.</p> <ul style="list-style-type: none"> • Engine Start / Stop • Door Lock / Unlock • Lights ON / OFF 	<p>Go to the MyMazda App to view the reason for remote function failure.</p>	<p>Push Notification</p>
