MAZDA DEALER EMAIL

Subject: Notification of Special Service Program (SSPC8) - 2023 CX-9, 2023 Mazda3, 2022-2023 MX-30 - Remote Tuner Concern

Special Service Program (SSPC8)

2023 CX-9, 2023 Mazda3, 2022-2023 MX-30 – Remote Tuner Concern

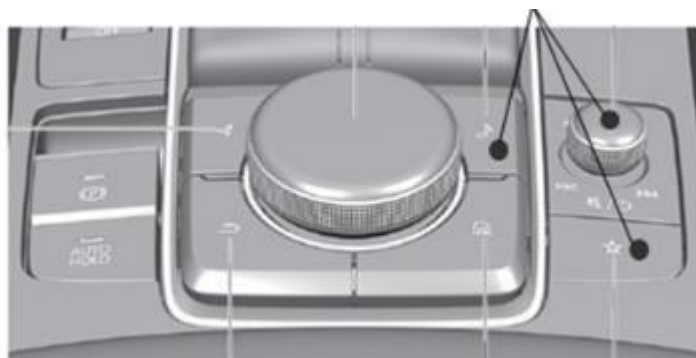
5. Press and hold Volume button, additionally press Music and Favorite buttons at the same time for 3-5 seconds and the Factory/Service Inspection screen will appear.

NOTE: Depending on vehicle type the location of buttons can be different

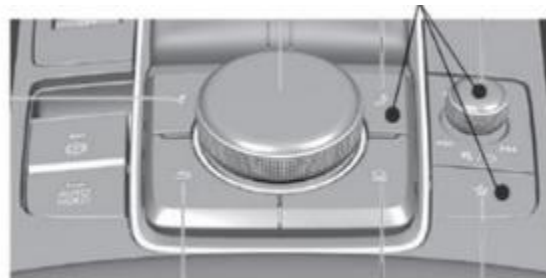
14. Press and hold Volume button and additionally press Music and Favorite buttons at the same time for 3-5 seconds and the Factory/Service Inspection screen will appear.

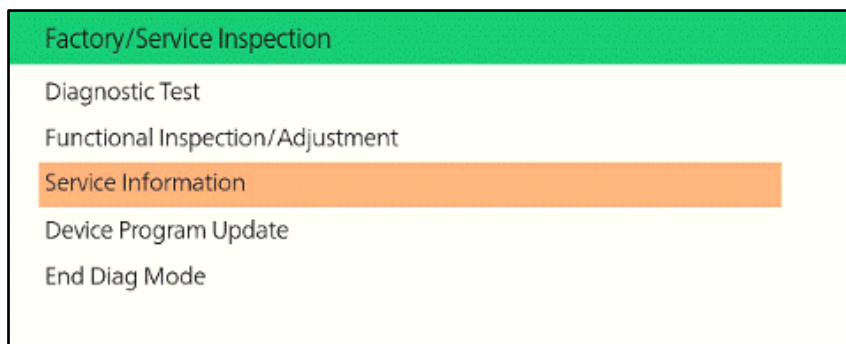
15. Select "Service Information" on the screen below.

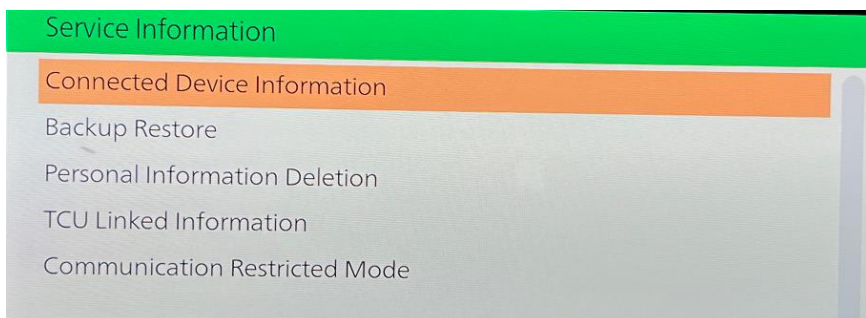
16. Select "Connected Device Information" on the screen below.

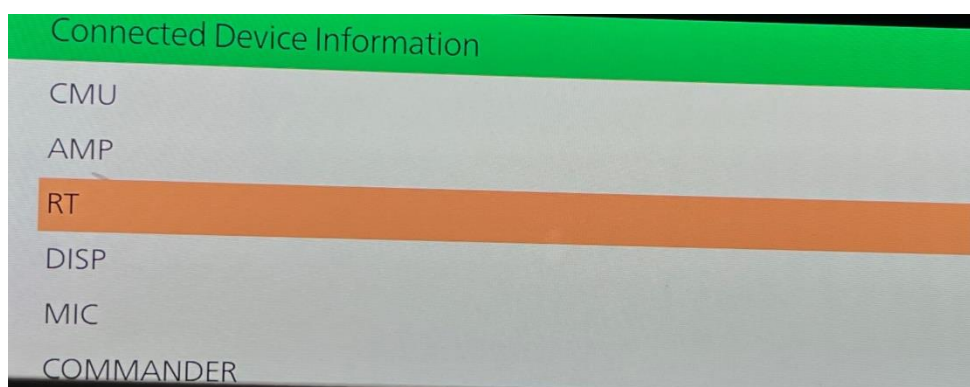
17. Select "RT" on the screen below.
