GLOBAL SAFETY FIELD INVESTIGATIONS
DCS6522
URGENT - DISTRIBUTE IMMEDIATELY

Subject: N222375791-01 - Customer Satisfaction Program
Park Assist Retrofit

Models: 2022 – 2023 Cadillac XT4
2022 – 2023 Cadillac XT5
2022 – 2023 Cadillac XT6
2022 – 2023 Chevrolet Camaro
2022 Chevrolet Silverado 1500 LTD
2022 – 2023 Chevrolet Silverado 2500HD/3500HD
2022 GMC Sierra 1500 Limited
2022 – 2023 GMC Sierra 2500HD/3500HD

N222375791 Park Assist Retrofit

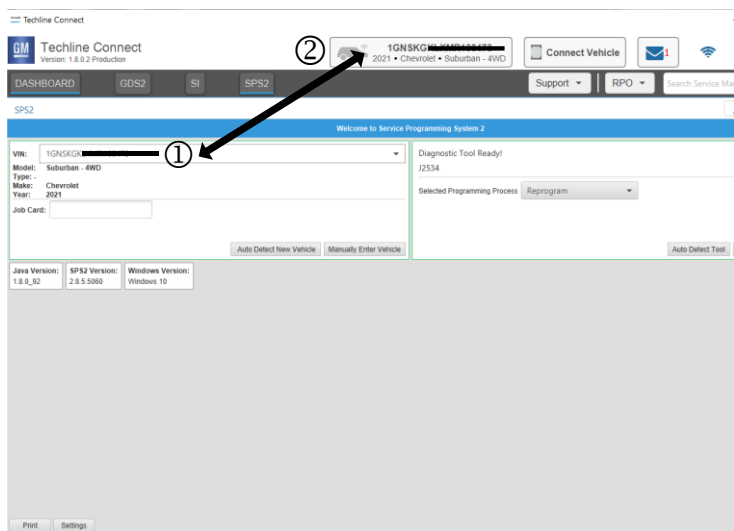
5743643

Caution: Be sure the VIN selected in the drop down menu (1) is the same as the vehicle connected (2) before beginning programming.

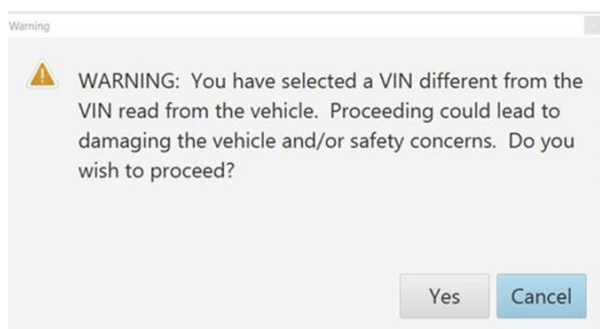
5877000

Important: If the vehicle VIN DOES NOT match, the message below will be shown.

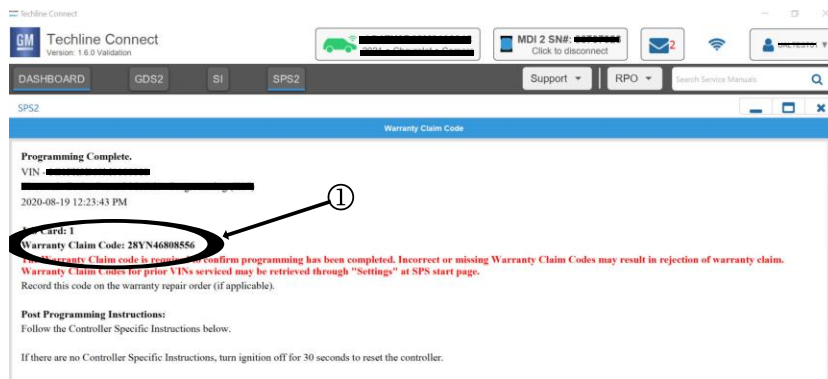
5644478

Note: The screenshot above is an example of module programming and may not be indicative of the specific module that is being programmed. Module selection and VIN information have been blacked out.

Important: To avoid warranty transaction rejections, you **MUST** record the warranty claim code provided on the Warranty Claim Code (WCC) screen shown above on the job card. Refer to callout 1 above for the location of the WCC on the screen.

1. Install the new Parking Assist Control Module. Refer to *Parking Assist Control Module Replacement* in SI.
Caution: When starting SPS2, select *Reprogram NOT Replace and Reprogram*.
2. Reprogram the Parking Assist Control Module. Refer to *K182 Parking Assist Control Module: Programming and Setup* in SI.
3. Perform setup and configuration on the Parking Assist Control Module. Refer to *K182 Parking Assist Control Module: Programming and Setup* in SI.
4. Perform setup and configuration on the Instrument Cluster. Refer to *P16 Instrument Cluster: Programming and Setup* in SI.

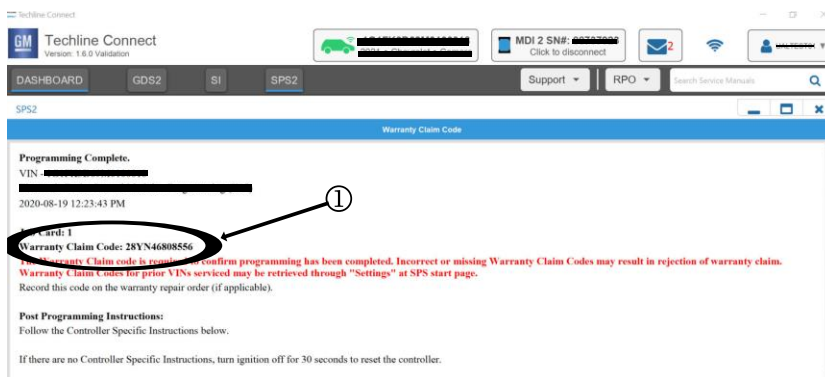
5644478

Note: The screenshot above is an example of module programming and may not be indicative of the specific module that is being programmed. Module selection and VIN information have been blacked out.

2. Reprogram the Parking Assist Control Module. Refer to *K182 Parking Assist Control Module: Programming and Setup* in SI.
3. Perform setup and configuration on the Parking Assist Control Module. Refer to *K182 Parking Assist Control Module: Programming and Setup* in SI.
4. Perform setup and configuration on the Instrument Cluster. Refer to *P16 Instrument Cluster: Programming and Setup* in SI.

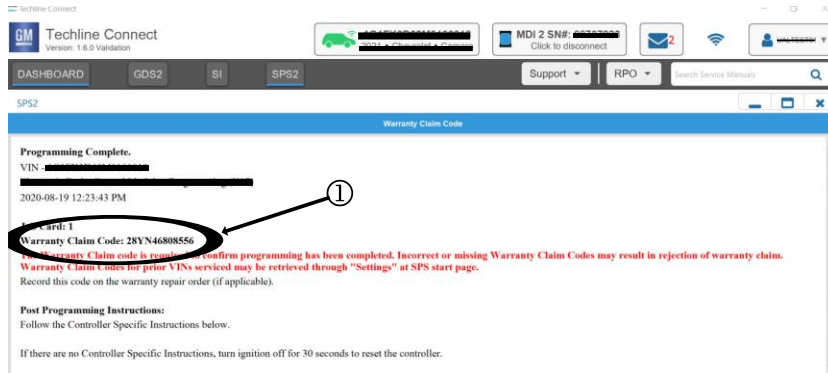
5644478

Note: The screenshot above is an example of module programming and may not be indicative of the specific module that is being programmed. Module selection and VIN information have been blacked out.

3. Perform setup and configuration on the Parking Assist Control Module. Refer to *K182 Parking Assist Control Module: Programming and Setup* in SI.
4. Perform setup and configuration on the Instrument Cluster. Refer to *P16 Instrument Cluster: Programming and Setup*.

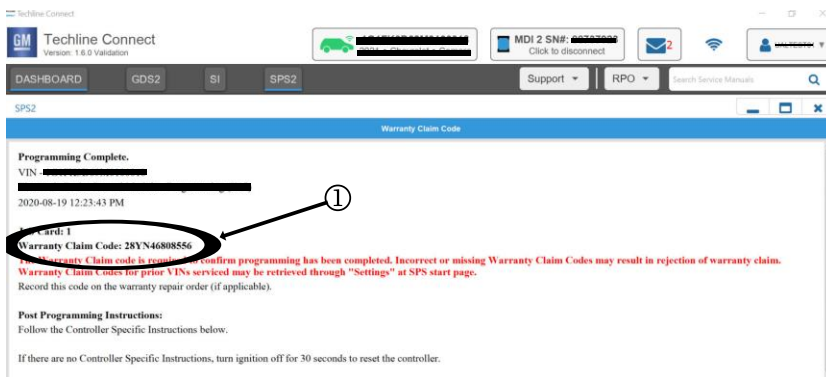
5644478

Note: The screenshot above is an example of module programming and may not be indicative of the specific module that is being programmed. Module selection and VIN information have been blacked out.

5. Reprogram the Active Safety Control Module. Refer to *K124 Active Safety Control Module: Programming and Setup*.

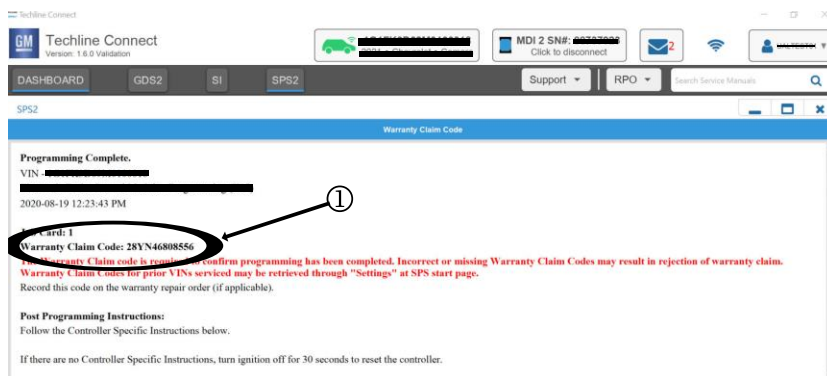
5644478

Note: The screenshot above is an example of module programming and may not be indicative of the specific module that is being programmed. Module selection and VIN information have been blacked out.

2. Reprogram the Parking Assist Control Module. Refer to *K182 Parking Assist Control Module: Programming and Setup* in SI.
3. Perform configuration on the Parking Assist Control Module. Refer to *K182 Parking Assist Control Module: Programming and Setup* in SI.
4. Reprogram the Body Control Module. Refer to *K9 Body Control Module: Programming and Setup* in SI.
5. Perform program and configuration on the Instrument Cluster. Refer to *P16 Instrument Cluster: Programming and Setup* in SI.
