**SERVICE BULLETIN**

**APPLICABILITY:** 2020-22MY Legacy and Outback Models      **NUMBER:** 15-261-20R  
**SUBJECT:** Reprogramming File Availability for Optimization of Gen 4 Denso CP1 Infotainment Systems      **DATE:** 03/10/20  
**REVISED:** 03/13/23

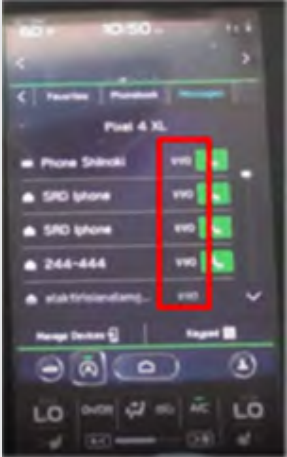
<p><b>15</b></p>	<p>When “Call” button is pressed in “Confirm Destination” screen of Navigation system (to call the destination site,) the call can be made but the screen does not transit to phone call screen.</p>
<p><b>16</b></p>	<p>When selecting “Phone-&gt;”Message,” message received time is displayed incorrectly as “1/1/0.”</p> <p>It can occur with an Android phone with a specific Android OS (Pixel 6, Pixel4a, Pixel4XL, Xperia etc. ) in which time zone data is attached to the message receiving time.</p>

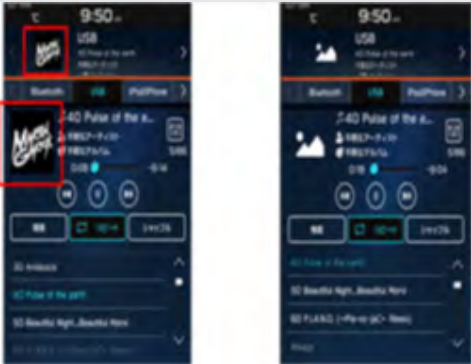
<p><b>17</b></p>	<p>Even when using the same mobile device that was paired previously, a message of “Are you sure you want to activate this profile?” is prompted and confirmation is needed to activate the device.</p>
<p><b>18</b></p>	<p>Cover art of previous music is displayed when playing music without cover art in USB audio. It can occur when music with and without cover art is mixed and stored together a single USB.</p>

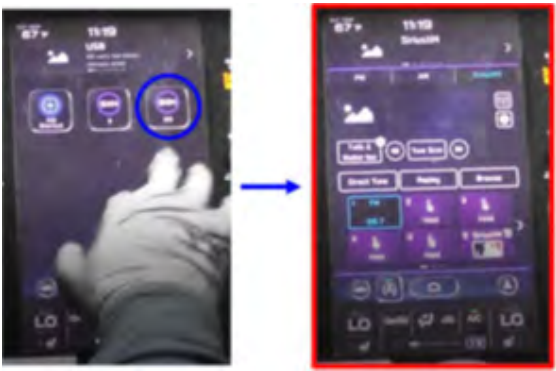
22	The mode does not switch to Media, after “Media” icon is selected.
23	When selecting shortcut for SXM channel on “Home” screen, the screen is changed to SXM but no sound is coming or no channel name is displayed.

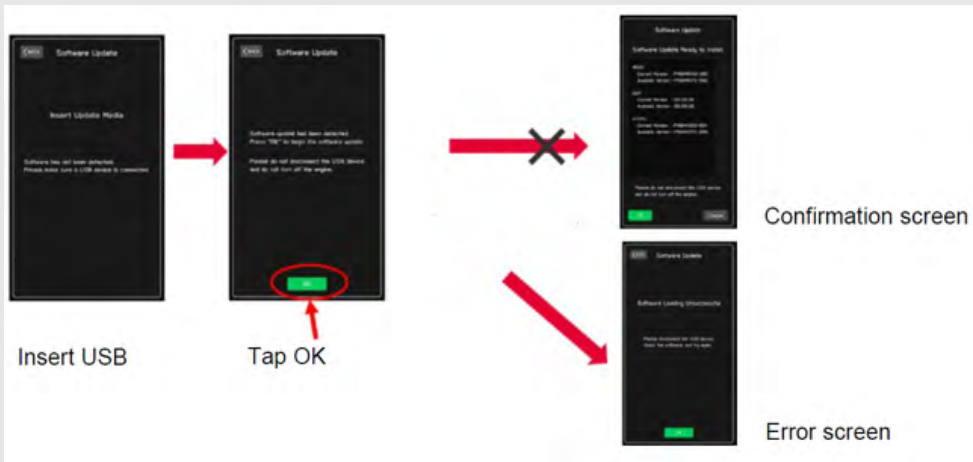
Number	Symptoms to be Improved:
12	<p>When conducting USB reprogramming, the screen transition to error screen instead of confirmation screen.</p>

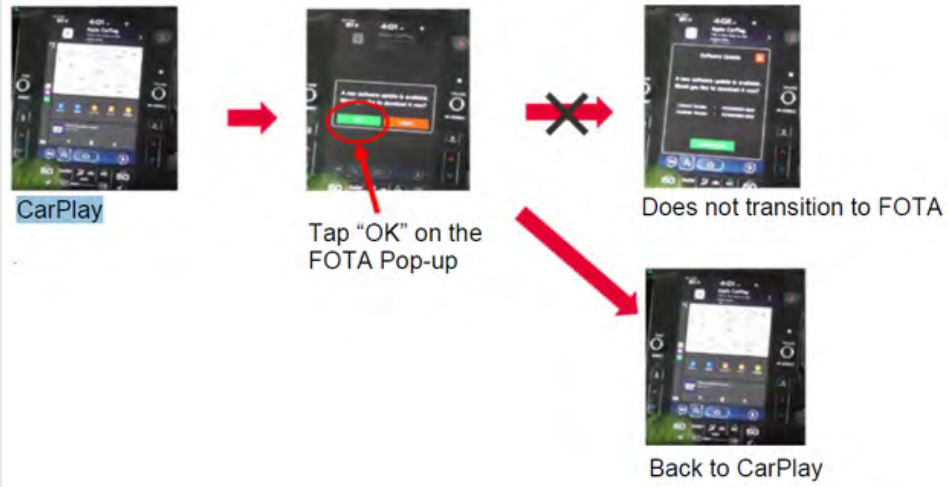
<p><b>Note*</b> In case this USB update failure occurs, retry updating according to the instructions in “Appendix A”</p>
14	<p>When the FOTA pop-up (new software availability notification) is displayed while the CarPlay is being used, the display comes back to CarPlay screen even if the customer tries to get into the FOTA screen.</p>

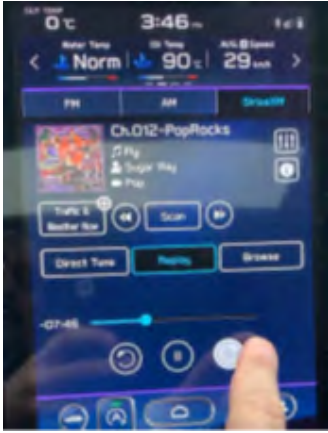
Number	Symptoms to be Improved:
28	SXM has blank screen and no sound when the audio source is change to SXM.
29	<p>“Fast forward” does not work in SXM replay function. (Fast Rewind works.)</p>

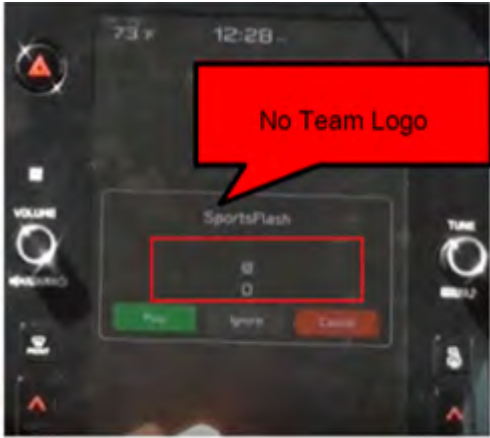
<p>The image shows a smartphone screen displaying the Sports Flash interface. A red box highlights the area where the team logo should be displayed, but it is missing.</p>
31	<p>The team logo is not displayed on Sports Flash screen when the SXM screen had been selected as audio source at the previous ignition off timing.</p>

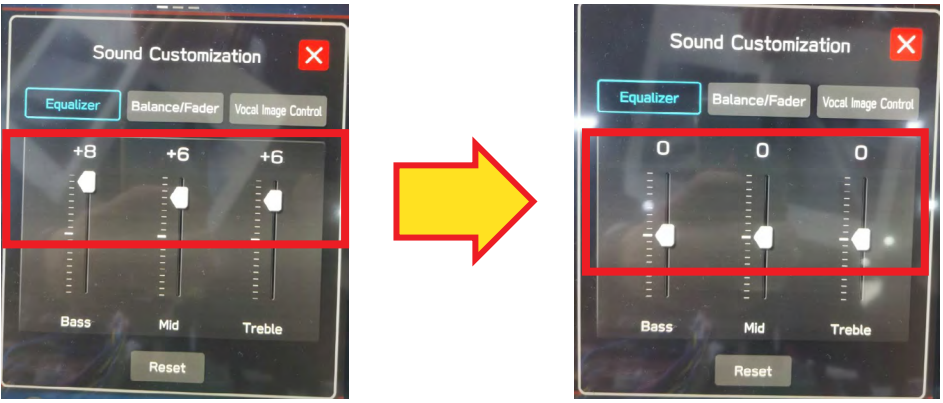
7	Customer-selected Equalizer settings are lost. Equalizer returns to the default settings after ignition switch is turned OFF and back ON.

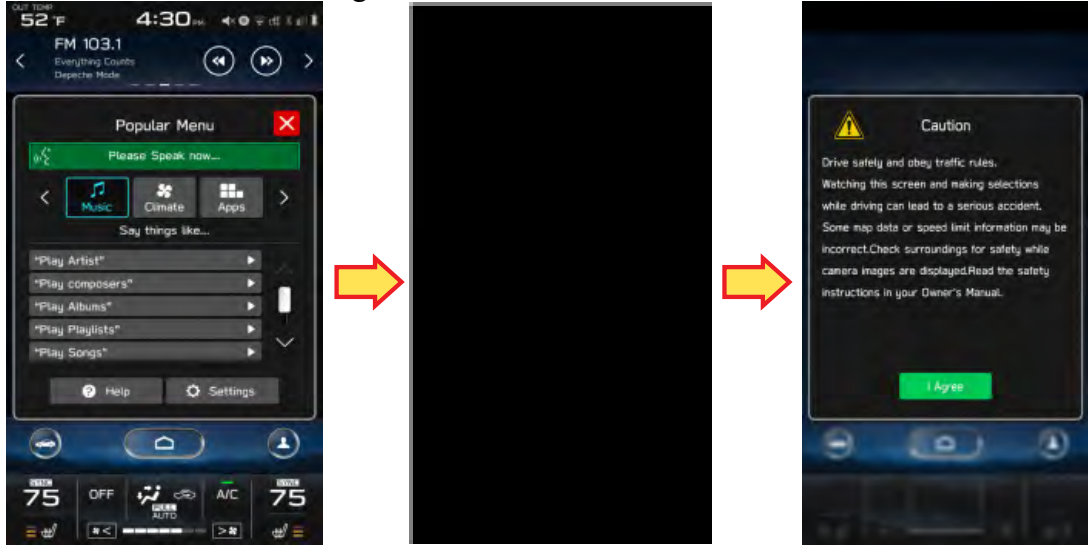
Symptom #	Description of Symptom:
5	<p>When using Voice Recognition to search for a 'Nearby POI' (Point of Interest) in Canada with FRENCH language selected, the CP1 display turns black and displays a Caution / disclaimer message.</p>
