**SERVICE BULLETIN**

**APPLICABILITY:** 2020-2022MY Outback & Legacy  
 2022-2023MY BRZ  
 2022-2023MY WRX

**NUMBER:** 15-270-20R  
**DATE:** 8/19/2020  
**REVISED:** 03/15/23

**SUBJECT:** FOTA (Firmware Over-The-Air) Reprogramming for DENSO Gen 4 Audio / Navigation Infotainment Systems

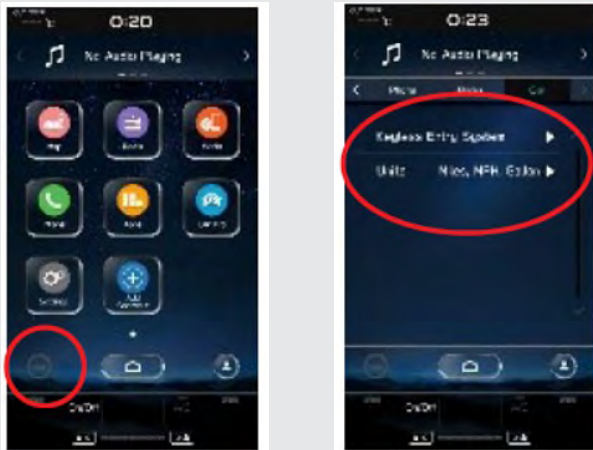
5	Ring tones and the voice from the other end on the hands-free phone call cannot be heard	USB ONLY
6	Android Auto does not function. “Android Auto is Disconnected” is displayed with Launch Error message.	USB ONLY
7	Time setting is not possible in Manual mode	USB ONLY
8	<p>Vehicle Setting Icon in &lt;Home&gt; menu is grayed out. Menu list in the “Car” tab in the Setting Menu is not displayed.</p>

USB ONLY
9	Incorrect translation for X-Mode in Spanish language	USB ONLY

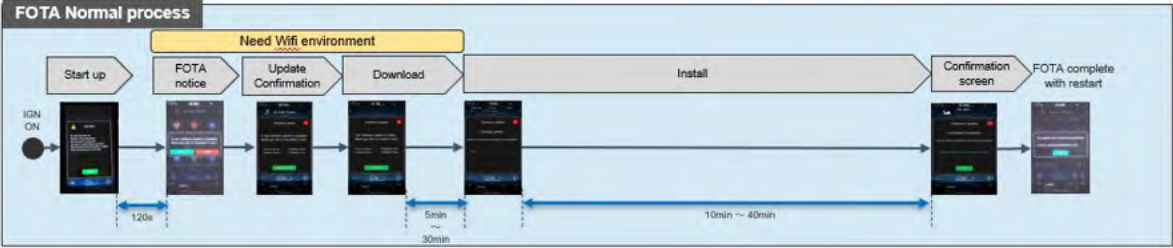
No.	Conditions/Symptoms to be improved
1	<p>System restarts itself during FOTA (Firmware Over The Air) update. FOTA operation is conducted in two processes: downloading (from the server to the Cockpit Control Unit via Wi-Fi) and installation (inside the Cockpit Control Unit). During the FOTA operation, after the new software has been downloaded to the Cockpit Control Unit (CCU) customer is to push “Install Now” on the Center Information Display (CID) to start installation of the software.</p>

<p>However, in rare case, the CCU restarts itself* during installation.</p>

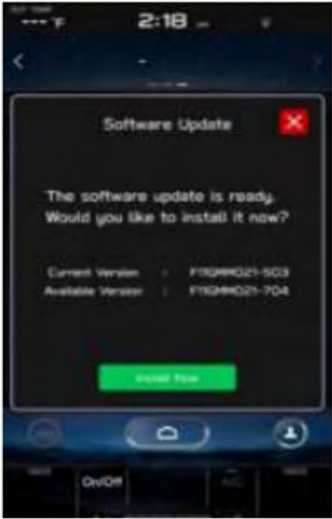
<p><b>Note*)</b> Even if this symptom occurs, after approximately 2 minutes, the system resumes, and the CID comes back to the below screen. Customer can then push the “Install Now” to proceed with the installation.</p>

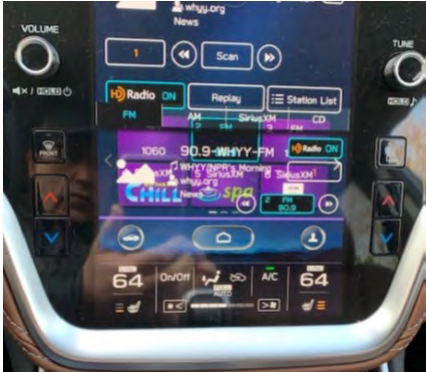
No.	Conditions/Symptoms to be improved
10	Screen is no changed to Composer or Album screen, iPhone /iPod connected as iPod mode
11	<p>CID shows multiple images simultaneously</p>

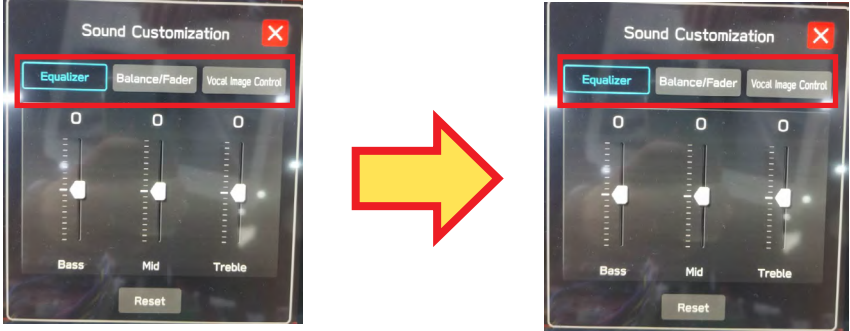
7	Equalizer setting returns to default setting. After ignition switch is turned Off and ON, the equalizer returns to default setting.

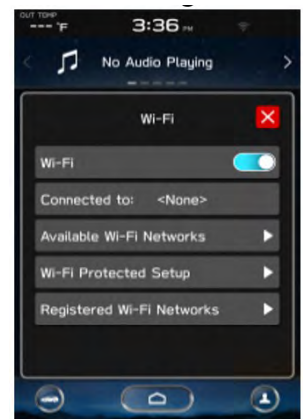
Tips:

- a. Check the internet connection to ensure it is active and shows full signal strength.
  - i. Select General tab under “Setting” screen and change the “Wi-Fi” to Off once then turn it back to On again.

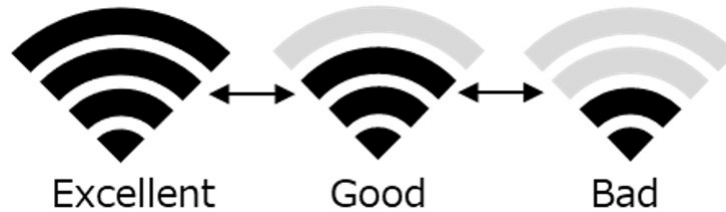
- 5. If the “progress bar” does not progress after selecting “Download” or, if you receive a “Connect to Wi-Fi” popup while downloading:

- b. Try moving the vehicle closer to the Wi-Fi source. If that is not possible, try a different Wi-Fi connection such as a phone hotspot.
