# TECHNICAL SERVICE BULLETIN

Classification: RS19-004C	Reference: NTB19-071C	Date: March 9, 2023
------------------------------	--------------------------	------------------------

## DTC B00A0-00 STORED

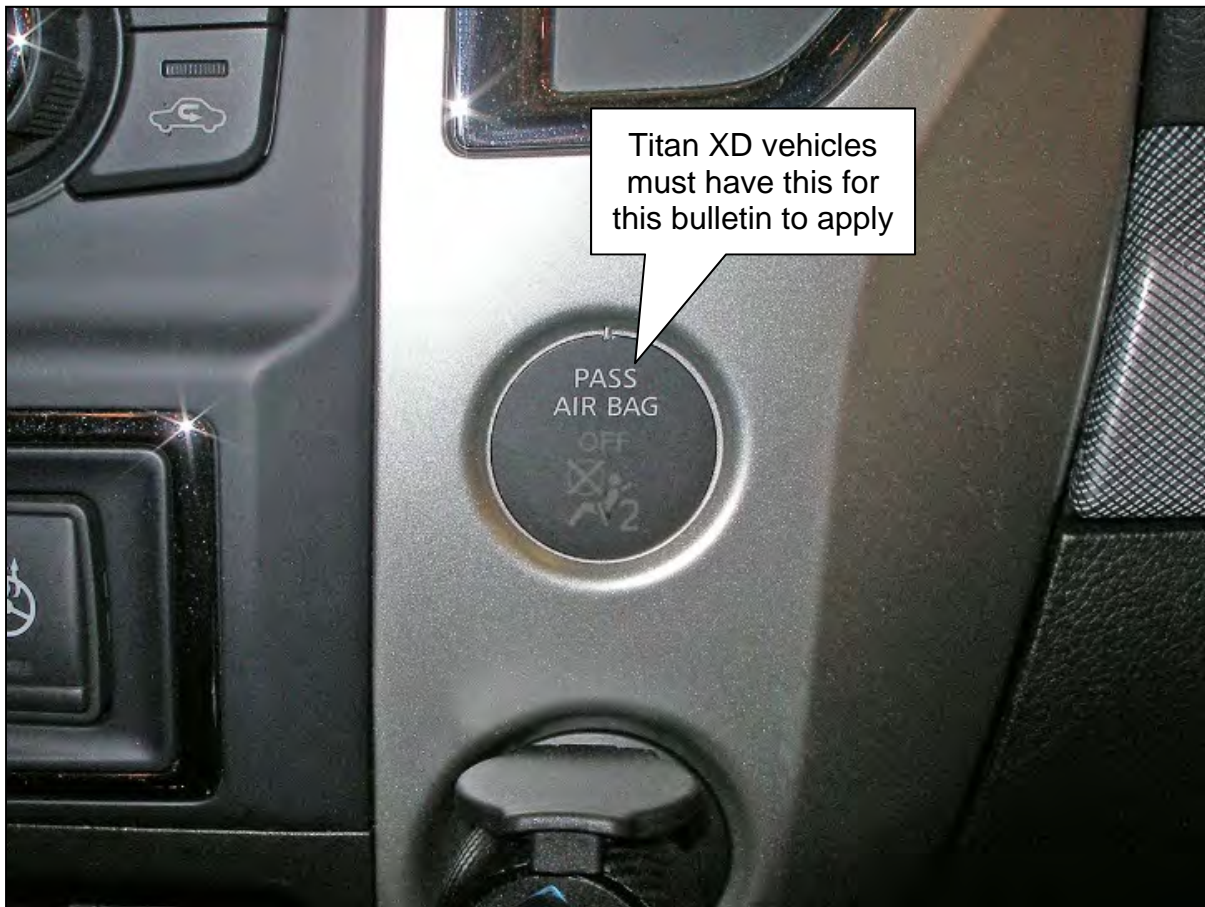
Figure 3

- ASIST on the CONSULT PC has been synchronized (updated) to the current date.
- All CONSULT-III plus (C-III plus) software updates (if any) have been installed.
- The CONSULT PC is connected to the Internet (Wi-Fi or cable).
- Titan vehicles: This bulletin applies to ALL Titan vehicles.
- Titan XD vehicles: This bulletin does NOT apply to all Titan XD vehicles. This bulletin applies to Titan XD vehicles equipped with OCS, as indicated by the presence of a front passenger air bag status light (see Figure 3).
