GLOBAL SAFETY FIELD INVESTIGATIONS
DCS6529
URGENT - DISTRIBUTE IMMEDIATELY

Subject: N222385490 - Customer Satisfaction Program
Power Outlet Retrofit with RPO 08R

Models: 2023 Chevrolet Silverado 1500
2023 GMC Sierra 1500

N222385490 Power Outlet Retrofit

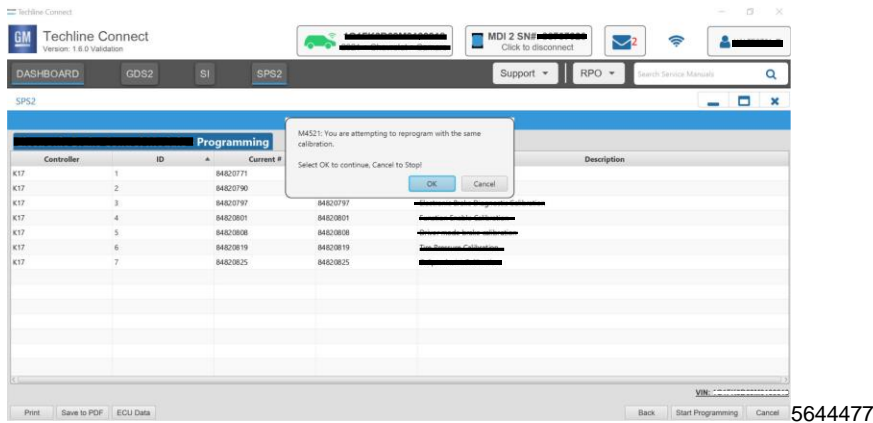
Important: Techline Connect screens shown above.

Important: If the same calibration/software warning is noted on the TLC Summary screen, select OK and follow screen instructions. After a successful programming event, the WCC is located in the Service Programming System dialogue box of the SPS Summary screen. No further action is required. Refer to the Warranty section of the bulletin.
