Rear Outrigger Hose Inspection

Units Affected: Certain LS60 aerial devices built from July 2018 to April 2022. Verify your unit is affected by reviewing the attached list or accessing Altec Connect.

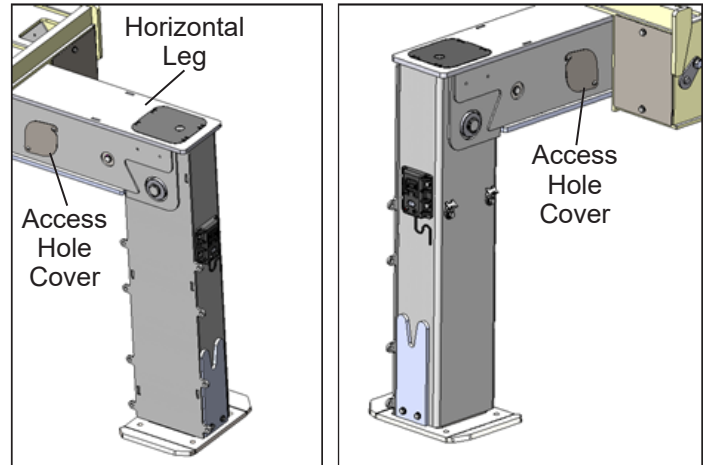
Figure 1 — Extending Legs to Expose Covers

2. Extend both rear outrigger horizontal legs far enough to expose the access hole covers on the sides (refer to Figure 1). Disengage the PTO, and turn off the engine. Remove the key from the ignition, and secure it following your employer’s vehicle lockout/tagout procedure.
