# Customer Satisfaction Program

## N222381840 Side Blind Zone Alert Retrofit

Release Date: April 2023

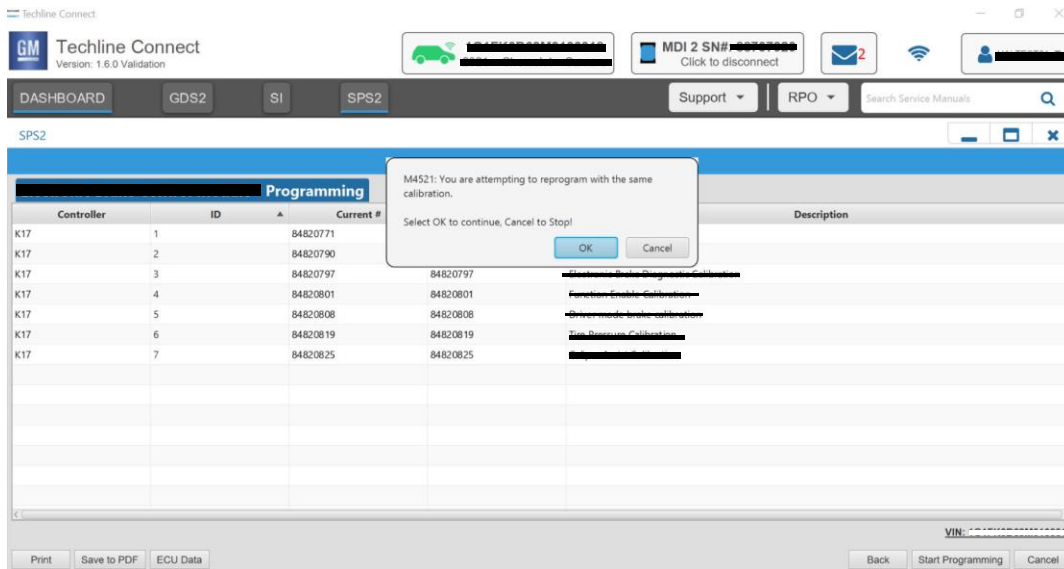
5644477

**Important:** Techline Connect screens shown above.

**Important:** If the same calibration/software warning is noted on the TLC Summary screen, select OK and follow screen instructions. After a successful programming event, the WCC is located in the Service Programming System dialogue box of the SPS Summary screen. No further action is required. Refer to the Warranty section of the bulletin.
