# Newmar Corporation

RSB 597  
April 28, 2023

NHTSA #23V 138  
TC #2023-110

## RECALL SERVICE BULLETIN

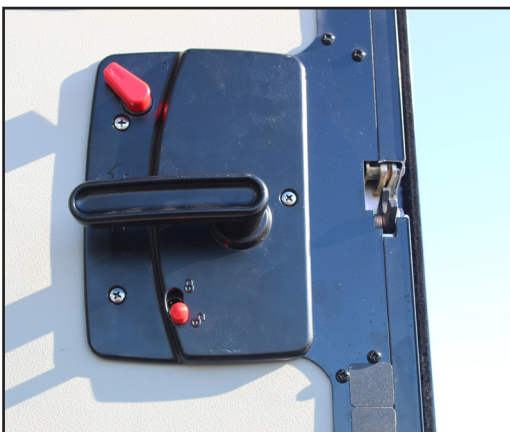
**Inside Latch Assembly**

This section of document refers to the replacement of the inside latch assembly of the complete door lock assembly with latch on certain motorized entry doors. A portion of the latch is breaking off when attempting to exit the coach. The instructions are applicable to using a replacement inside latch assembly PN 2023005033 for the 920 Series door and inside latch assembly PN 2022010407 for the 3500 Series door.

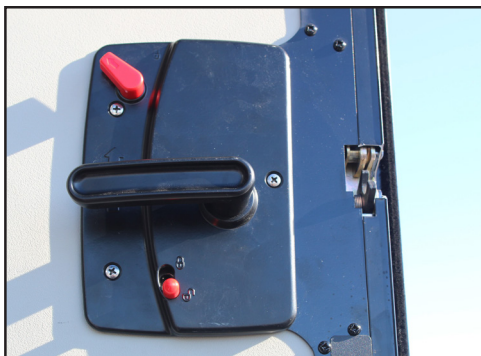
**Inside Latch Assembly**

The section of this document refers to the replacement of the complete door lock assembly with latch on certain motorized entry doors. A portion of the latch is breaking off when attempting to exit the coach. The complete door lock assembly with latch, PN 2021097898, is to be replaced with a redesigned part.
