Service Update

N232401090 Power Tonneau Cover Inoperative

Subject: N232401090 - Service Update
Power Tonneau Cover Inoperative

Models: 2022-2023 GMC HUMMER EV
Equipped with Accessory Power Tonneau Cover (RPO 5KM)

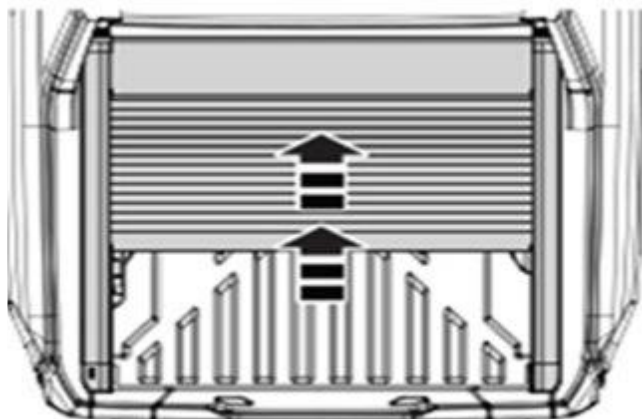
6325291

Condition	On certain 2022-2023 model year GMC HUMMER EV vehicles, equipped with an accessory power tonneau cover (RPO 5KM), the power tonneau cover may be inoperative.
Correction	Dealers are to replace the electronic control unit.

2. Inspect the Electronic Control Unit for a sticker containing the part number 86575630 as shown.
 - If the ECU has the part number sticker 86575630, no further action is required.
 - If the ECU does not have the part number sticker 86575630, proceed to step #3.
3. Remove the existing ECU and replace it with the new service part identified in the part table above.
