**PRODUCT CAMPAIGN BULLETIN**

<p><b>APPLICABILITY:</b> 2003-14 MY Legacy          2003-14 MY Outback          2003-06 MY Baja          2009-13 MY Forester          2004-11 MY Impreza          2004-14 MY WRX and STI</p> <p><b>SUBJECT:</b> Takata Front Passenger Airbag Module / Inflator “Like for Like” Recall</p>	<p><b>NUMBERS:</b> TKA-20R          TKB-20R          TKC-20R</p> <p><b>DATE:</b> 01/06/20</p> <p><b>REVISED:</b> 04/04/23</p> <p><b>NHTSA ID:</b> 20V001          20V002          20V003</p>
--	--

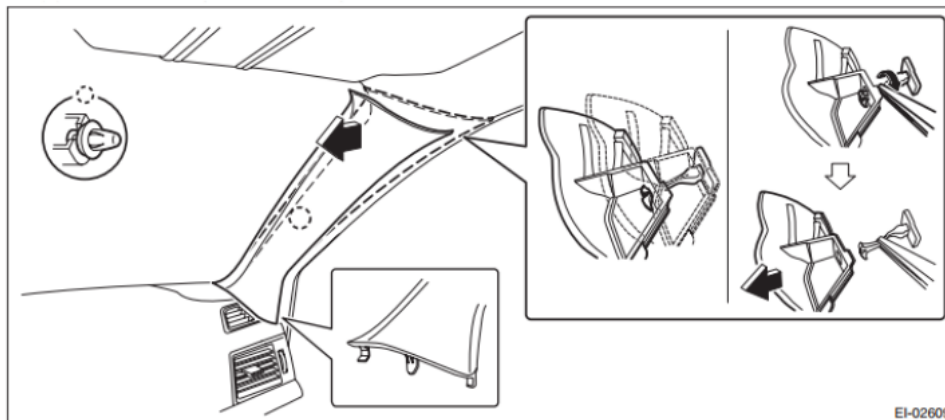
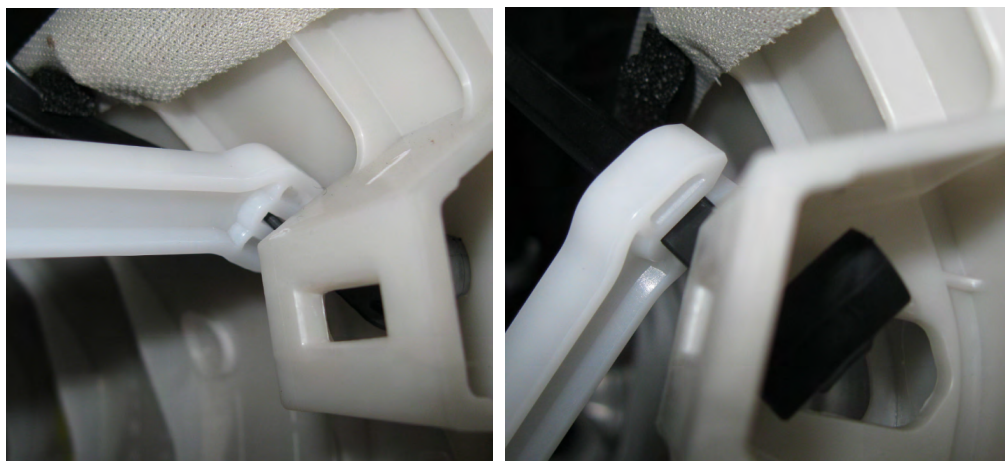
**NOTE:** Some models utilize a “tether clip” to secure the upper portion of the “A” pillar trim. The tether clip is located just below where the “A” pillar trim meets the head liner. If the tether clip becomes damaged, it **MUST** be replaced. The illustrations and photos below show the location of the tether clip and how to release it. It is **STRONGLY RECOMMENDED** to use the release tool (p.n. **SOA635147**) specifically designed for tether clip removal. Each Retailer has been supplied with 2 of these tools. If the tool is unavailable, a needle-nosed plier can be used to **CAREFULLY** release the tether clip as shown in the illustration below.

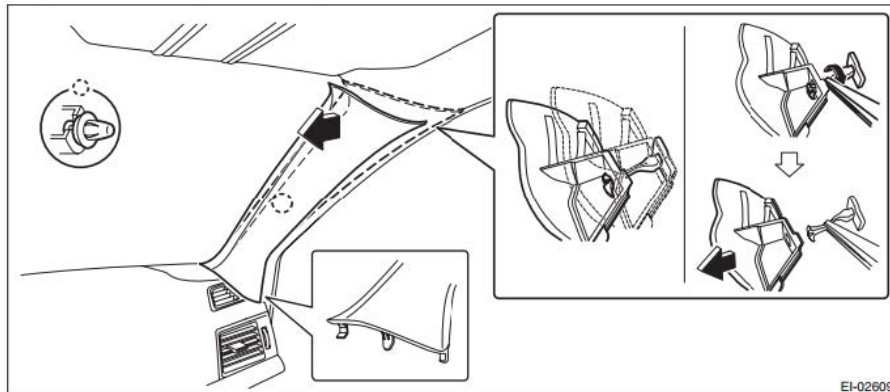
**NOTE:** When removing the “A” pillar trim, be **VERY CAREFUL** not to damage the upper trim retaining (tether) clip. The clip is located just below where the trim panel meets the head liner. If the tether clip becomes damaged, it **MUST** be replaced. The illustrations below show how to release the tether clip and remove the “A” pillar trim. It is **STRONGLY RECOMMENDED** to use the release tool (p.n. SOA635147) specifically designed for tether clip removal. See pg. 8 of this bulletin for more information.

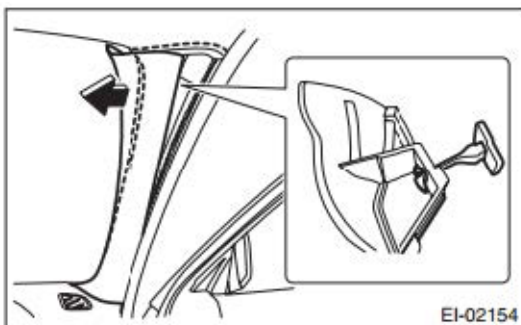
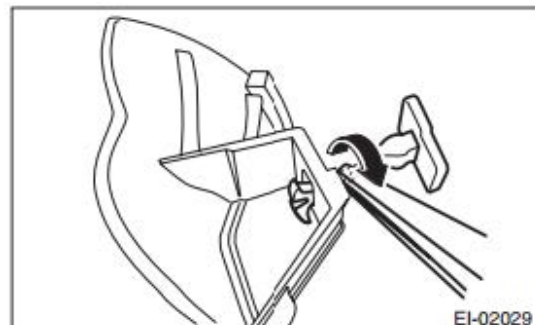
**NOTE:** On **FORESTER** models, when removing the “A” pillar trim, be **VERY CAREFUL** not to damage the upper trim retaining (tether) clip. It is **STRONGLY RECOMMENDED** to use the release tool (p.n. SOA635147) specifically designed for tether clip removal. See pg. 8 of this bulletin for more information. The clip is located just below where the trim panel meets the head liner. If the tether clip becomes damaged, it **MUST** be replaced. The illustrations below show how to release the tether clip and remove the “A” pillar trim.
