Subject: OIL SEEPAGE OR LEAKS AT ENGINE FRONT COVER	Bulletin No.: 01-006/23
	Last Issued : 04/26/2023

2018-2023 CX-5 2.5L with cylinder deactivation

NOTE: This service information applies to vehicles with SKYACTIV-G 2.5 (PYUD engine) with cylinder deactivation.

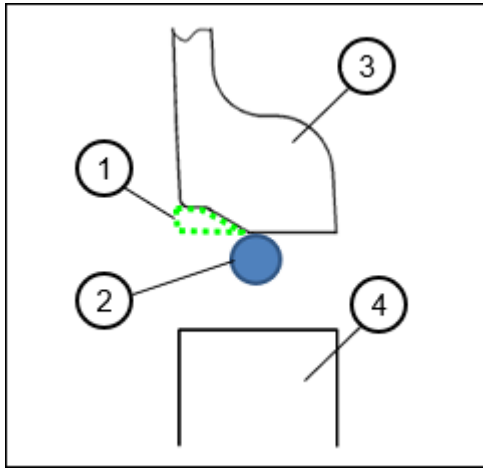
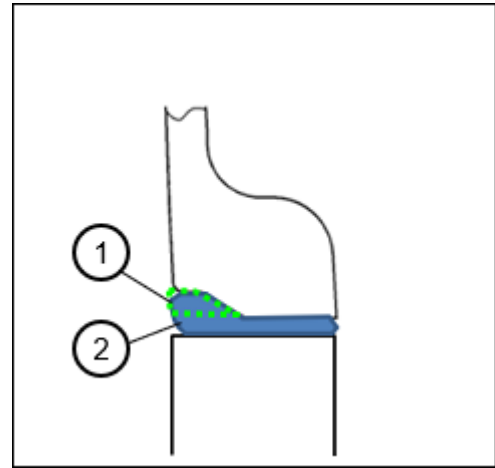
Sealant (2) spreads to the step bead (1) and sealing performance is ensured.

The following are required to achieve the effective sealing.

- 1 □ Clean and degrease the mating surfaces.
- 2 □ Apply the proper amount and location of sealant.

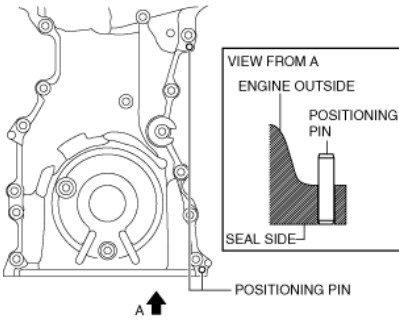
NOTE: For a new engine front cover, the positioning pins in the two locations shown below project to the outside of the engine.
