Technical Service Bulletin

Mazda North American Operations
Irvine, CA 92618-2922

Subject: WRINKLES ON LEATHER SEAT SURFACE OF NEW (UNSOLD) VEHICLE	Bulletin No.: 09-007/23
	Last Issued : 04/03/2023

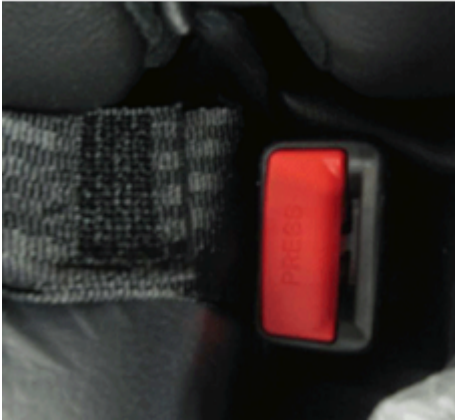
- **DO NOT** keep the iron in the same area for a long time. Doing so could damage the seat surface, as shown below.
- **DO NOT** run the iron without a water-soaked cloth, especially over the seat trim beading and seat side trim areas.
