Service Alert

Subject: CONNECTED VEHICLE SYMPTOM TROUBLESHOOTING	Service Alert No.: SA-009/23
	Last Issued : 04/25/2023

2019-2023 Mazda3
2020-2023 CX-30
2021-2023 CX-5
2021-2023 CX-9
2022-2023 MX-30
2023 CX-50
2024 CX-90

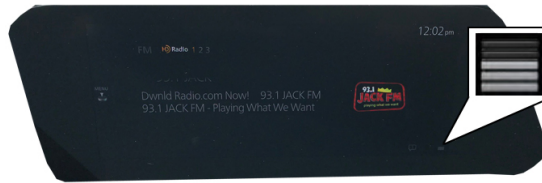
MAZDA CONNECT Indication

Radio waves are not being received. Move to a location with good reception.

Weak reception.

Good Reception

Strong reception.

Currently conducting an operation check of the communication unit. If this condition continues, consult an Authorized Mazda Dealer.

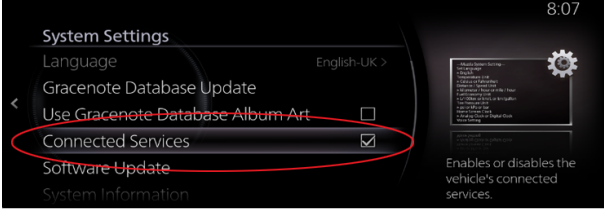
<p>Connected Services disabled (box unchecked)</p>

<p>Enable Connected Services (box checked) to prevent message appearing at engine start up.</p>

<p>Note: If customer Opted-Out (CSP04), advise customer to keep Connected Services box checked. The vehicle will not transmit data.</p>
<p>Connected Vehicle Maintenance Mode</p>

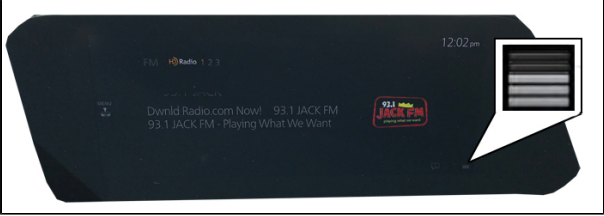
Infotainment Center Display	TCU Active	<p style="text-align: center;">Reception Icon Shows normal strength</p>

TCU in Deactivation Mode	<p style="text-align: center;">Reception Icon Shows "X"</p>

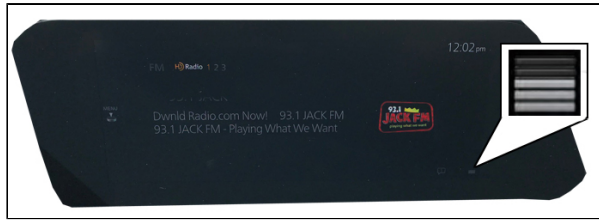
- If the reception icon shows "X", the vehicle is possibly in Deactivation Mode.

- Customer/Dealer can activate CV services anytime via MyMazda app (there just might be a slight delay in making the backend connection since it was temporarily deactivated).
- If the reception is weak, move the vehicle to a location where the reception is good to strong as shown in the table, then try to get the Authorization Code and/or operate the remote functions before proceeding to the Repair Procedure if there is still an issue.
- If the reception is good to strong, proceed to Connected Vehicle Troubleshooting below.

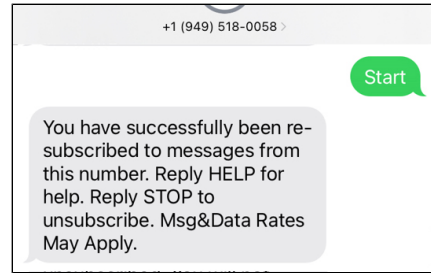
The customer is not able to create a MyMazda account. The customer receives the following error:

MyMazda App - Internal Usher SDK error.

MyMazda Website - ERROR! Unable to send one-time password.

Customer inadvertently texted "Stop" to 1-949 518-0058 (Twilio SMS for Mazda)

1. Text "Start" to 1-949 518-0058 (Twilio SMS for Mazda)
2. Retry to create a MyMazda account.
