## Corrective Action Report (8D)

| <b>2A</b> | Describe the Problem: Loose bottom lifting bracket screw at the customer site leading to the engine falling off and causing safety issue while lifting the engine. | | |
| | Lifting Bracket capscrew (LA 9172 option) | 3903990 | B6.7 300 HP-2023 |

## QUALITY ALERT

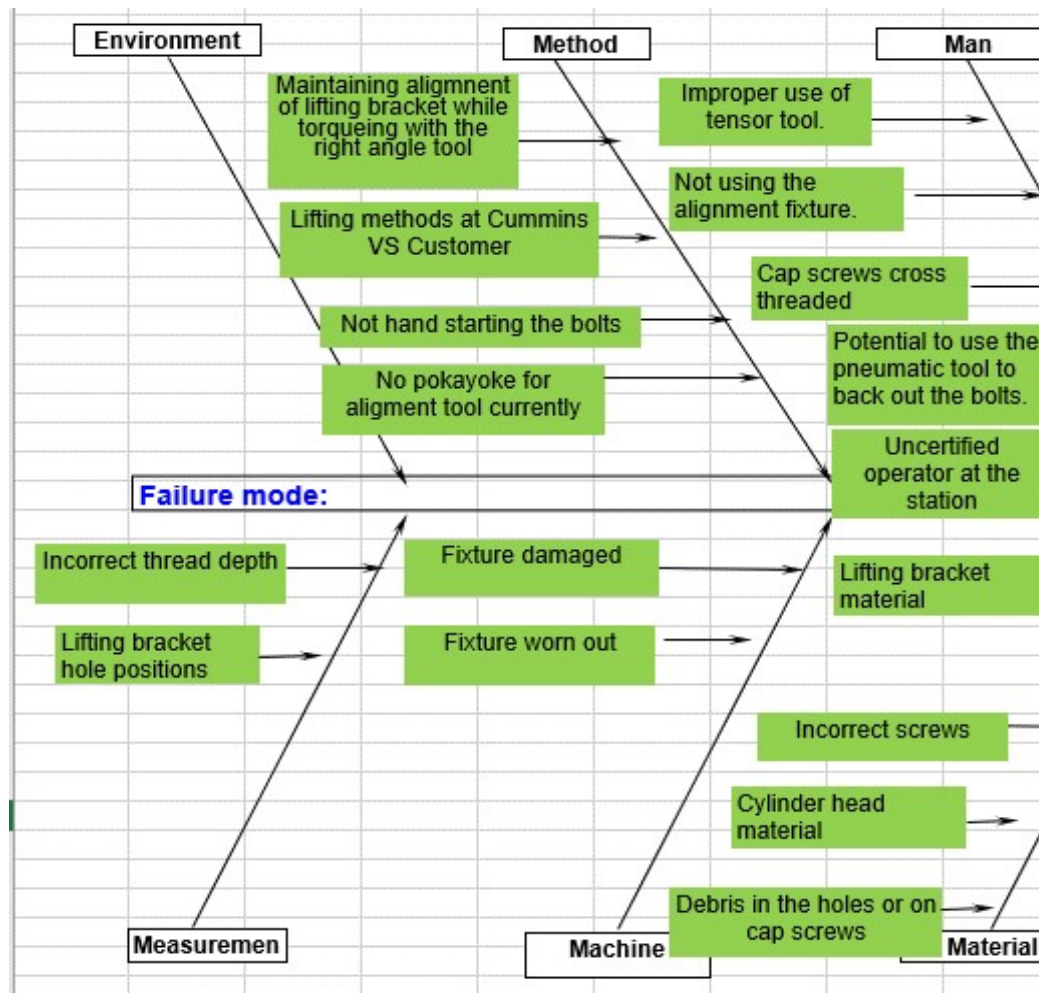
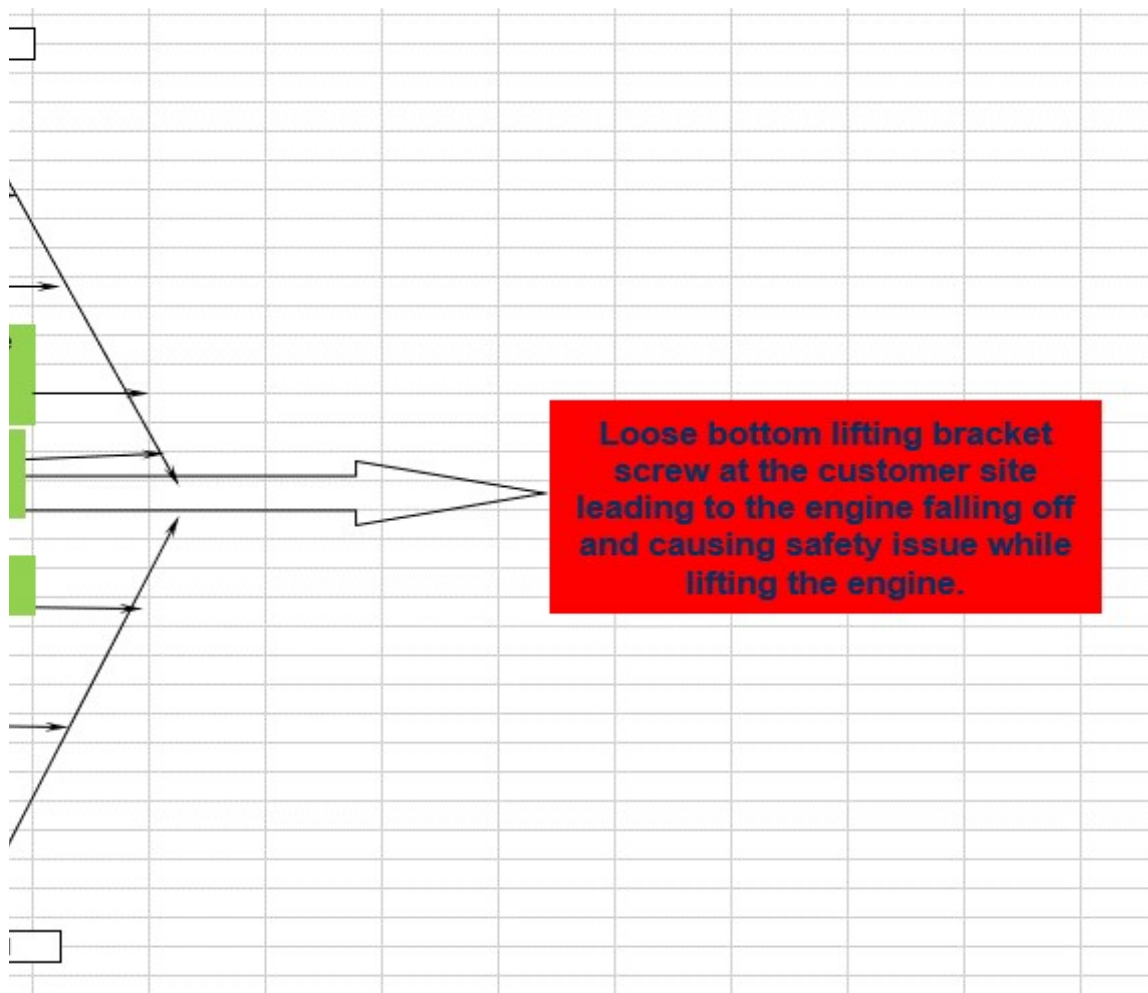
Due to recent (B.I.S.) Lifting Bracket Cap Screw not Torque causing a Catastrophic Damage to Engine.  
Operators that Run Critical Torque Station 4860:  
Operators Need to Verify Lifting Bracket Cap Screws are Torque .
