# Service Bulletin

Bulletin No.: 21-NA-268

**Subject:** Information on Crank No Start or Extended Crank, Malfunction Indicator Lamp (MIL) Illuminated - DTC P0014, P0017, P0365 and/or P0366 Set

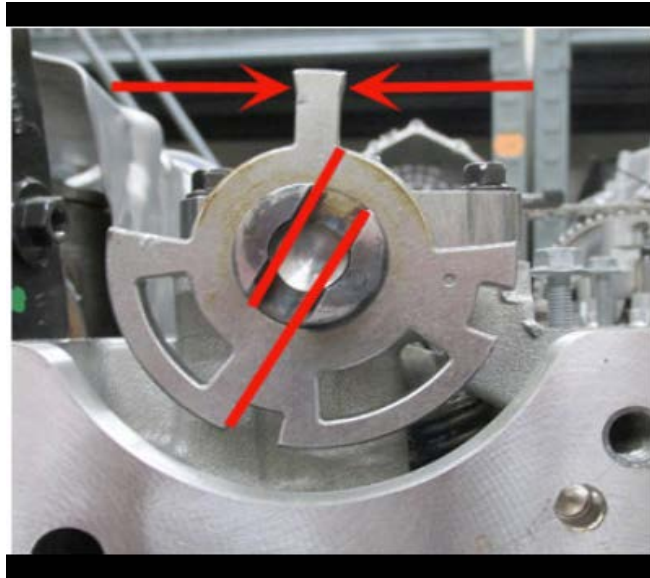
5921666

⇒ Once the exhaust camshaft 2D matrix has been positioned at 12' o'clock, verify the small tang located on the camshaft reluctor ring (Arrows below showing tang on reluctor) is in-line with the 2D matrix marking.

**Important:** If the reluctor is out of phase, inspect the exhaust camshaft position actuator dowel pin for damage..

If you find the vacuum pump drive lugs are broken and/or the exhaust camshaft reluctor is out of position, then replacement of the exhaust camshaft and vacuum pump will be required.

**Note:** If needed, It will also be necessary to locate and remove the broken vacuum pump drive lugs and other metal debris during repairs.
