| | | <b>Tesla, Inc.</b><br>Service Bulletin | | <b><i>Reseal Trunk Lid to Prevent Water Ingress</i></b> | |
| <b>SB-23-10-002</b><br>April 27, 2023 | | <b>R2</b> | | | |
| 2017 - 2023 | Model 3 | All | | Fremont | |

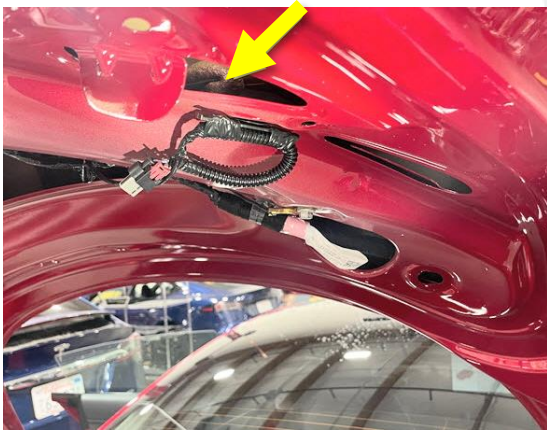
Figure 2 – LH factory foam inside trunk lid; RH similar

1. Remove the trunk lid trim (refer to Service Manual procedure [15111902](#)).
2. Remove the LH and RH rear fog/reverse lights (refer to Service Manual procedure [17402702](#)).
3. Remove and discard the factory foams (x2) (Figures 1–4) located under the LH and RH lamp can panels inside the trunk lid.

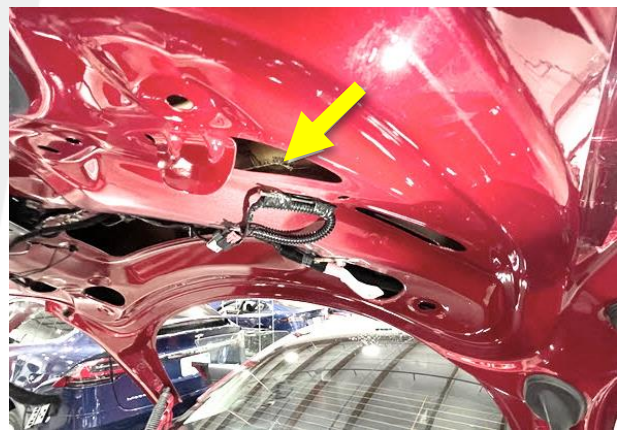
Figure 3 – LH factory foam removed from the trunk lid; RH similar
