Service Bulletin

Bulletin No.: 16-NA-405

Subject: Poor Engine Performance in Extremely Cold Weather Conditions, PCV Bypass Hose and Charge Air Cooler Icing for LUV Engines, Malfunction Indicator Lamp (MIL) Illuminated - DTC P0299, P0234, P2227, P00C7 Set

Brand:	Model:	Model Year:		VIN:		Engine:	Transmission:
		from	to	from	to		
Buick	Encore	2013	2021	Refer to Parts Information section for breakpoints.		1.4L (RPO LUV)	—
Chevrolet	Trax

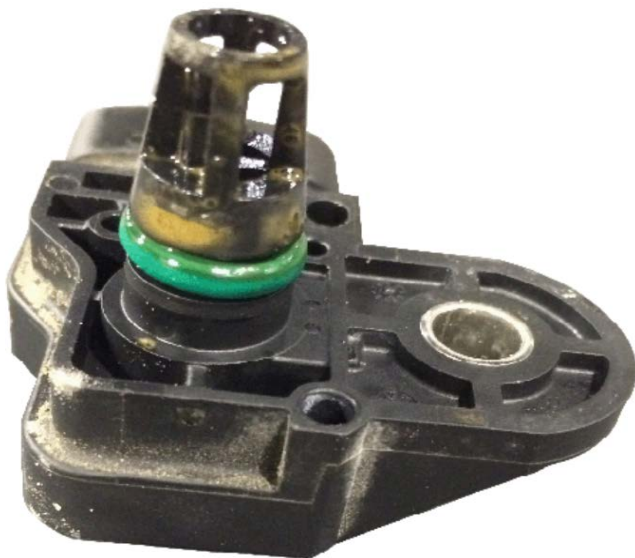
4910683

2. Inspect the IAPT sensor for any contaminants.

Important: Due to the sensitivity of the IAPT, **Do Not** use any chemical cleaners including water and **Do Not** use compressed air to remove contaminants.
