# Service Alert

<b>Subject:</b>  <b>CONNECTED VEHICLE SYMPTOM TROUBLESHOOTING</b>	<b>Service Alert No.:</b> SA-009/23
	<b>Last Issued :</b> 05/24/2023

2019-2023 Mazda3  
2020-2023 CX-30  
2021-2023 CX-5  
2021-2023 CX-9  
2022-2023 MX-30  
2023 CX-50  
2024 CX-90

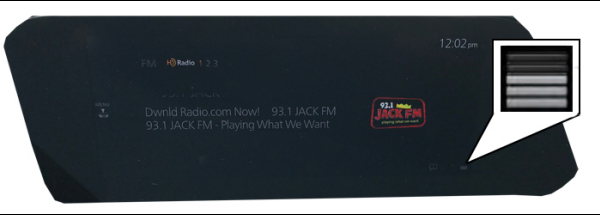
<p>Infotainment Center Display</p>	<p><b>TCU Active</b></p>	<p><b>Reception Icon Shows normal strength</b></p>

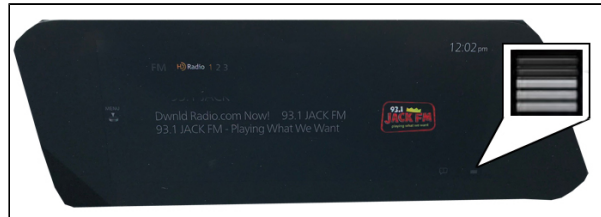
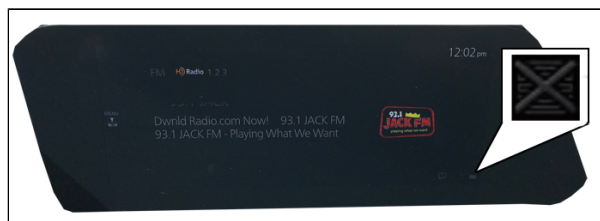
- If the reception icon shows "X", the vehicle is possibly in Deactivation Mode.

- Customer/Dealer can activate CV services anytime via MyMazda app (there just might be a slight delay in making the backend connection since it was temporarily deactivated).
- If the reception is weak, move the vehicle to a location where the reception is good to strong as shown in the table, then try to get the Authorization Code and/or operate the remote functions before proceeding to the Repair Procedure if there is still an issue.
- If the reception is good to strong, proceed to Connected Vehicle Troubleshooting below.

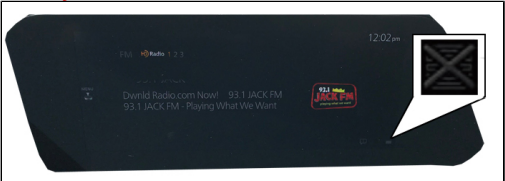
Engine started with key transmitter instead of MyMazda App.	Advise customer they will see an error message when attempting to make a Remote Engine Off request if they initially turned on vehicle with a physical key (instead of through their MyMazda app).
3	No One Time Passcode (OTP) (Vehicle infotainment center display does not provide the Authorization Code during the MyMazda App enrollment)	<p><b>Deactivation Mode</b></p> <ol style="list-style-type: none"> <li>1. Check the reception level strength on the mobile device and vehicle. If weak, move to a location with good strength and retry.</li> <li>2. If the vehicle reception strength icon shows "X", the vehicle may be in Deactivation Mode.</li> </ol>

<ul style="list-style-type: none"> <li>• Wait 30 minutes to an hour until the reception icon shows normal reception.</li> </ul>

- Repeat the enrollment process.

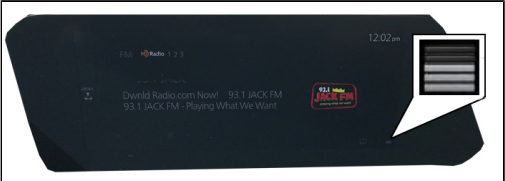
4	<p>MAZDA CONNECT connected vehicle reception strength icon shows "X" or "\". Mazda3, CX-30, CX-50, MX-30</p>

<p>Campaign Status</p>	<p>Go to <a href="#">eMDCS Vehicle Inquiry</a> and confirm the following campaigns are not shown or closed:</p> <ul style="list-style-type: none"> <li>• CSP06</li> <li>• CSP07</li> <li>• SSPC7</li> <li>• DRW41</li> </ul>
