SERVICE BULLETIN

APPLICABILITY: 2019-23MY Impreza
 2019-23MY Crosstrek (Including Hybrid Model)
 2019-23MY Forester
 2019MY Legacy/ Outback
 2019-21MY WRX
 2019-21MY WRX STI
 2019-21MY BRZ- Navigation -equipped ONLY
 2019-22MY Ascent

NUMBER: 15-236-18R

SUBJECT: Reprogramming File Availability for Optimization of Harman Gen 3.1 and Gen 3.1α Audio and Navigation Head Units

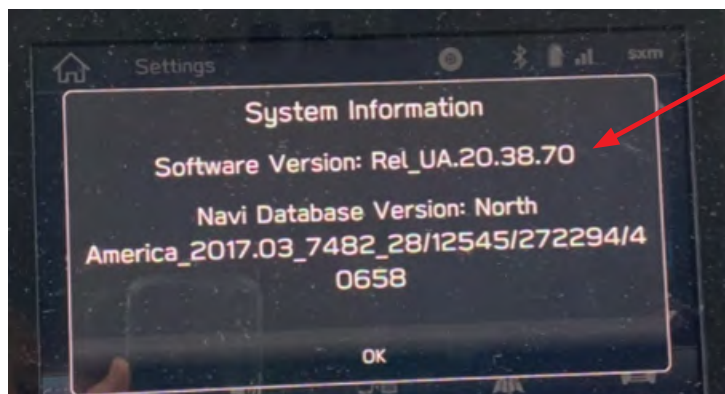
- The currently installed software version will be displayed. If the Software Version is **Rel_UG.22.13.70 or Rel_UG.22.39.70** NAVI only, (or before), proceed to **Step 2**.

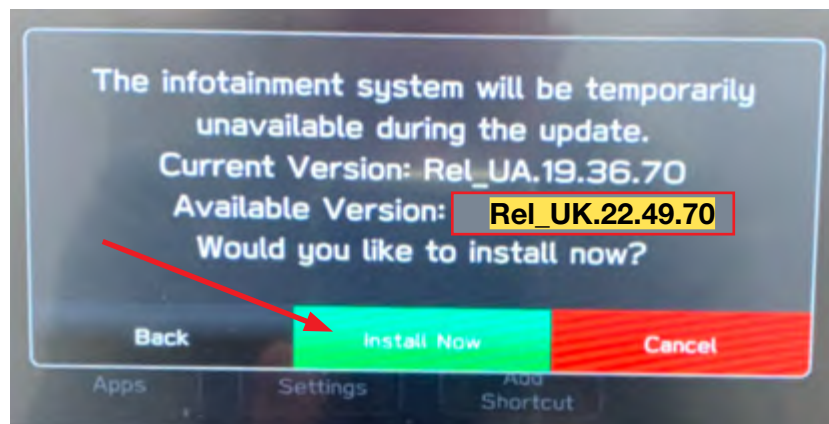
- The current and available software version information will be displayed. The Available Version I.D should be **Rel_UK.22.49.70**.

- After confirming the Available Version, press “Install Now” to start the reprogramming process. The screen will go blank (black) for a brief period after installation begins.
- Each of the updates (Base, Mid and High) should take less than 10 minutes to install.

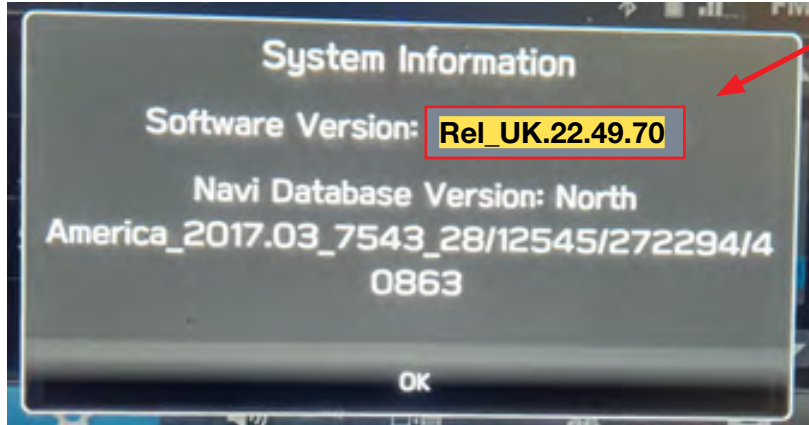
- Confirm Software Version is now “**Rel_UK.22.49.70**”.
